**Chemung County Stormwater  
Construction Inspection  
Erosion and Sediment Control**

<b>Project Name</b> NYSEG Substation Transmission Project	<b>Date</b> 1-16-2020
<b>Location</b> Watercure Hill Elmira (T), NY	<b>Permit #</b> NYR11F644
<b>Weather Conditions</b> cold, windy, rain/snow	<b>Entry Time:</b> 7:51 am
<b>On-Site Representative Present:</b> Brain Bury, NYSEG / Representatives from BlueRoc	<b>Exit Time:</b> 9:01 am

PROJECT: NYSEG Substation  
Town of Elmira  
Municipal Inspection  
January 16, 2020

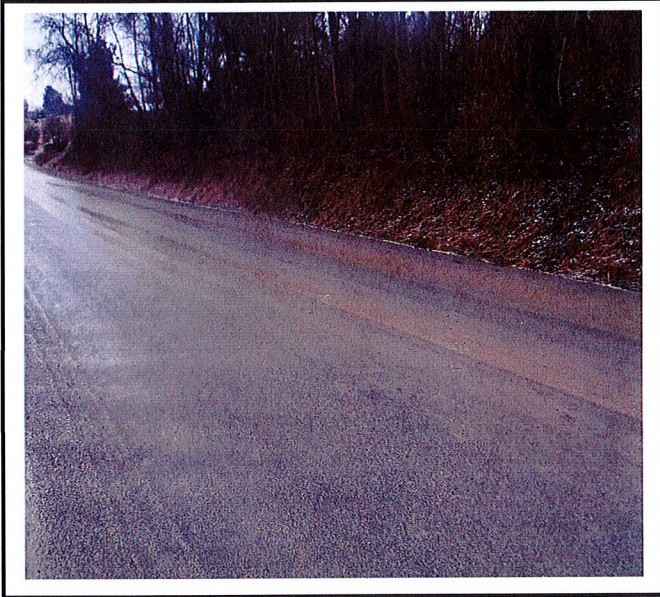
Mud tracked onto Watercure Hill Road.

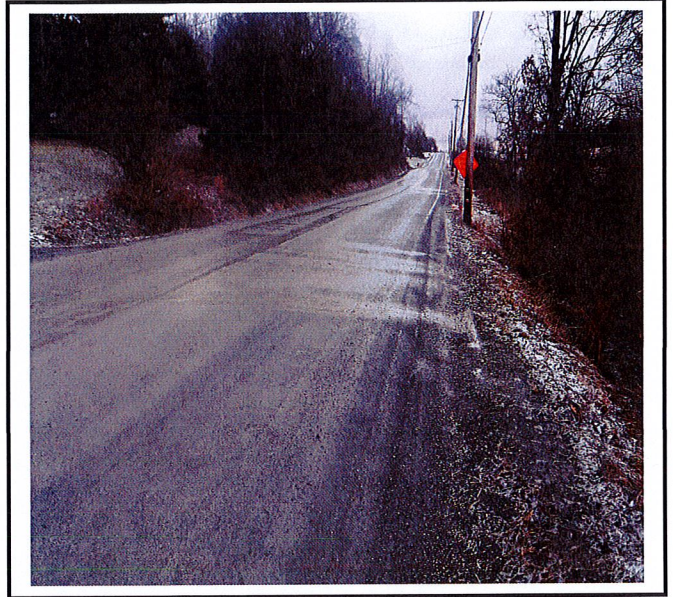
Rain has caused sediment tracked from site to runoff road.

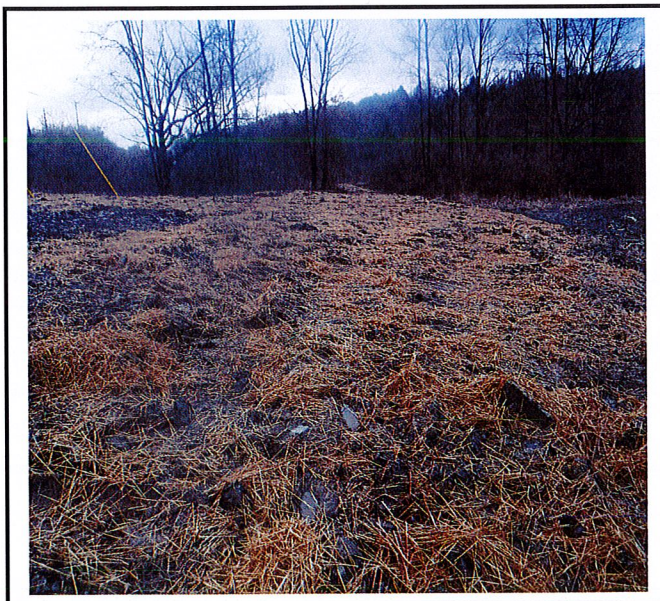
Straw mulch does not meet stabilization standards.

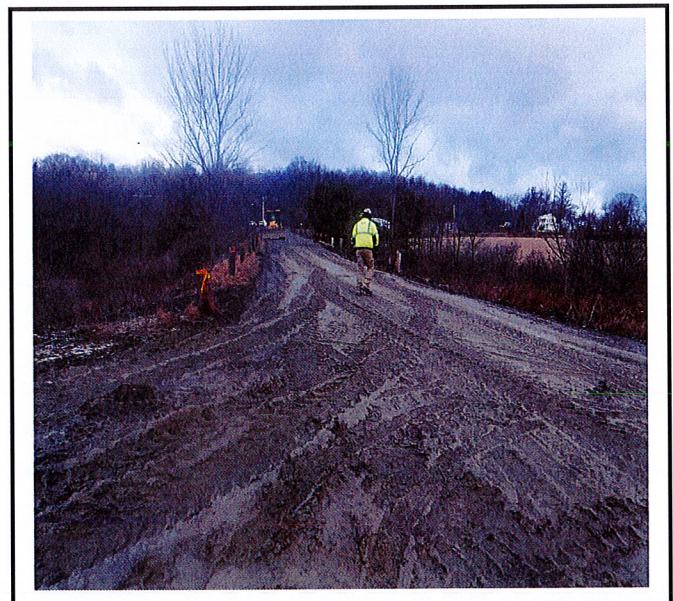
Road into substation many inches thick of mud.
