**Chemung County Stormwater
Construction Inspection
Erosion and Sediment Control**

| Project Name Dollar General Southport | Date 12-11-19 |

PROJECT: Dollar General Southport
Town of Southport
Municipal Inspection
December 11, 2019

BY: Jessica Verrigni, CPESC, CPSWQ

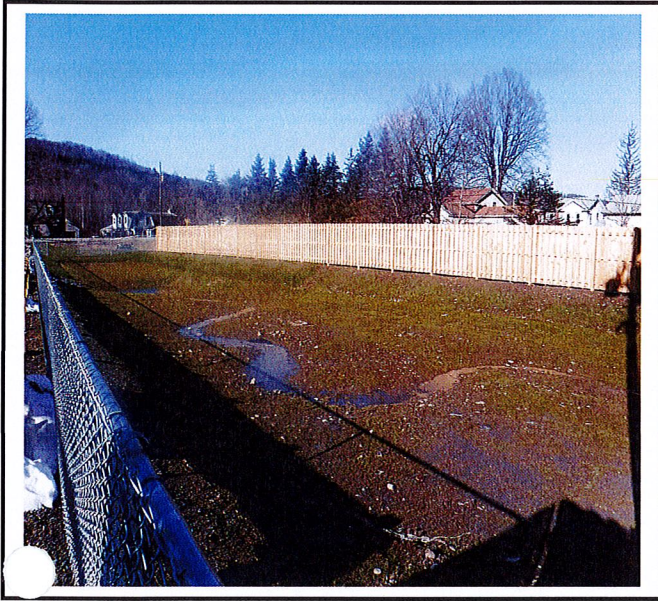
| -Trash and debris from the store is blowing around the entire site. |

Trash and debris in the pond.

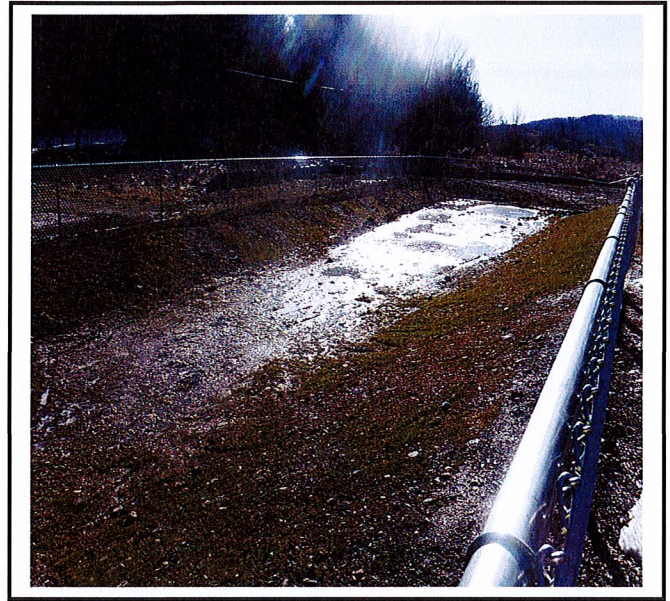
Area where wetland plants are supposed to be planted.

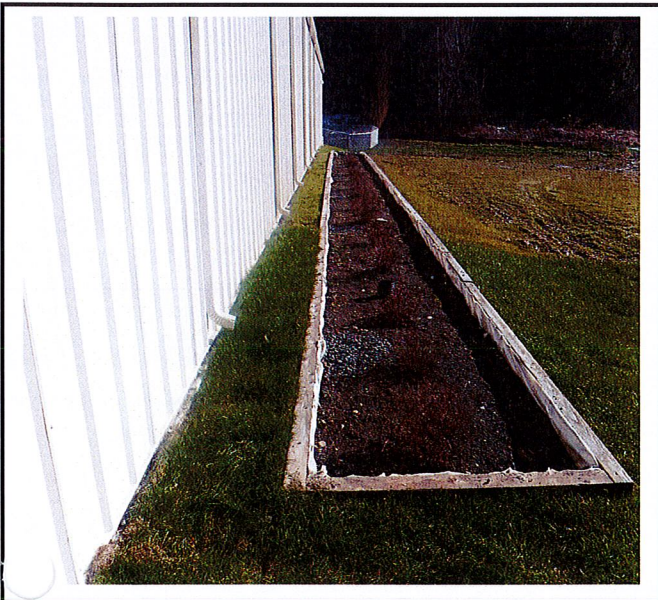
| -roof drains have not been connected to the tree planter box. |

Roof leaders are still not connected to the tree planter box. Erosion is occurring on the end closest to the stormwater basin.

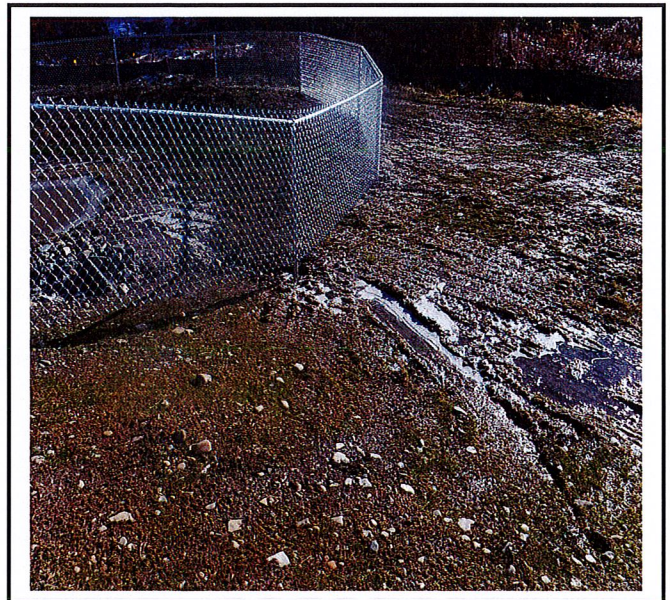
| -Grades have been disrupted from construction traffic and have created low spots, compacted spots and other drainage issues. |

Area not de-compacted, topsoiled or in good condition.
