**Chemung County Stormwater
Construction Inspection
Erosion and Sediment Control**

Project Name Villa's at Gardner Road	Date 5-24-2018
Location Lynhurst Ave. Village of Horseheads	Permit # NYR11A108
Weather Conditions Hot, sunny	Entry Time: 11:38
On-Site Representative Present: John Makinster-Bomack	Exit Time: 12:20

PROJECT:	Villa's @ Gardner Road Village of Horseheads MS4 Construction Inspection May 24, 2018
BY:	Jessica Verrigni, CPESC, CPSWQ

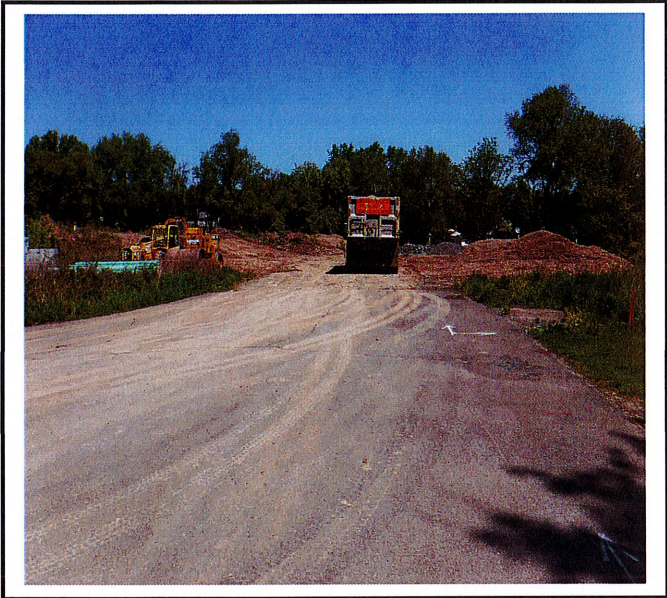
Construction Entrance requires maintenance.

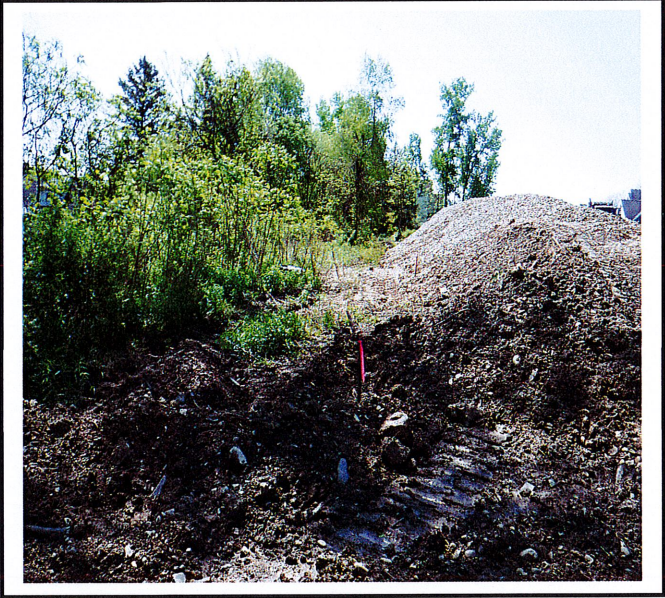
Silt fence is not installed at the toe of the slope between house lots and stormwater basin.

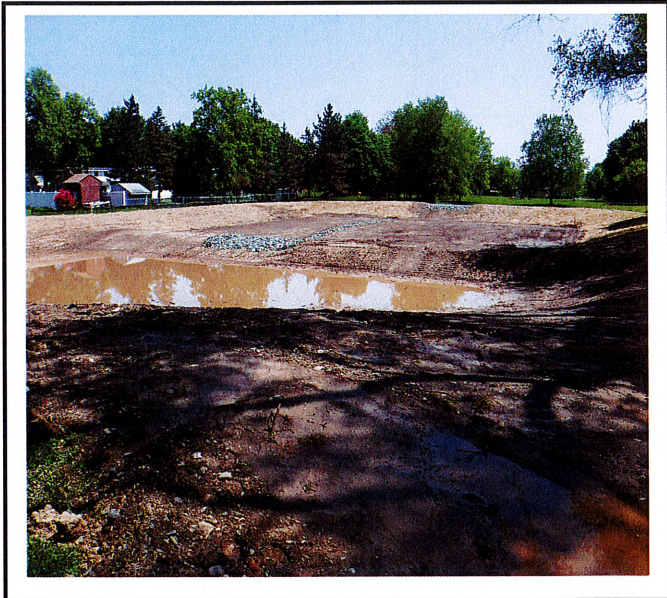
Stormwater Basin has been constructed. Recent rain events have caused erosion on the side slopes of basin. Forebay has taken substantial sediment.

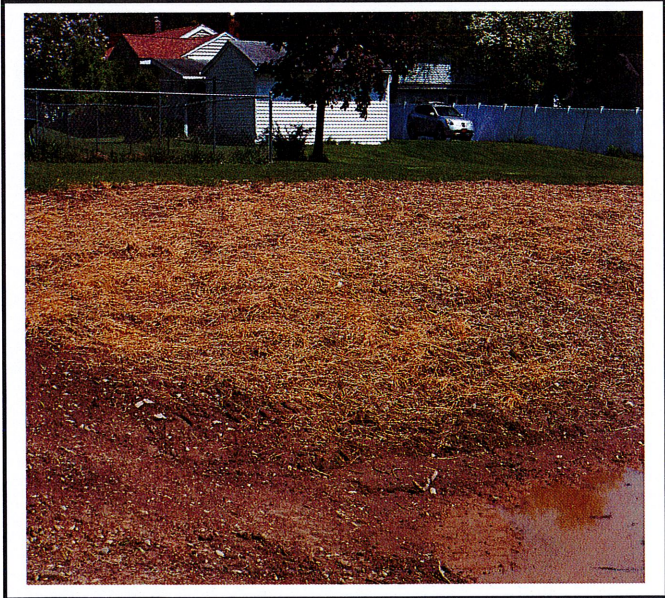
Mulch rates on side slopes does not meet the 2 tons per acre standard.

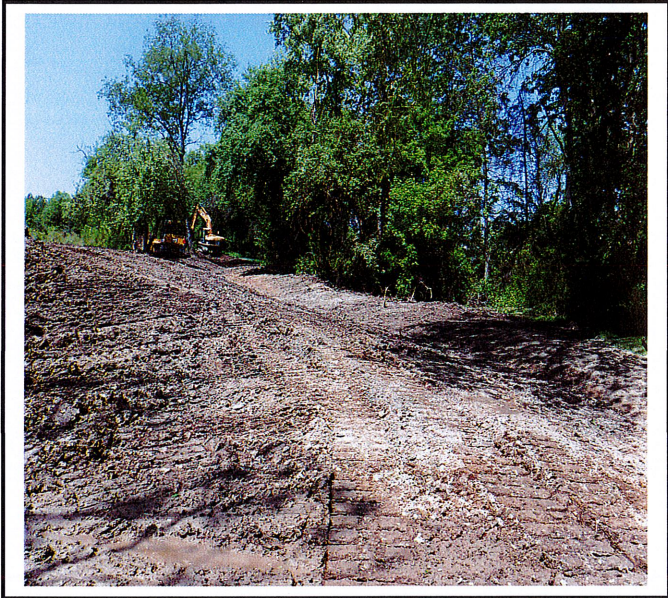
Drainage swale along north end of property being constructed.

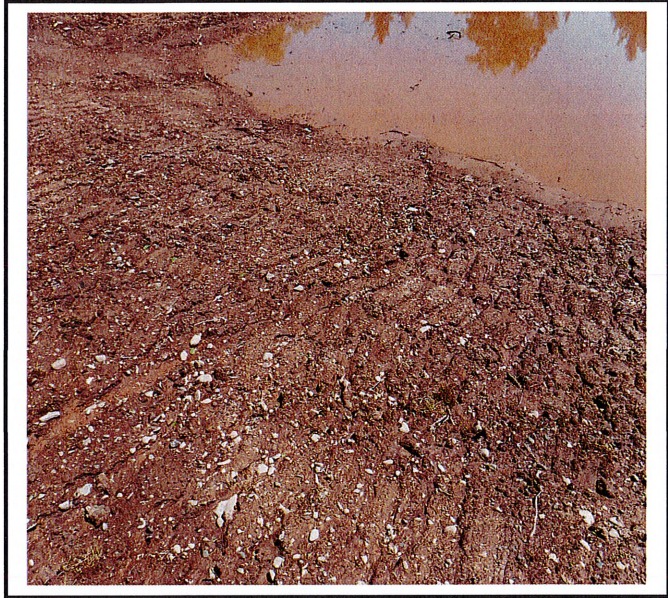
Erosion from heavy rain on the side slopes of the stormwater basin forebay.
