**Chemung County Stormwater
Construction Inspection
Erosion and Sediment Control**

Project Name Villa's at Gardner Road	Date 6-26-18
Location Lynhurst Ave. Village of Horseheads	Permit # NYR11A108
Weather Conditions Sunny, warm	Entry Time: 9:00
On-Site Representative Present: John Mackinster-Bomack	Exit Time: 9:40

PROJECT: Villa's at Gardner Road
Village of Horseheads
Municipal Construction Inspection
June 26, 2018

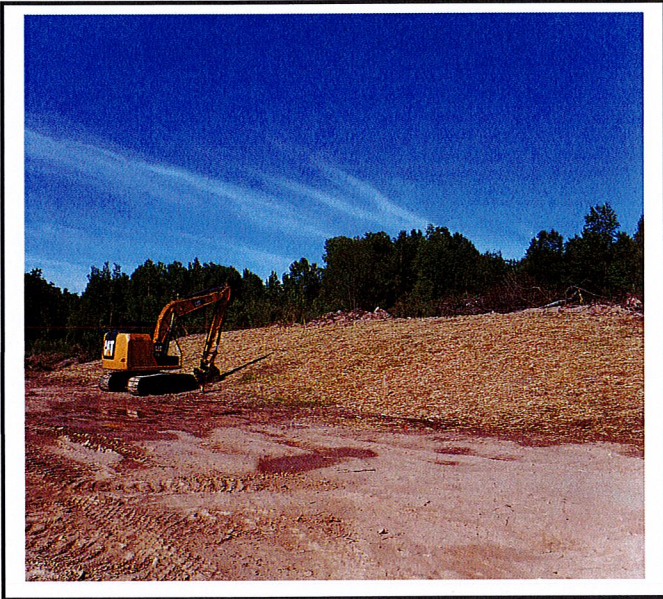
Slopes on west end of phase 1 have been properly stabilized.

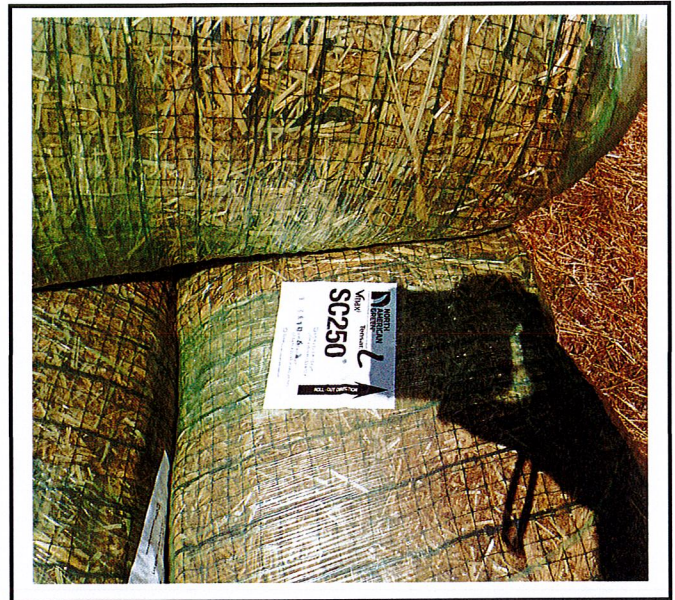
Turf Reinforcement Mat (TRM) on site for swale on north end of property.

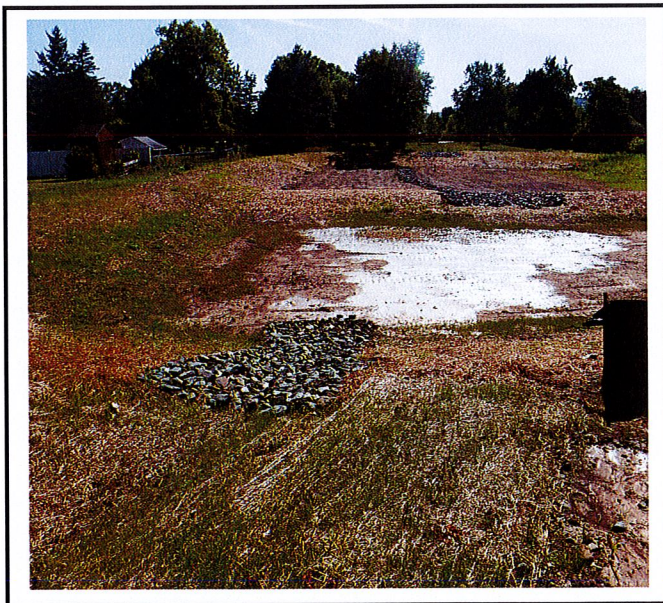
Stormwater forebay and retention basin.

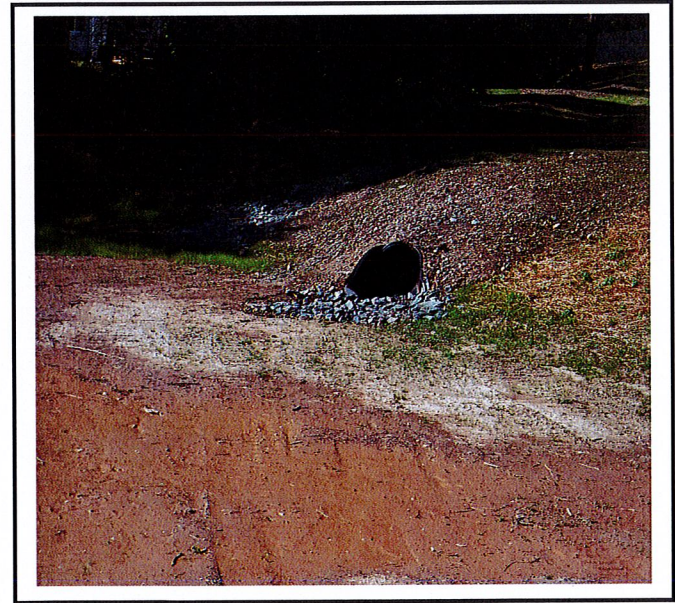
Swale inlet and storm sewer inlet on south side of forebay.

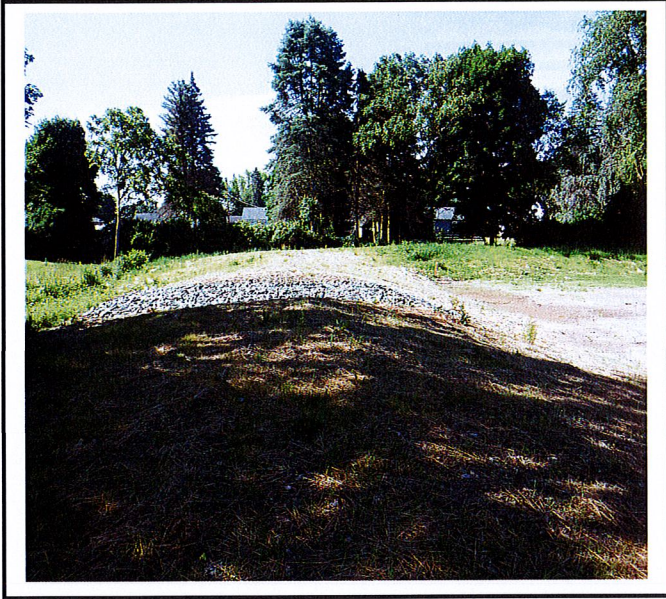
Emergency Spillway in stormwater retention basin.

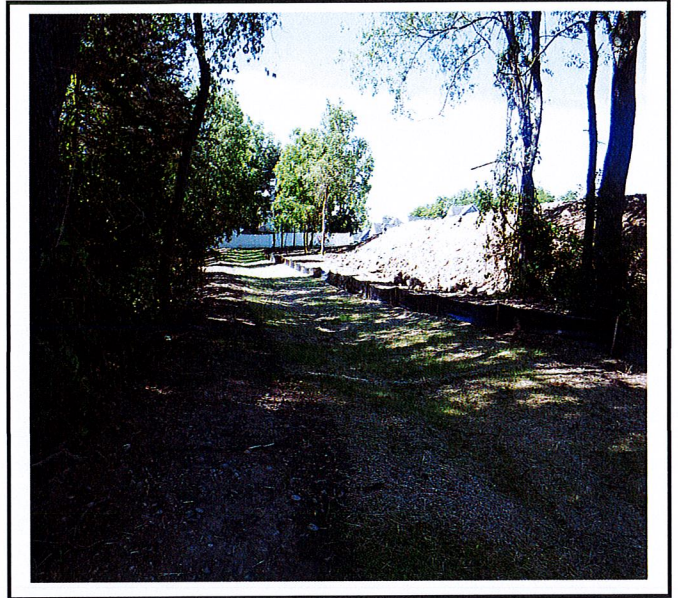
Swale along south end of Phase 1 is growing grass and been stabilized.

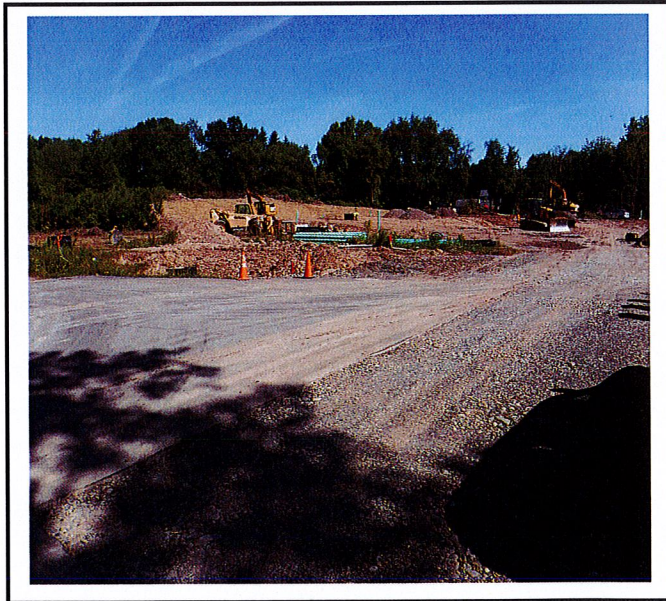
Construction entrance may need maintenance soon.

-Construction entrance will need maintenance soon.
