**Chemung County Stormwater  
Construction Inspection  
Erosion and Sediment Control**

<b>Project Name</b> Villa's at Gardner Road	<b>Date</b> 7-30-18
<b>Location:</b> Lynhurst Avenue, Horseheads (V)	<b>Permit #</b> NYR11B687
<b>Weather Conditions:</b> overcast	<b>Entry Time:</b> 11:44 am
<b>On-Site Representative Present:</b> none present	<b>Exit Time:</b> 12:30 pm

<b>PROJECT:</b>	Villa's at Gardner Road Village of Horseheads Municipal Construction Inspection July 30, 2018
<b>BY:</b>	Jessica Verrigni, CPESC, CPSWQ

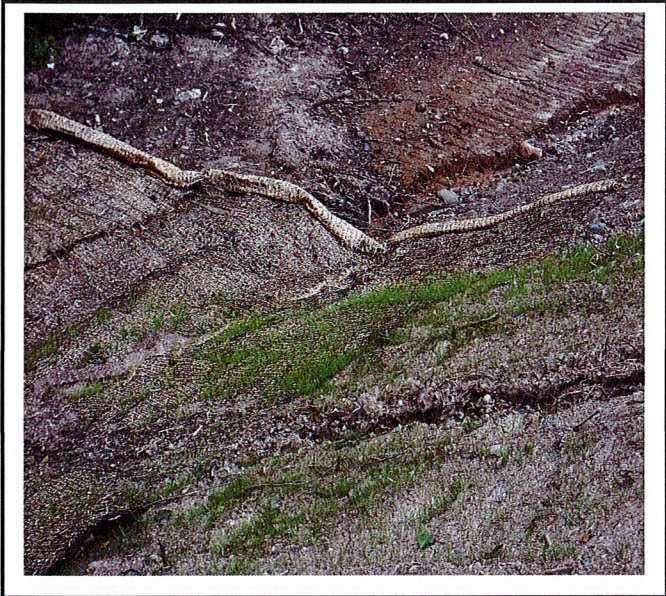
Erosion has occurred on the side slopes of the north drainage swale.

Corrections Needed:
-Swale along the North side of this project has had severe erosion occur. The erosion control blanket was not installed the entire length of the swale. Because of this major erosion has headcut up the swale and undercut the soils where blanket has been installed. This requires immediate repair.
-Soil Stabilization- Areas that remain idle for longer than 14 days require temporary or permanent stabilization. The slopes behind buildings 1,2 and 3 have been idle for many weeks. Because they were left exposed the slopes eroded.
-All eroded soil from the site has ended up in the stormwater forebays. These will need to be cleaned out prior to completion of the project.

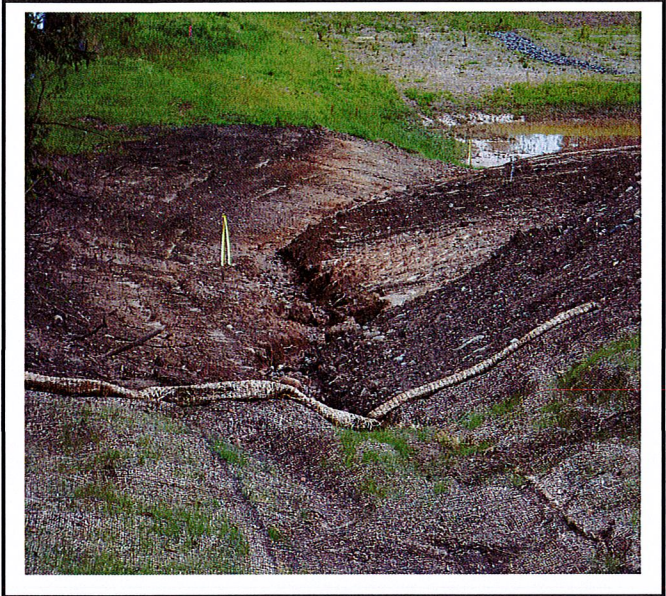
Erosion has occurred in the center of the swale where the erosion control blanket ends. The erosion has headcut under the blanket as well.

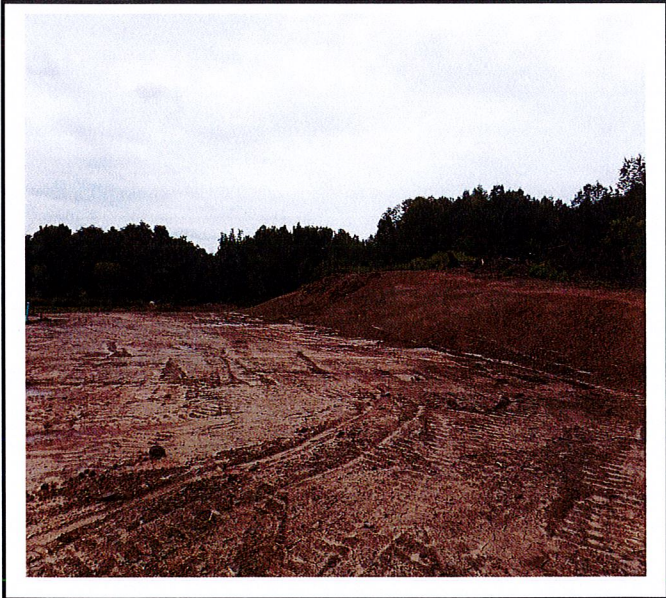
Graded areas around buildings 7,8, and 9.

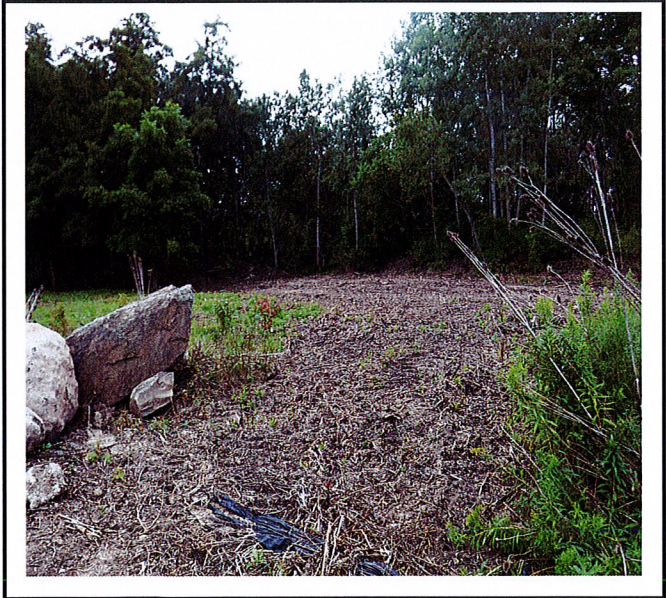
Graded area behind Lot #10 (Lynhurst Ave).

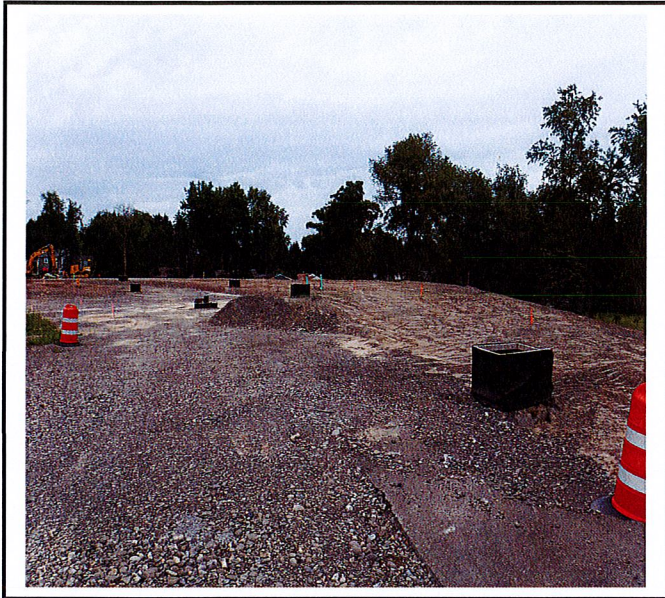
Site is being graded and storm sewer has been installed. All catch basins have protection.

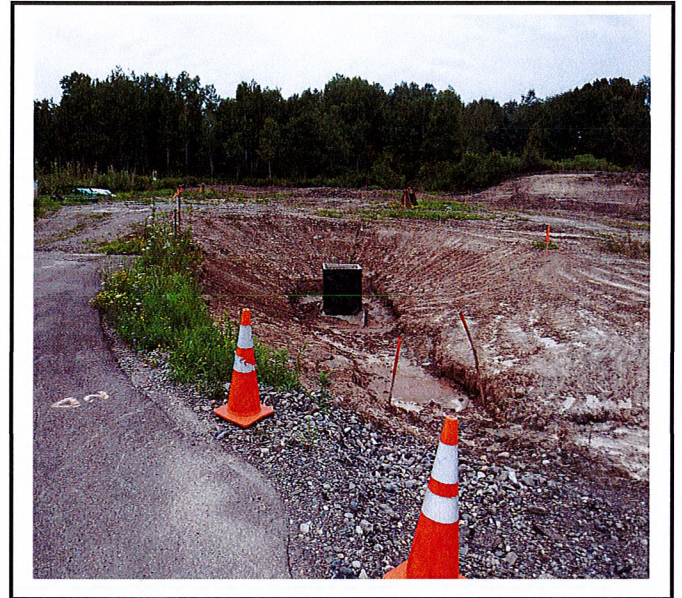
Erosion has occurred around the catch basin closest to Lynhurst Ave.

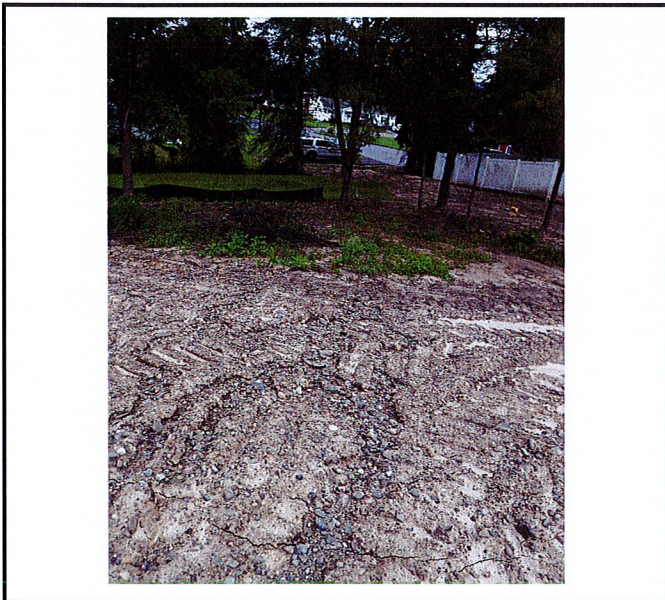
Slopes behind Building 1, 2 and 3 eroded. Open soil remaining idle for longer than 14 days requires temporary stabilization.

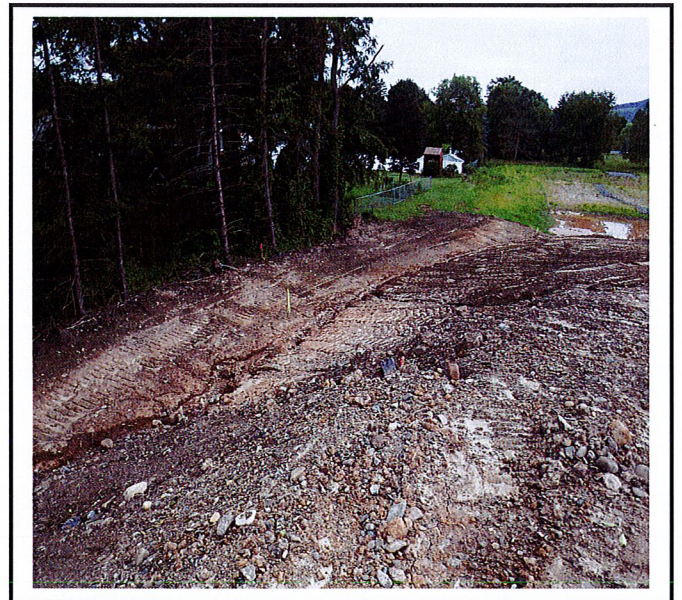
Erosion of the drainage swale along the North end of the property occurred where erosion control blanket was not installed.
