**Chemung County Stormwater  
Construction Inspection  
Erosion and Sediment Control**

<b>Project Name</b> Villa's at Gardner Road	<b>Date</b> 9-4-18
<b>Location</b> Lynhurst Ave. Village of Horseheads	<b>Permit #</b> NYR11B687
<b>Weather Conditions</b> Sunny, hot, humid	<b>Entry Time:</b> 11:17 am
<b>On-Site Representative Present:</b> None	<b>Exit Time:</b> 11:30 am

<b>PROJECT:</b>	Villa's at Gardner Road Village of Horseheads Municipal Construction Inspection September 4, 2018
<b>BY:</b>	Jessica Verrigni, CPESC, CPSWQ

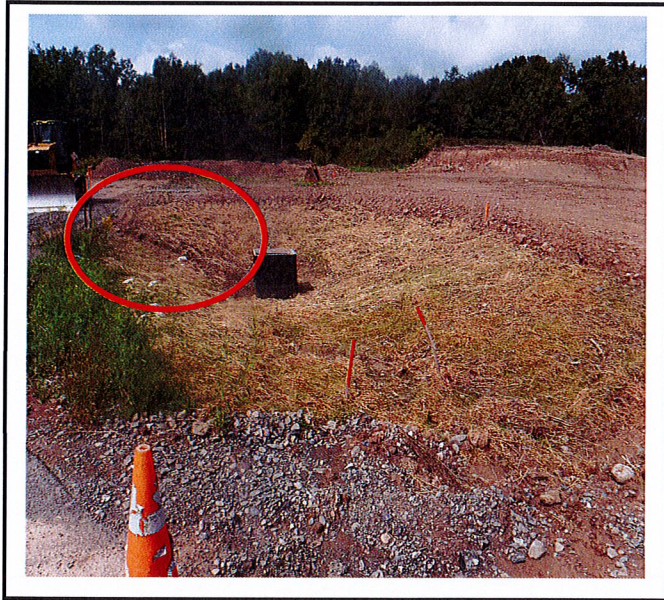
Erosion has started at side slopes leading to catch basin. Re-stabilizing side slopes will prevent further erosion.

-Slopes around the entire site are eroded. This erosion will not stop until they are stabilized. Some slopes are steep enough that they require erosion control blankets (discussed this with Karl from Fagan's). Stabilize slopes.

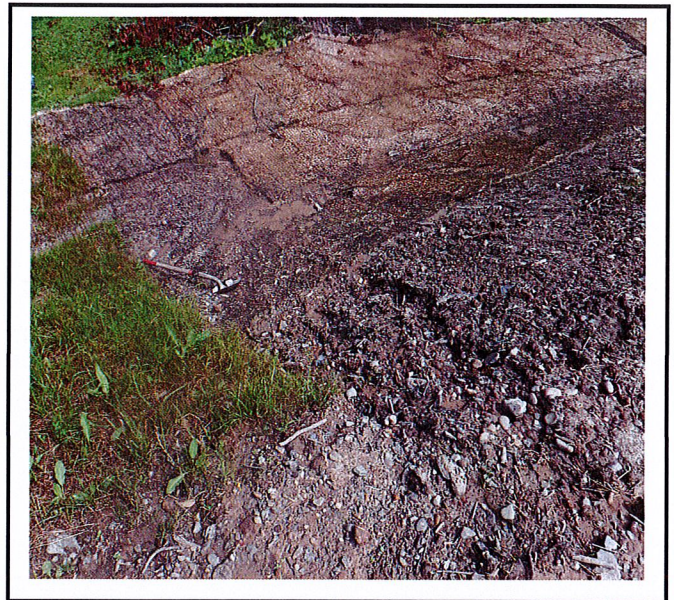
Eroded side slopes of north end drainage channel. All exposed slopes require stabilization.

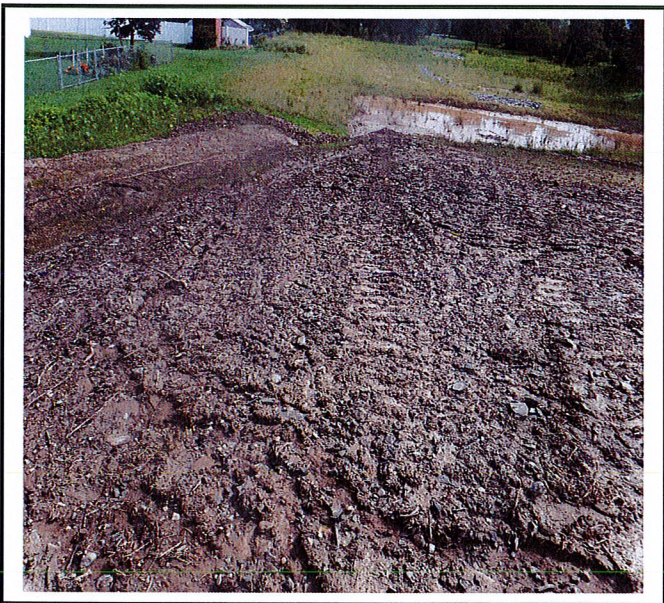
Eroded side slopes of north end drainage channel. All exposed slopes require stabilization.

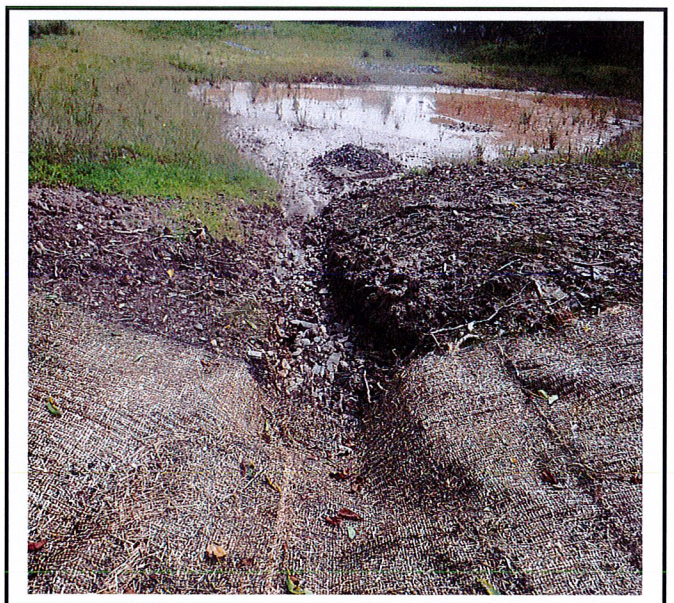
North end drainage swale needs to be re-graded, blanket added and rock outlet protection installed once forebay is cleaned out.

-North end drainage swale has major erosion that requires repair. Repair, stabilize and install proposed rock outlet protection once forebay is cleaned out.

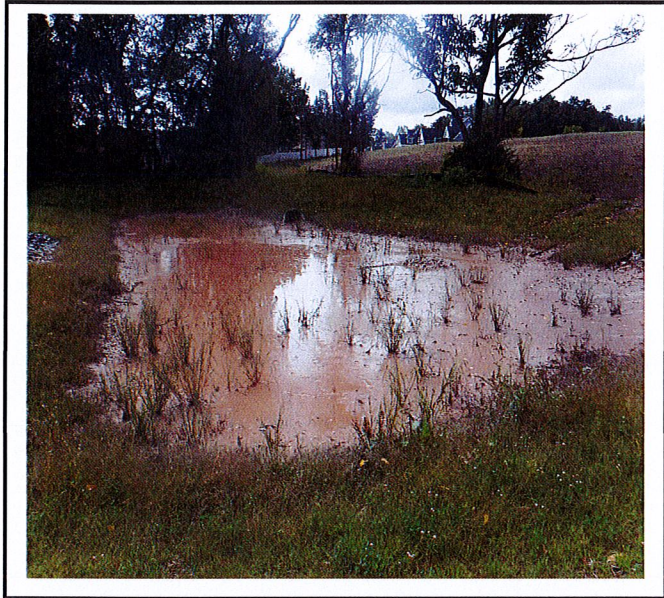
Stormwater forebay completely silted in. It will need to be cleaned out.

-Stormwater forebay has been completely silted in. It needs to be cleaned out and put back to design elevations. Until all erosion on site has been repaired and stabilized there is no point in cleaning out the forebay.

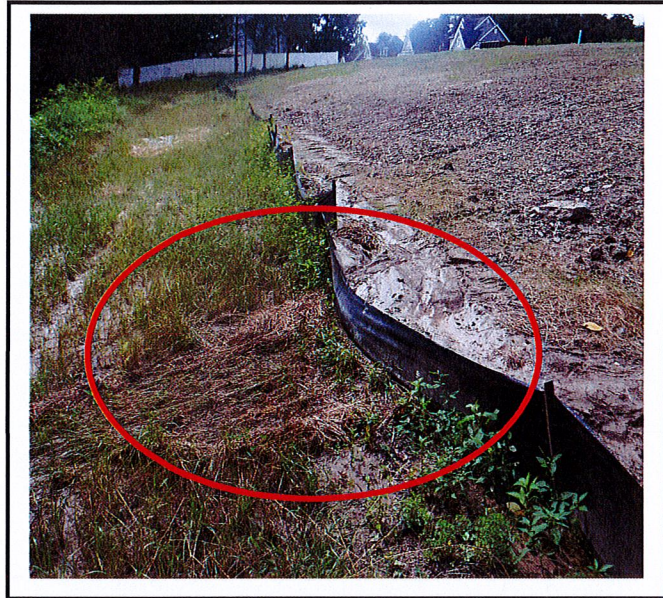
Silt fence requires replacement. Water and sediment have gone over and filled the drainage ditch on the east side of property.

-Silt fence requires replacement along east end of the property. See photos for explanation.

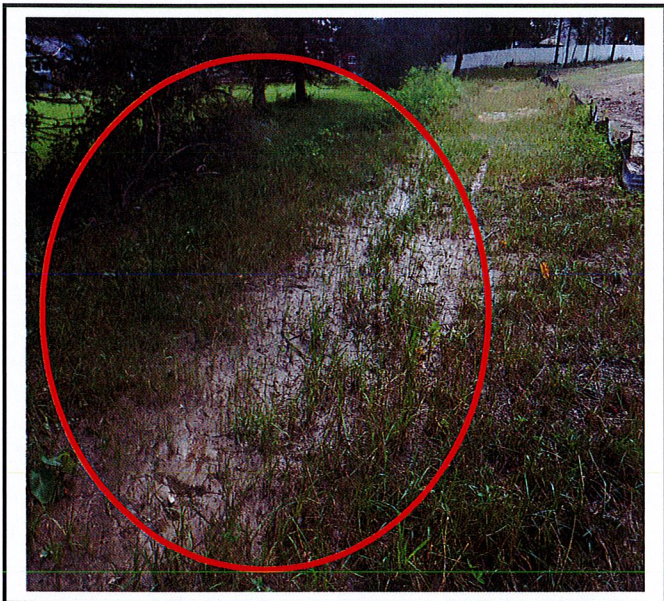
Sediment that went over silt fence has filled the east end drainage swale.

**Corrections Needed:** -East end drainage swale/ maintenance easement area is silted in and will need to be re-shaped.

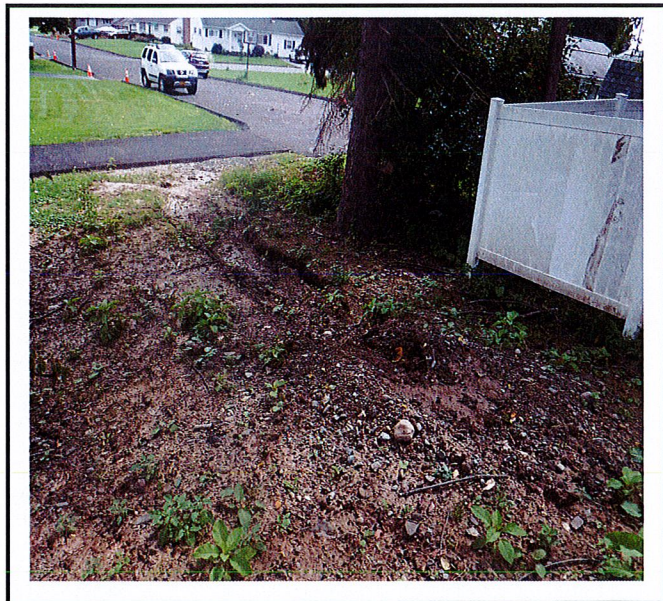
10' utility easement needs to be stabilized.

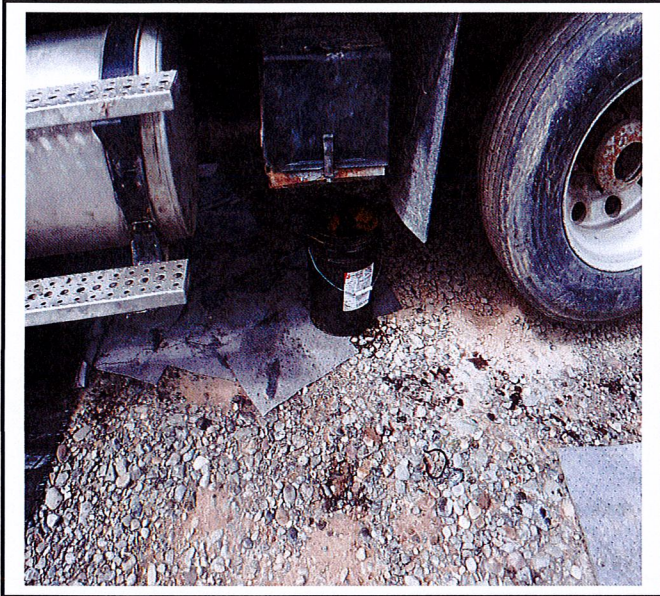
Reportable spill has occurred on construction site on the ground.
