**Chemung County Stormwater  
Construction Inspection  
Erosion and Sediment Control**

| <b>Project Name</b> Villa's | <b>Date</b> 1-29-20 |
| <b>Location</b> Lynhurst Ave, Horseheads (V), NY | <b>Permit #</b> NYR11P622 |

**PROJECT:** Villa's at Gardner Road  
Village of Horseheads  
Municipal Inspection  
January 29, 2020

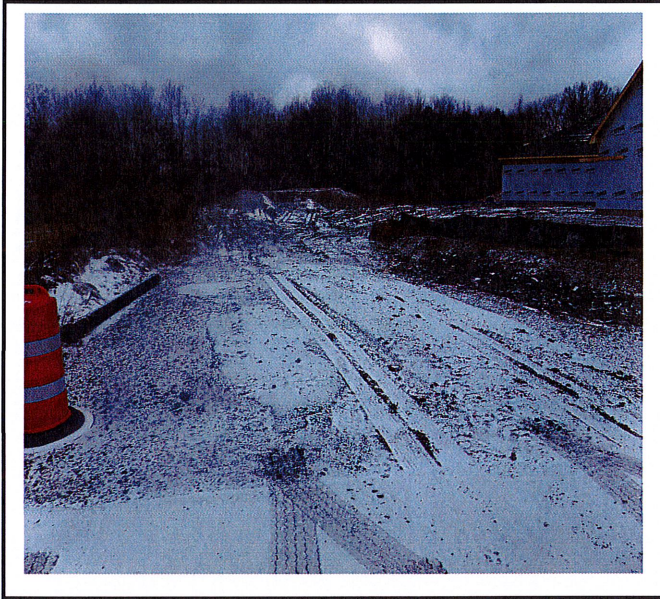
Construction Entrance to the constructed road for phase 2 has not been installed. Traffic from the lots that are under construction are using this road and sediment is being tracked onto the road.

Construction entrance has not been installed at this location. This is the road to Phase II and traffic is using it.

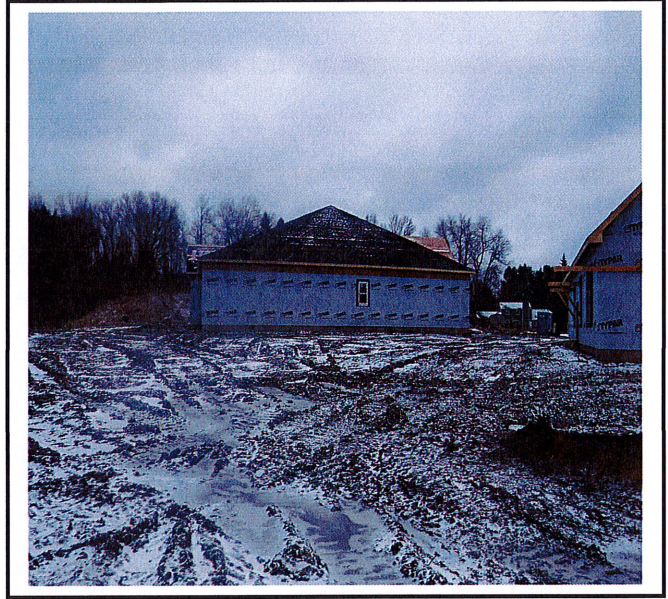
Lot #9 has no erosion and sediment controls installed at all. The area surrounding the house is rutted up from construction. Lot 9 has opened soil on Lot 8.

Lot 9 has no erosion and sediment controls installed.

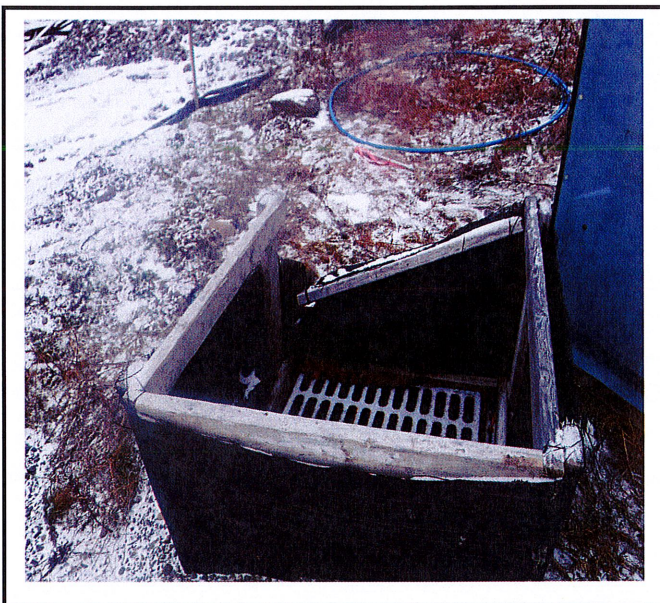
*-CB 7 inlet protection broken and requires repair*

CB 7 drop inlet protection requires repair and maintenance.

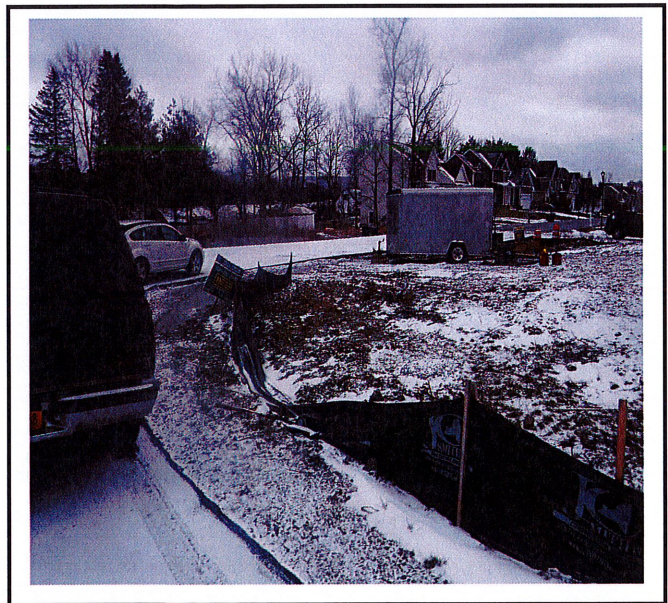
Lot #10 The silt fence on this lot has required maintenance for months. The qualified inspector has noted the issue as well.

Silt fence around Lot 10 continues to be left unmaintained.
