**Chemung County Stormwater
Construction Inspection
Erosion and Sediment Control**

Project Name Villa's at Gardner Road	Date 9-24-20
Location Lynhurst Ave Horseheads, NY	Permit # NYR11A108
Weather Conditions sunny	Entry Time: 12:06 pm
On-Site Representative Present: Jim Clark	Exit Time: 12:37 pm

PROJECT: Villa's at Gardner Road
Village of Elmira Heights
MS4 Construction Inspection
September 24, 2020

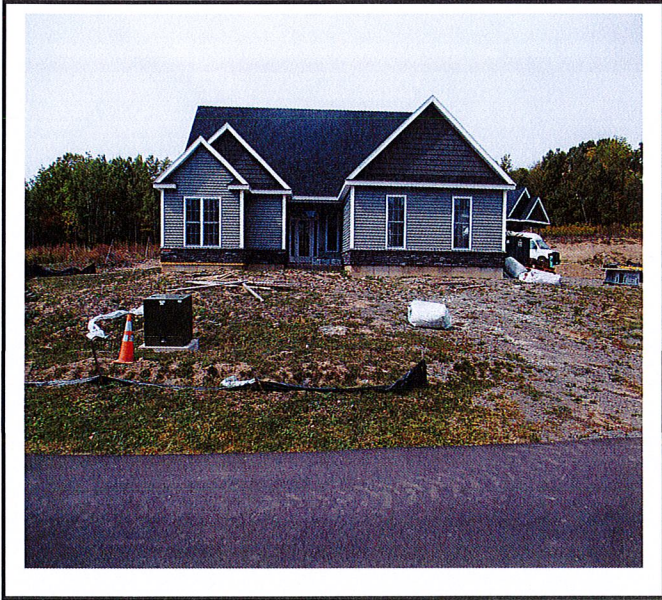
No E&S controls are being maintained.

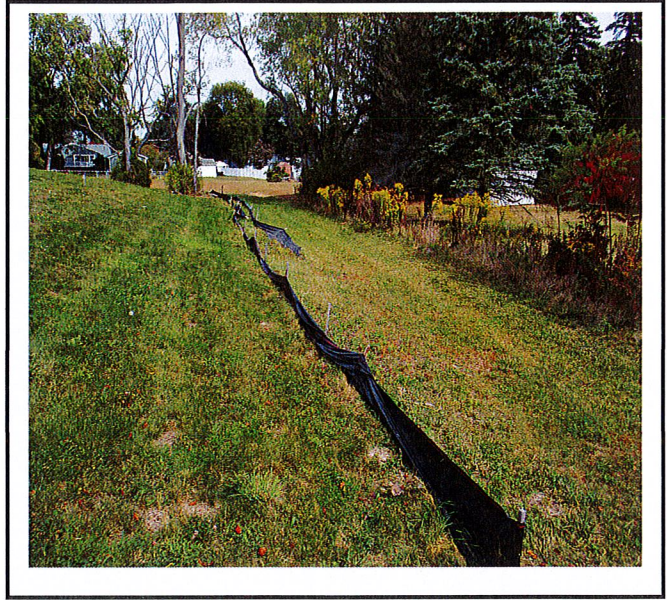
This line of silt fence can be removed. Grass is 80% vegetated and there is no active construction. Will need to be reinstalled on individual lots when built.

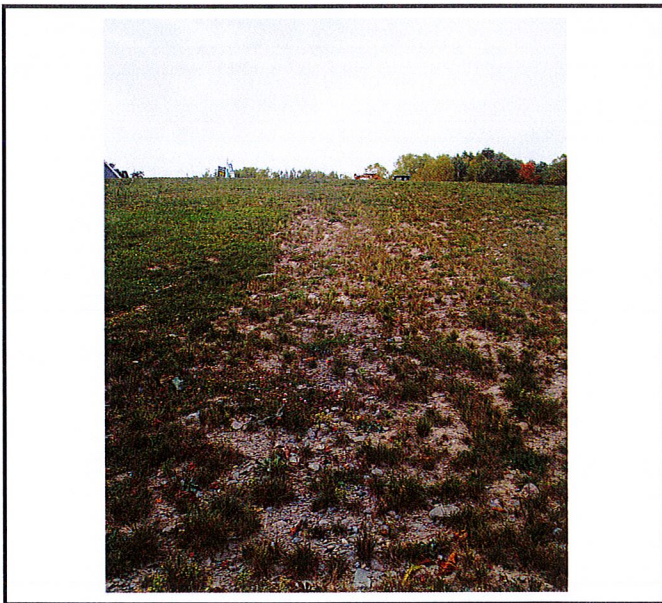
Stabilization required in areas of bare soil.

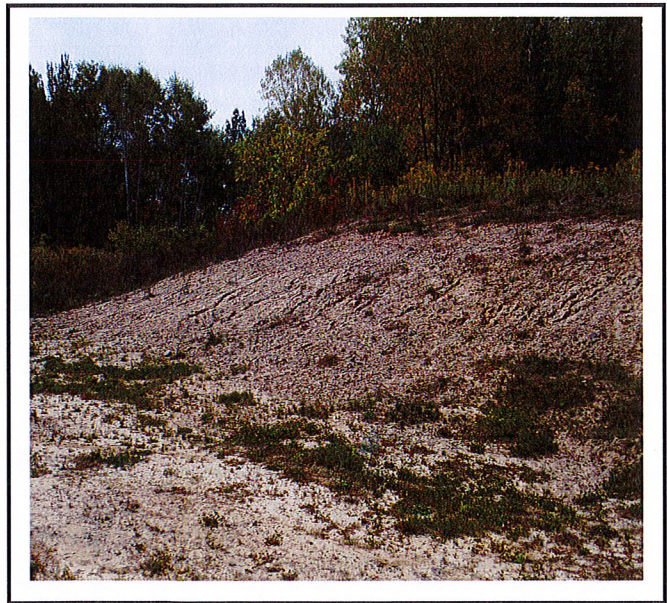
Erosion control blanket has disintegrated and no perennial vegetation established. Major erosion is occurring.
