**Chemung County Stormwater
Construction Inspection
Erosion and Sediment Control**

Project Name Villa's at Gardner Road	Date 10-15-18
Location Lynhurst Ave. Village of Horseheads	Permit # NYR11A108
Weather Conditions Overcast, cool	Entry Time: 1:04 pm
On-Site Representative Present: NONE	Exit Time: 1:12 pm

PROJECT:	Villa's at Gardner Road Village of Horseheads Municipal Construction Inspection October 15, 2018
BY:	Jessica Verrigni, CPESC, CPSWQ

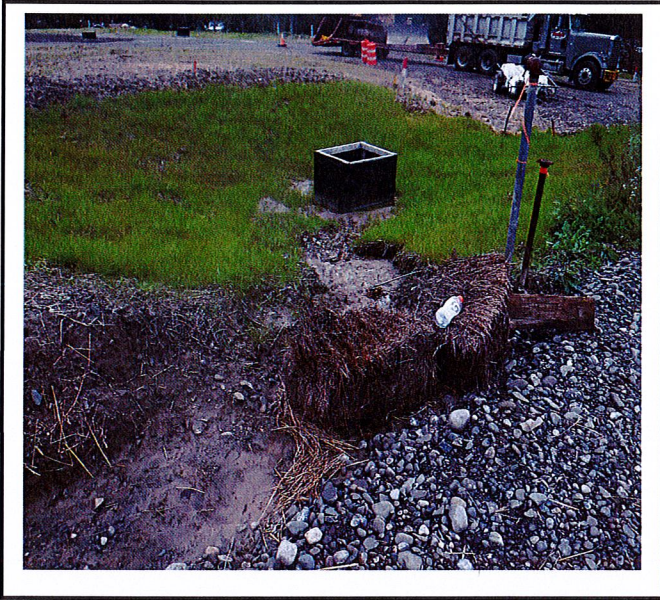
-Active erosion is occurring down to CB3. Straw bales have been put in place to correct this issue. Straw bales are not an accepted bmp in this application. As you can see they have actually caused more erosion. Erosion needs to be controlled. Have consultant assist with alternative practice.

Erosion occurring down to CB3. Straw bales are not an accepted practice for erosion control and as you can see caused more damage and erosion.

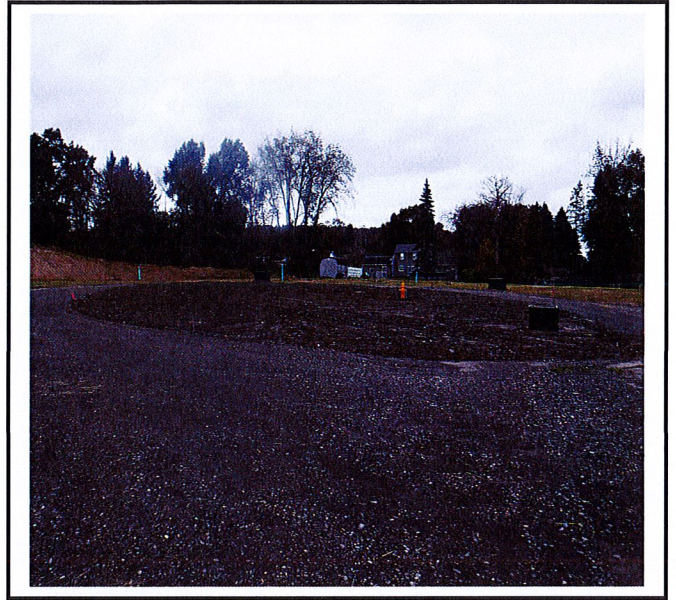
-Center island soil has not been stabilized.

Center of island not stabilized with seed and mulch.

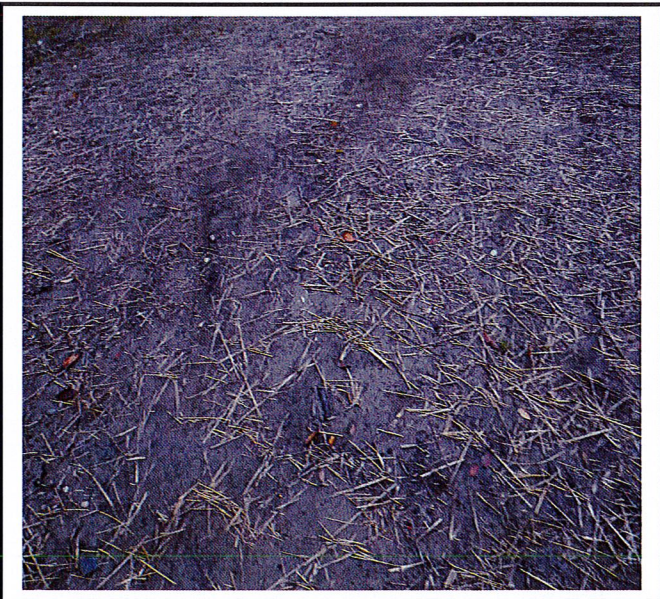
-Areas that have been stabilized with mulch are not at the correct mulching rate. 4 tons per acre is the winter stabilization (Effective Nov.1st) rate.

Mulch rate does not meet NYS standards (2 tons per acre) and because this project will be open in the winter the site must meet winter rate of 4 tons per/ac.

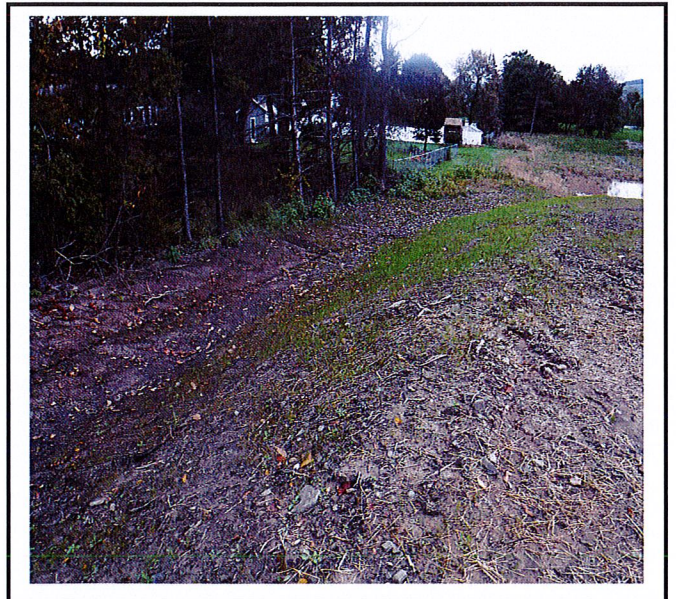
-Stormwater forebay and Drainage swale have not been corrected.

Drainage swale has not been corrected yet.

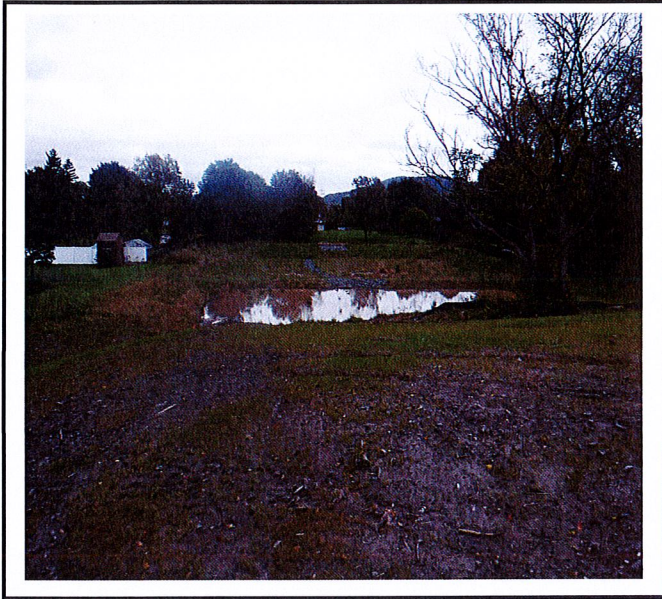
Stormwater forebay still too wet to dredge out.

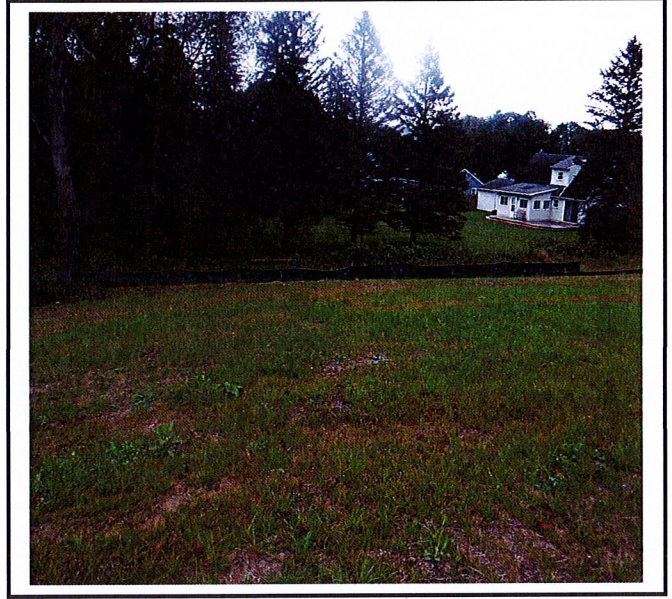
Silt fence has been repaired.
