**Chemung County Stormwater
Construction Inspection
Erosion and Sediment Control**

Project Name Horseheads Hotel	Date 11-15-19
Location State Route 14 Horseheads (V), NY	Permit # NYR10Y122
Weather Conditions sunny, cold	Entry Time: 10:35 am
On-Site Representative Present: Mike Bezon	Exit Time: 10:55 am

PROJECT: Horseheads Hotel
Village of Horseheads
Municipal Construction Inspection
November 15, 2019

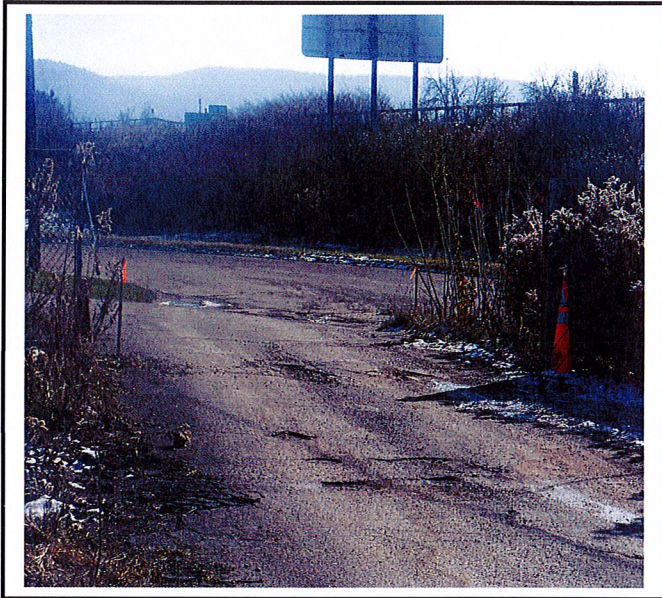
Construction entrance needed at first location off pavement. Too much sediment is getting tracked off site.

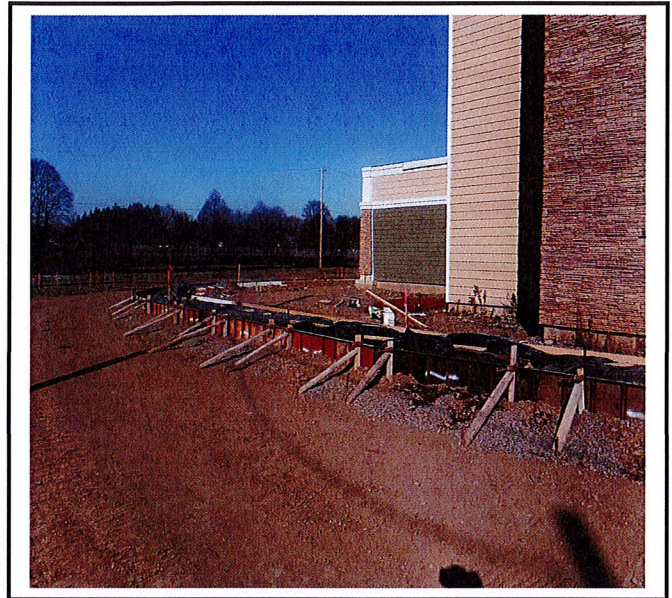
Concrete washout is required. Sidewalks have been poured and there is no washout at this time.

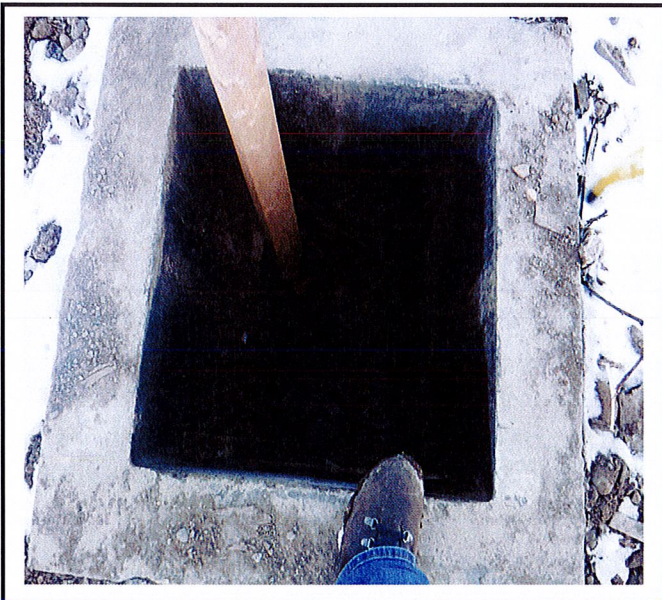
Catch basin grate is required for safety but inlet protection is required to prevent sediment and debris from getting into stormwater basin.

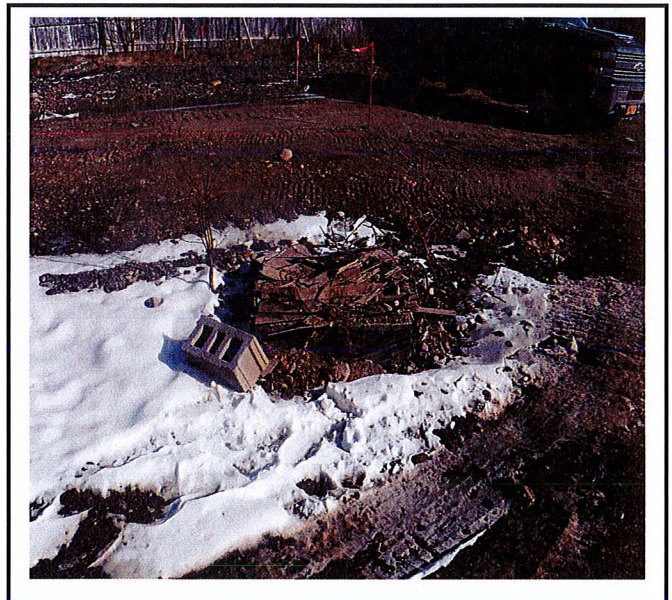
Drop inlet protection required.
