**Chemung County Stormwater
Construction Inspection
Erosion and Sediment Control**

PROJECT:	Horseheads Hotel
	Village of Horseheads
	Municipal Inspection
	March 18, 2020

BY:	Jessica Verrigni, CPESC, CPSWQ
------------	--------------------------------

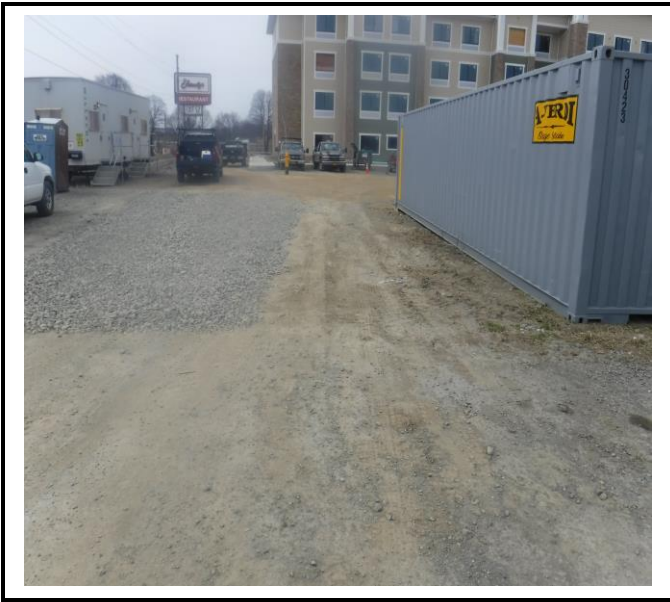
Construction entrance is correct but traffic can go around it. Monitor to ensure that traffic doesn't track mud.

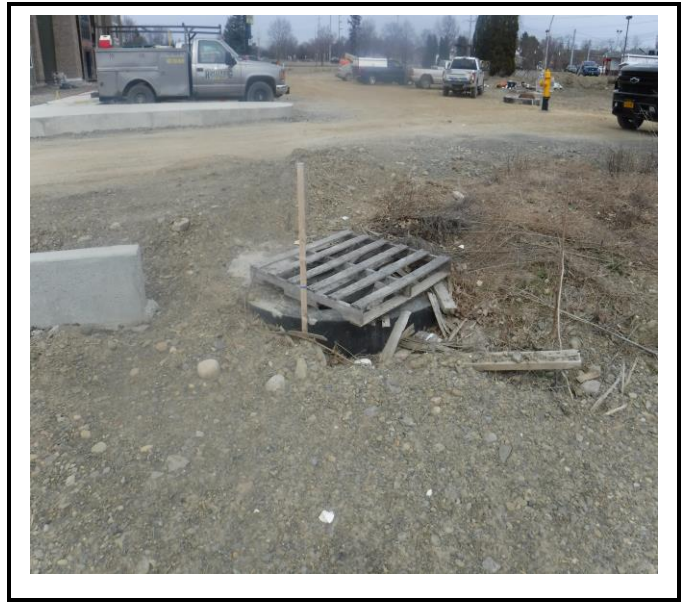
Grading is getting to the point where drop inlet protection is needed in areas where water can get into the stormwater system.

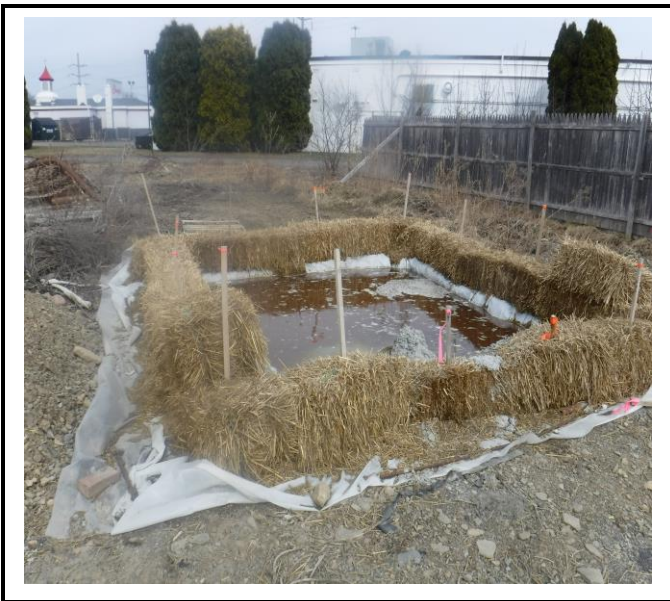
Concrete washout is at capacity and needs to be replaced before the next pour.
