**Chemung County Stormwater  
Construction Inspection  
Erosion and Sediment Control**

| <b>Project Name</b> Horseheads Hotel | <b>Date</b> 8/3/2022 |
| <b>Location</b> SR 14 Horseheads, NY | <b>Permit #</b> NYR10Y122 |

PROJECT: Horseheads Hotel  
Village of Horseheads  
Municipal Inspection  
August 3, 2022

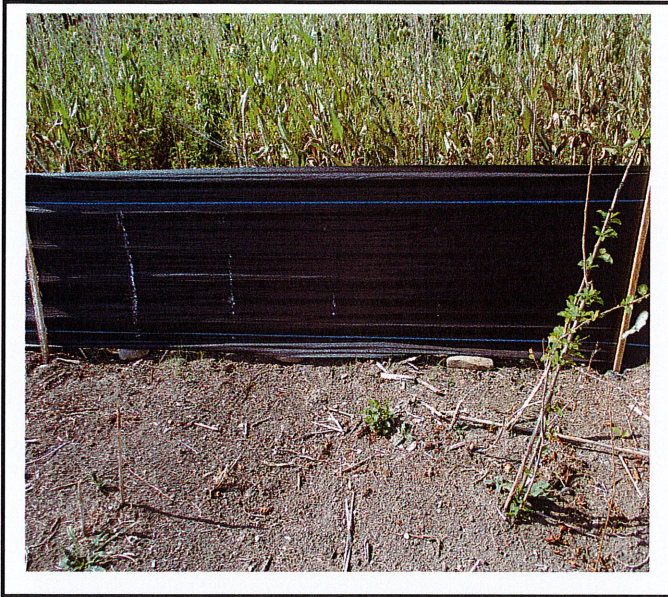
| | -Silt fence installed at entrance is not installed correctly. The silt fence is not toed into the ground 6". |

Silt fence is not installed correctly.

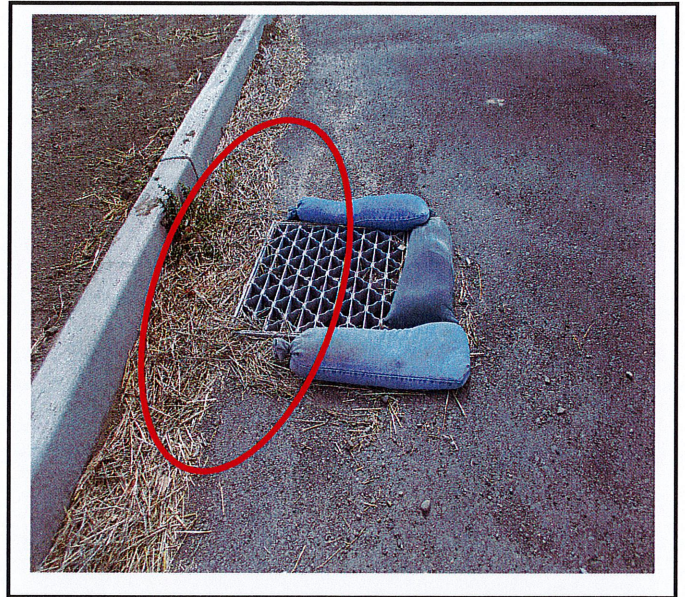
| | -Catch basin inlet protection not installed correctly on CB 10. |

Inlet protection placed is not protecting the catch basin. More bags are needed.

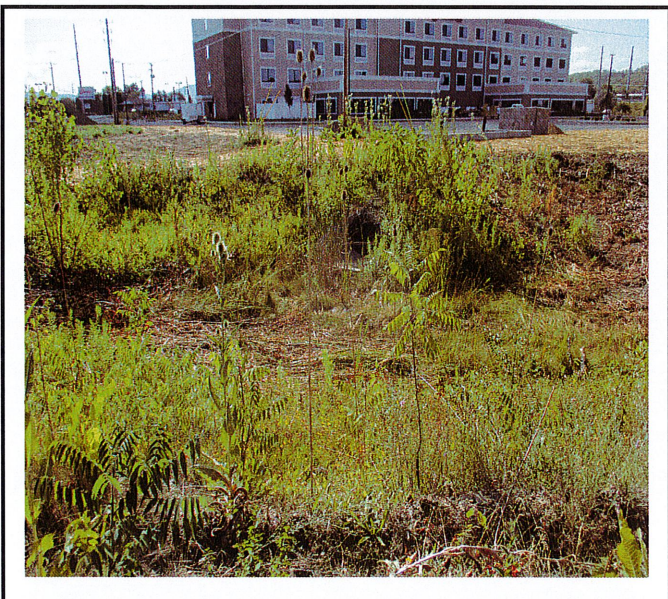
| | -Woody vegetation needs to be removed from stormwater forebay. |

Woody vegetation needs to be removed from the forebay.

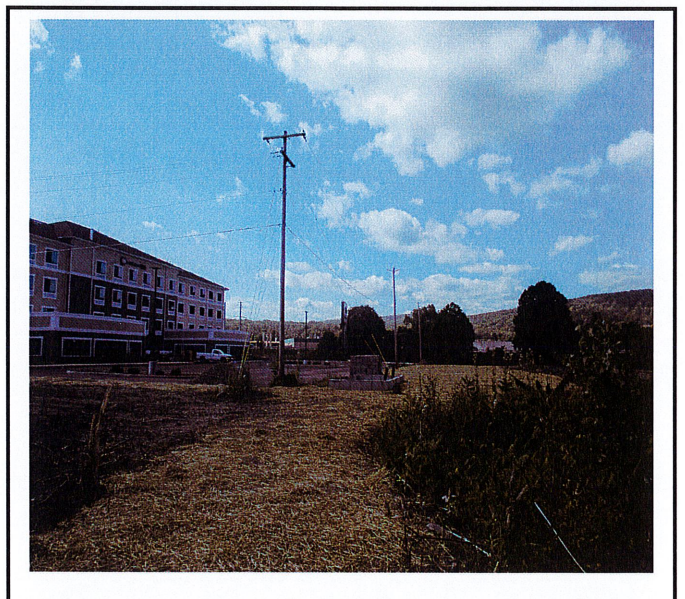
Some areas have been stabilized with straw mulch.
