**Chemung County Stormwater
Construction Inspection
Erosion and Sediment Control**

Project Name Horseheads Hotel	Date 9-14-2022
Location SR 14 Horseheads, NY	Permit # NYR10Y122
Weather Conditions sunny	Entry Time: 11:41 am
On-Site Representative Present: None	Exit Time: 11:50 am

PROJECT: Horseheads Hotel
Village of Horseheads
Municipal Inspection
September 14, 2022

BY: Jessica Verrigni, CPESC, CPSWQ

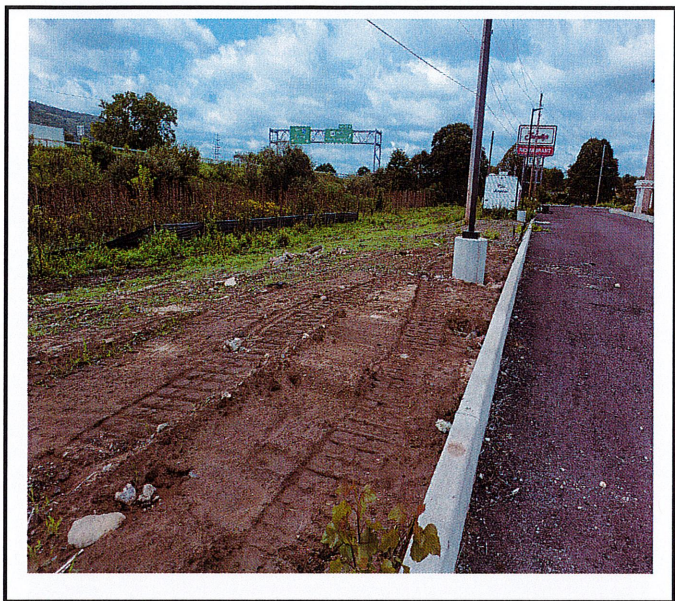
Open soil has not been stabilized around entire site. Silt fence is not installed correctly or in its entirety.

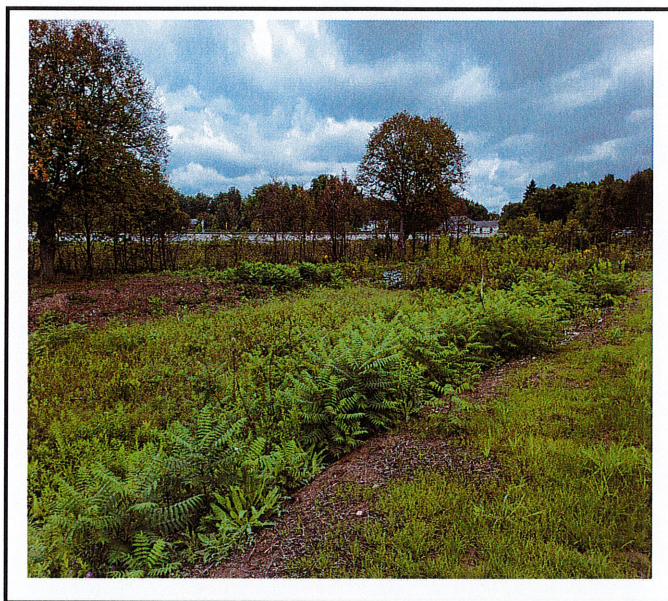
Stormwater basin needs to be finalized. Woody vegetation needs to be removed entirely to achieve final stabilization.

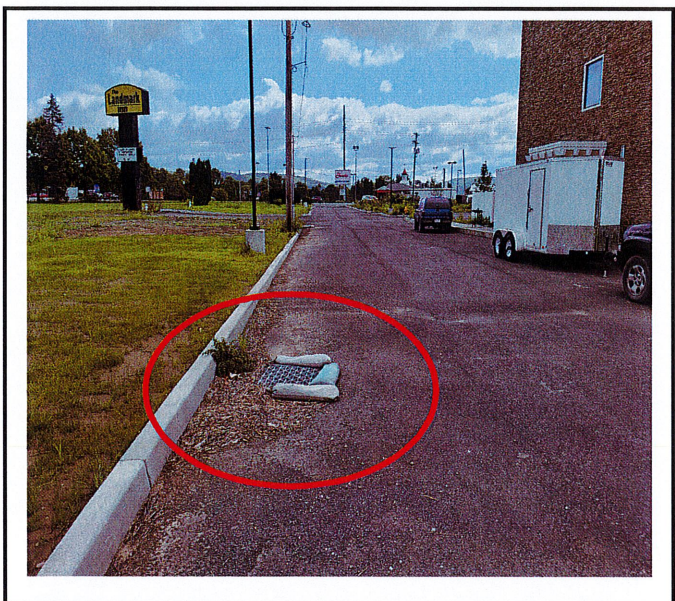
Inlet protection is not installed correctly. Look at debris flowing along curb line into catch basin.

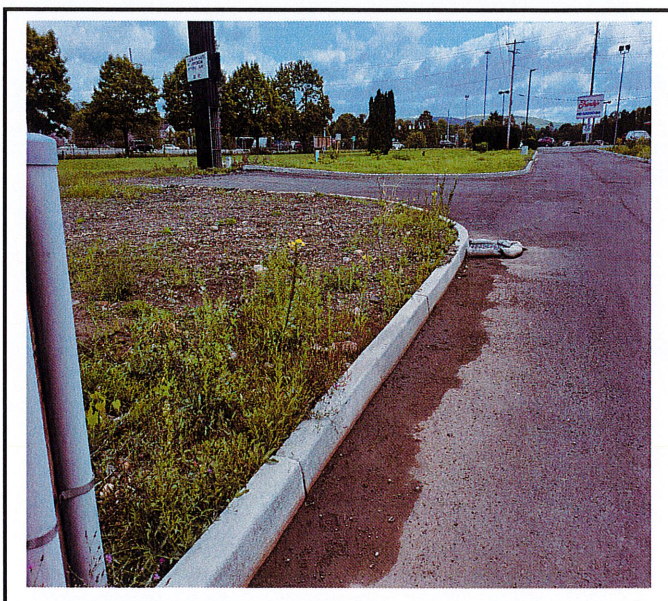
All open bare soil have not been stabilized. Bare soil is eroding and getting into storm sewer.
