**Chemung County Stormwater
Construction Inspection
Erosion and Sediment Control**

Project Name Byrne Dairy	Date 8/13/2021
Location Pennsylvania Ave Elmira, NY	Permit # NYR111426
Weather Conditions sunny, warm	Entry Time: 9:34 am
On-Site Representative Present: none	Exit Time: 9:51 am

PROJECT: Byrne Dairy
City of Elmira
Municipal Construction Inspection
August 13, 2021

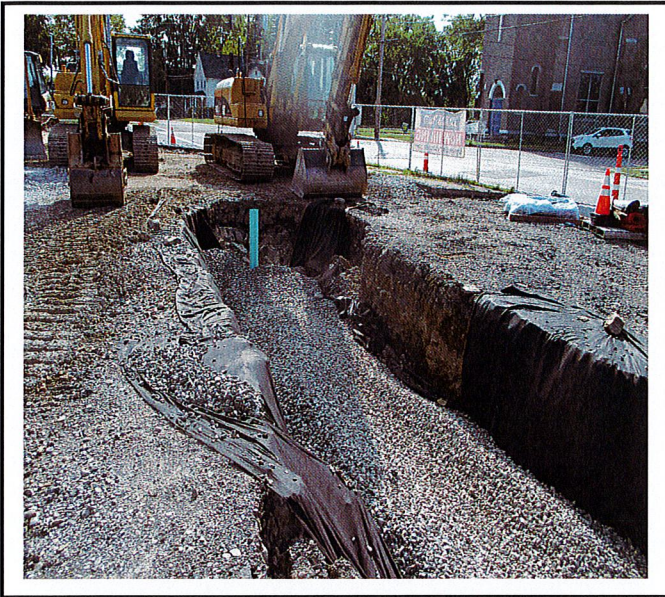
Infiltration Basin under construction.

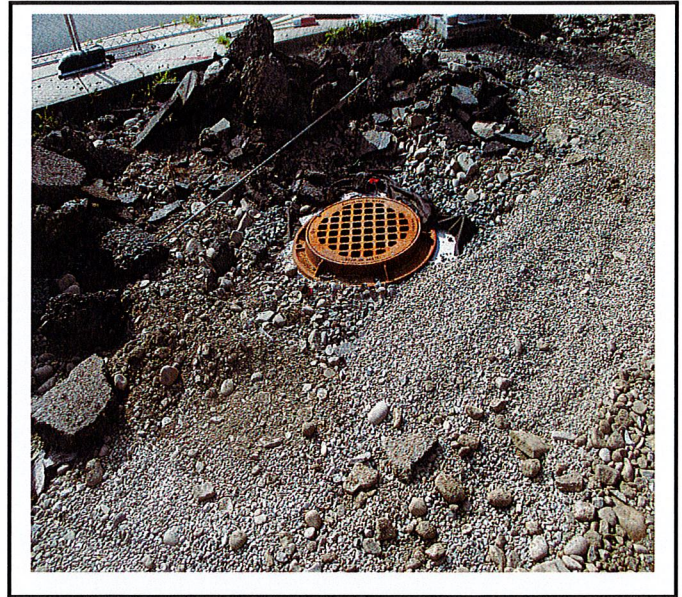
DW-5 no inlet protection installed.

Corrections Needed:
-Approximately 8 of the 13 drainage structures (DW & CB) don't have inlet protection. This makes them susceptible to sediment. Inlet protection is required. Many of these structures are in drive zones and alternative practices should be considered.
-Stormwater Quality Unit has not had the grates placed on top of them and debris can get down into structure.
-Qualified Inspections- it does not appear inspections are being conducted on a consistent basis. Most recent inspection is from July. Report was unsigned so unsure whether person is qualified.

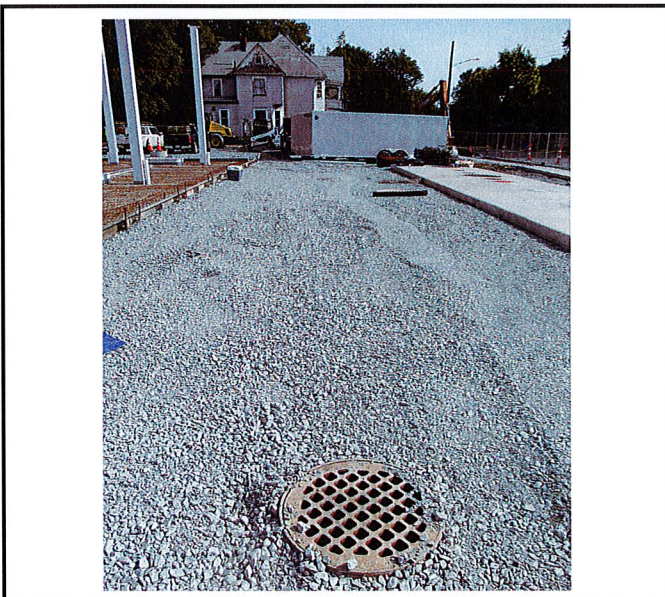
Drop inlet protection is not installed on the majority of the catch basins. Protection is required.

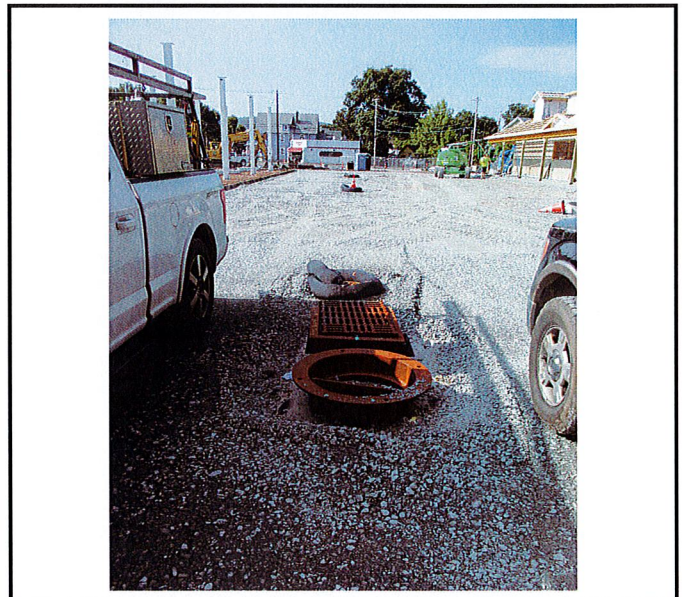
Stormwater pretreatment device- the lids are not placed on them and material can get down into them.
