**Chemung County Stormwater  
Construction Inspection  
Erosion and Sediment Control**

<b>Project Name</b> Six67 Apartments	<b>Date</b> 8/13/2021
<b>Location</b> W. Fifth and College Ave. City of Elmira	<b>Permit #</b> NYR11G564
<b>Weather Conditions</b> sunny, warm	<b>Entry Time:</b> 8:55 am
<b>On-Site Representative Present:</b> none	<b>Exit Time:</b> 9:27 am

**PROJECT:** Six67 Apartments  
City of Elmira  
Municipal Construction Inspection  
August 13, 2021

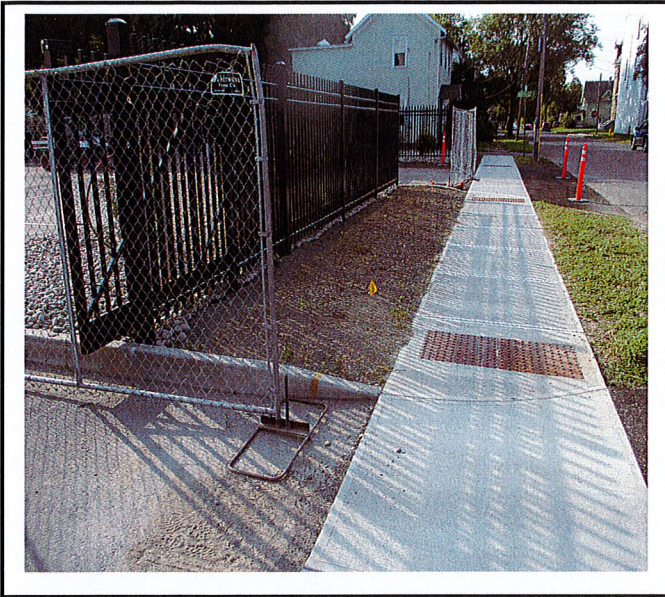
Area along Columbia Street requires stabilization.

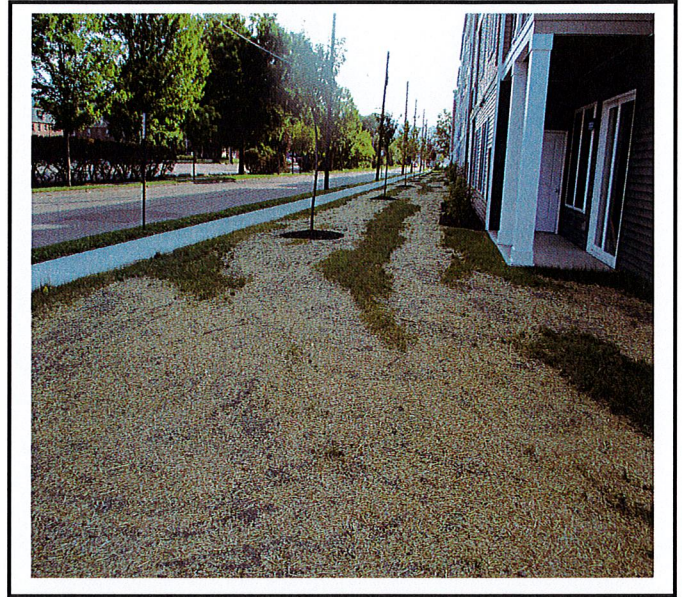
Area along Fifth Street that has been re-stabilized.

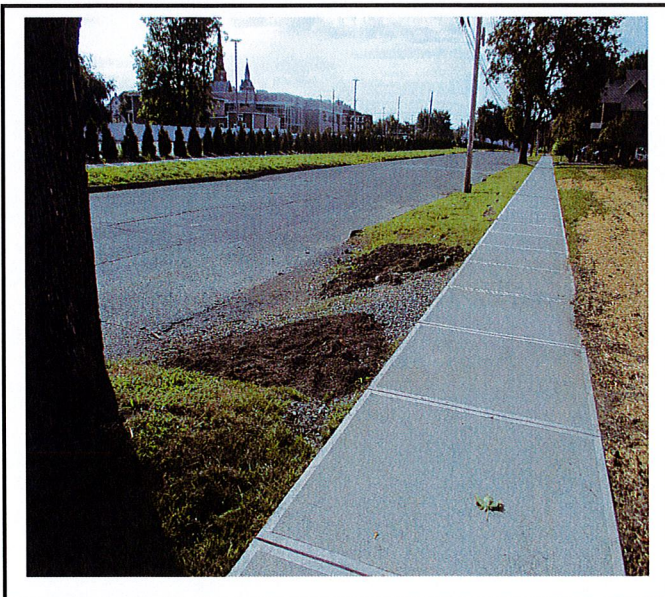
Area along College Ave needing stabilization.

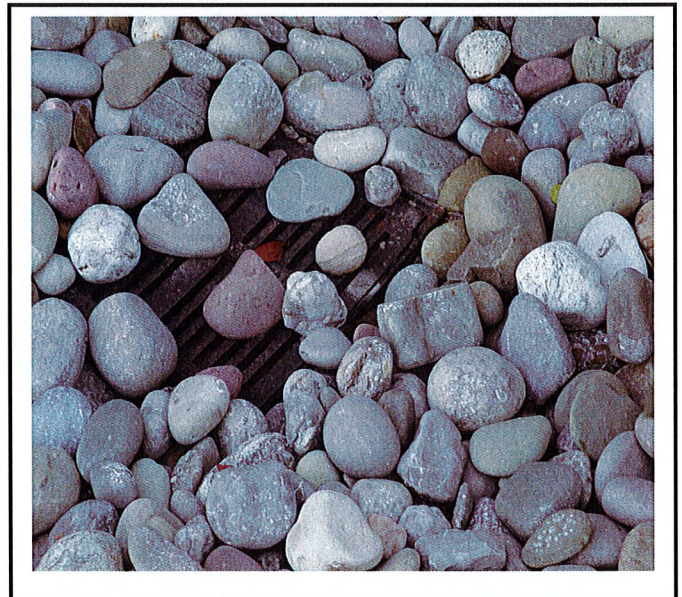
Drainage Grates between the building and the sidewalk need to have the fabric removed from under the grate.
