CONSTRUCTION DURATION INSPECTIONS

4/26/ 2019
 Date of Inspection
Karl Schwesinger
 Qualified Professional Signature

**HILLIARD CORPORATION EXPANSION
EROSION AND SEDIMENT CONTROL CONSTRUCTION DURATION INSPECTIONS**

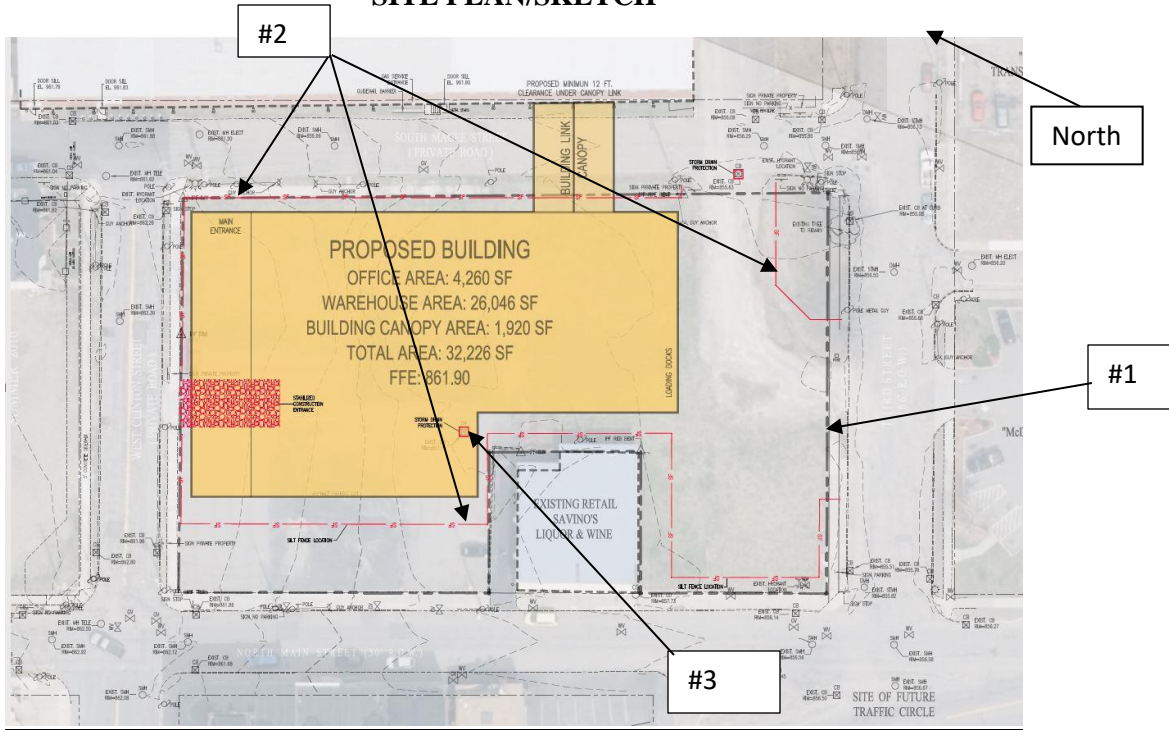
SITE PLAN/SKETCH

Notes: #1 Construction entrance covered in dirt and incomplete, mud between stone and road.
 #2 Silt fence is in need of repair.
 #3 Stormwater inlet in center of property does not have the proposed sediment control measures and is full of sediment and debris.

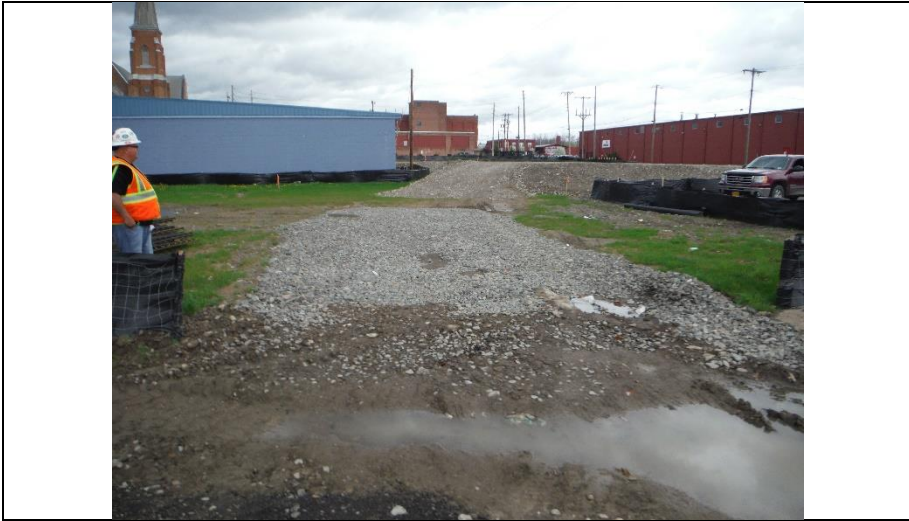
1.) Construction entrance at southwestern corner facing north.

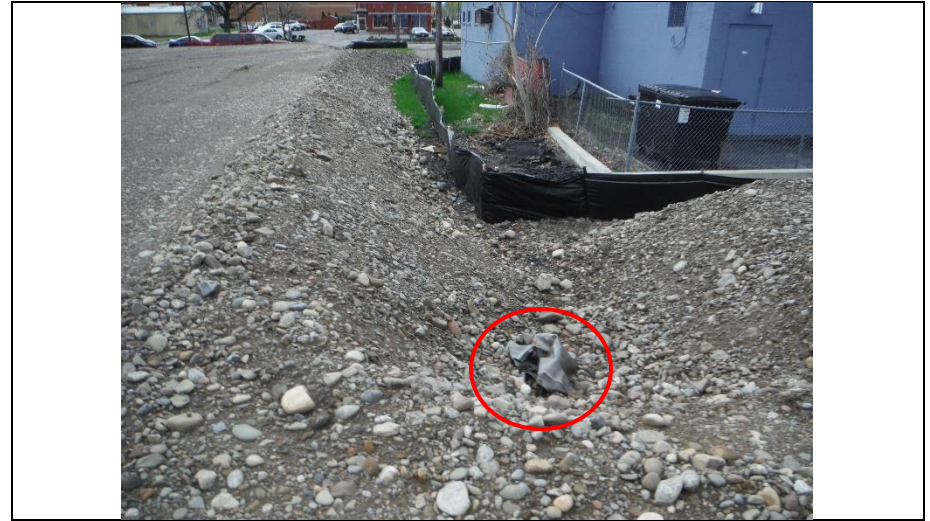
2.) Unacceptable stormwater inlet on western side of property facing south (corner of existing Savino's Liquor).

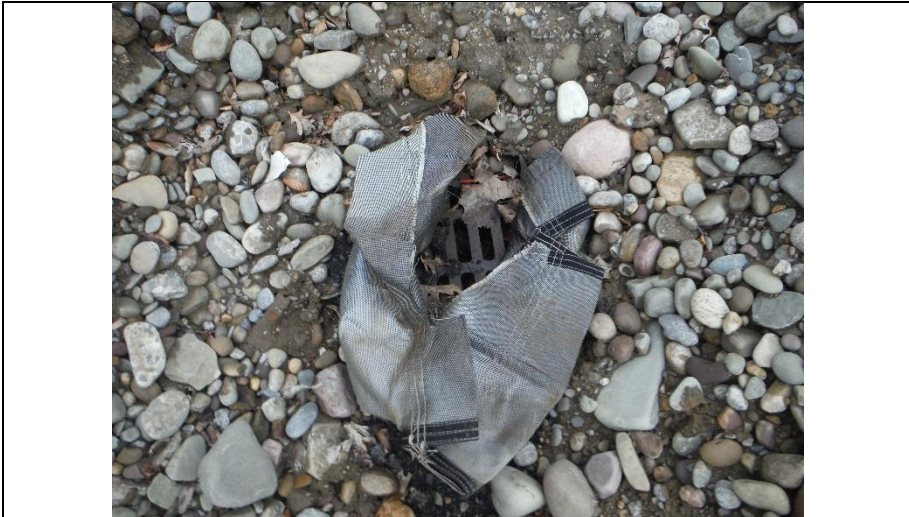
3.) Another view of storm inlet in center of property.

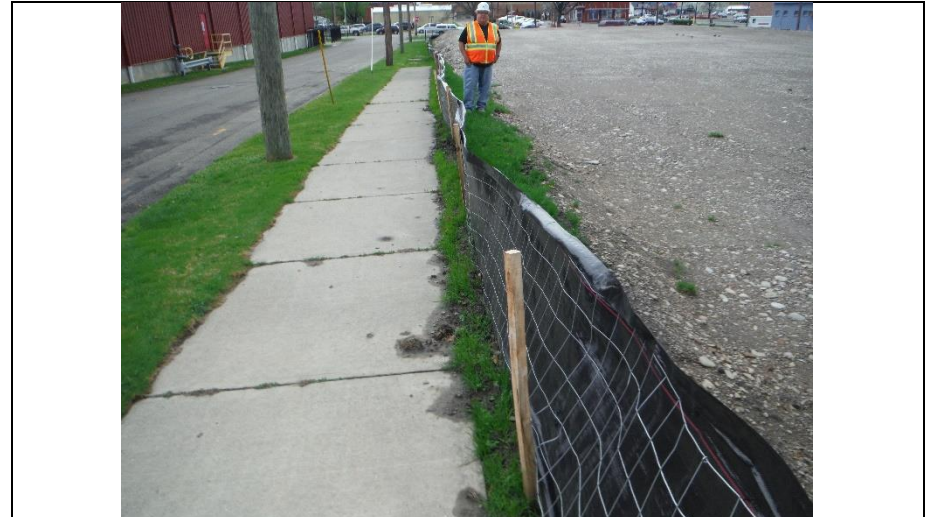
4.) Silt fence off stake. Northeastern corner of property facing south.

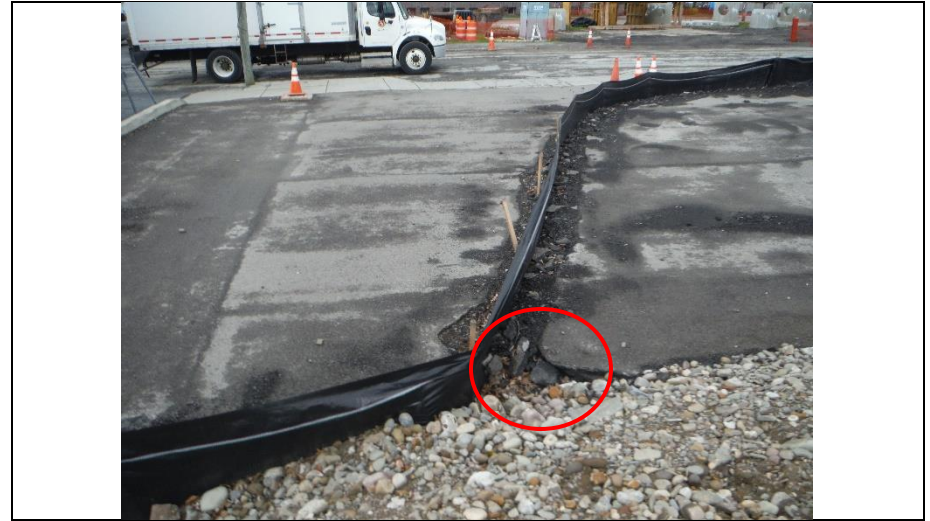
6.) Silt fence off wood stakes. Western side of property facing west.
Just north of Savino's Liquor.
