**Chemung County Stormwater
Construction Inspection
Erosion and Sediment Control**

Project Name Hilliard Building Expansion	Date 6-8-2020
Location W. Clinton Street Elmira (City), NY	Permit # NYR11F218
Weather Conditions sunny, warm	Entry Time: 9:53 am
On-Site Representative Present:	Exit Time: 10:00 am

PROJECT:	Hilliard Building Expansion Project City of Elmira Municipal Inspection June 8, 2020
BY:	Jessica Verrigni, CPESC, CPSWQ

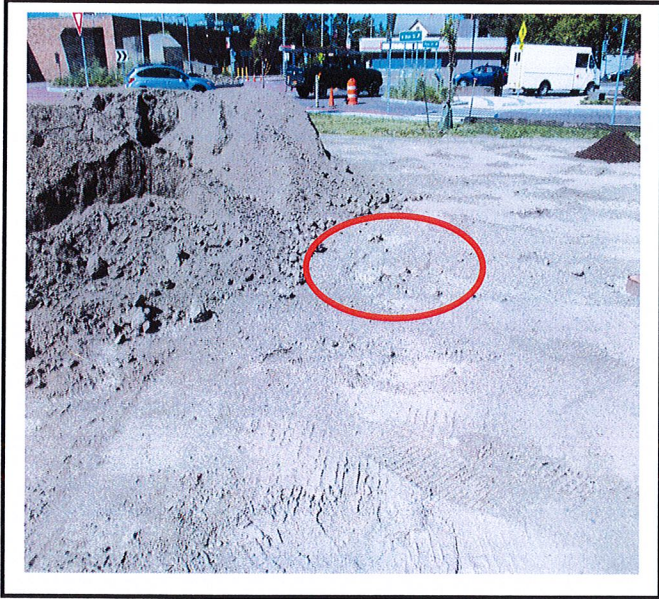
Topsoil was stockpiled on top of underground infiltration and one of the observation ports has been hit by equipment.

Corrections Needed:			
-The area next to the building and above the underground infiltration system has not yet been stabilized. This area has been sitting idle for many weeks.			
Topsoil has been stockpiled on the area above the underground system. One of the observation ports has been knocked crooked and requires repair.

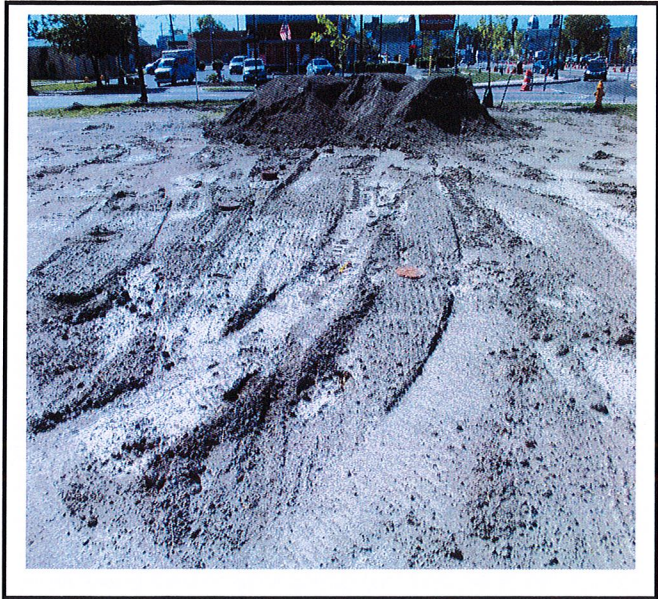
Topsoil was stockpiled on top of underground infiltration and one of the observation ports has been hit by equipment.

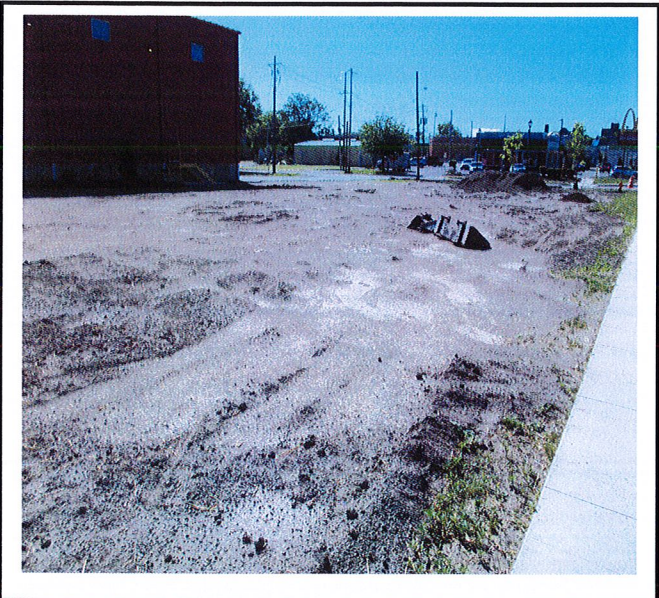
Future green area next to building and above the underground infiltration has not been stabilized.

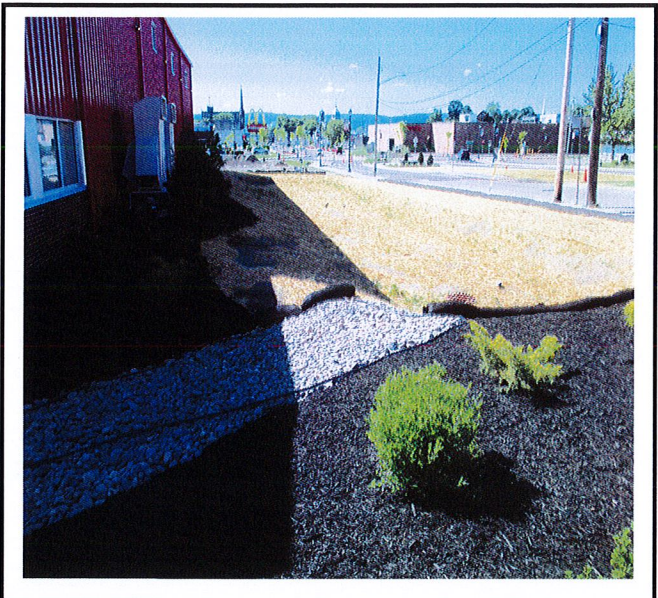
Rain Garden- repairs have been made to eroded areas but landscaping is not completed.
