Chemung County Stormwater
Construction Inspection
Erosion and Sediment Control

Project Name LECOM	Date 6-24-19
Location Park Place Elmira, NY	Permit #NYR11E617
Weather Conditions sunny clear	Entry Time: 11:18 am
On-Site Representative Present: NONE	Exit Time: 11:30 am

PROJECT: LECOM
City of Elmira
Municipal Construction Inspection
June 24, 2019

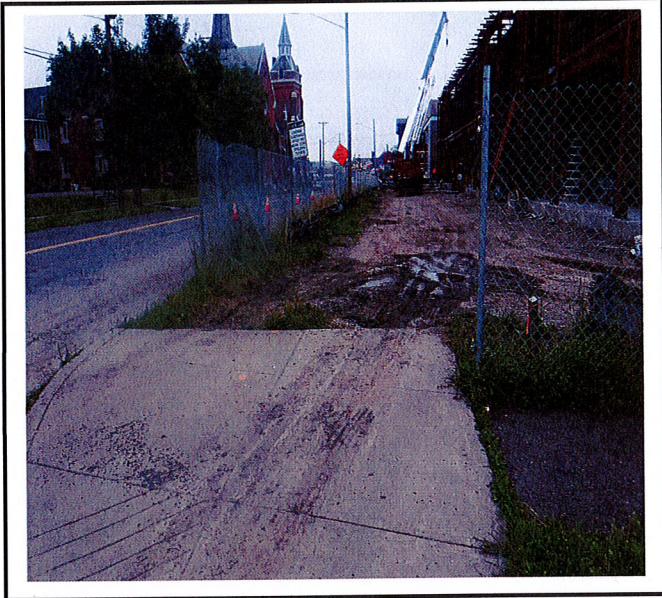
-Drop inlet protection requires repair. There is no top rail along the top of the frame to make it structurally sound.
-Traffic is entering/exiting at the corner of Park Place and Fourth street. This is not a construction entrance.

Traffic moving through area without construction entrance.

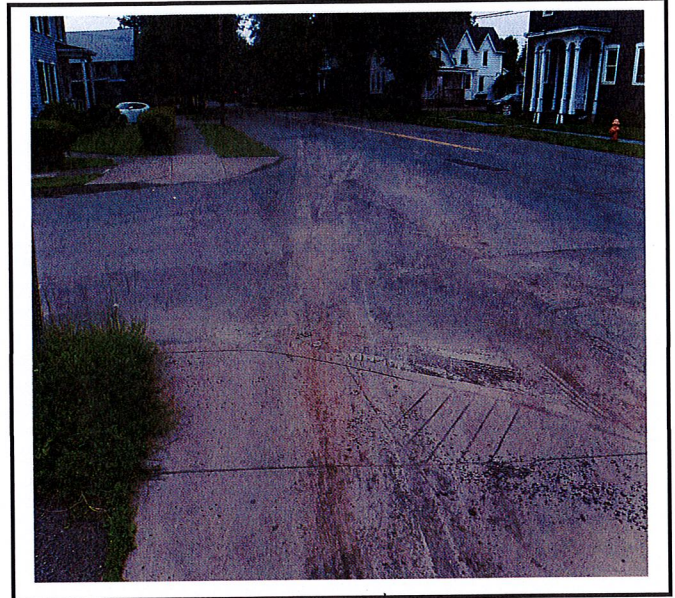
Sediment/mud from sit tracked up Park Place.

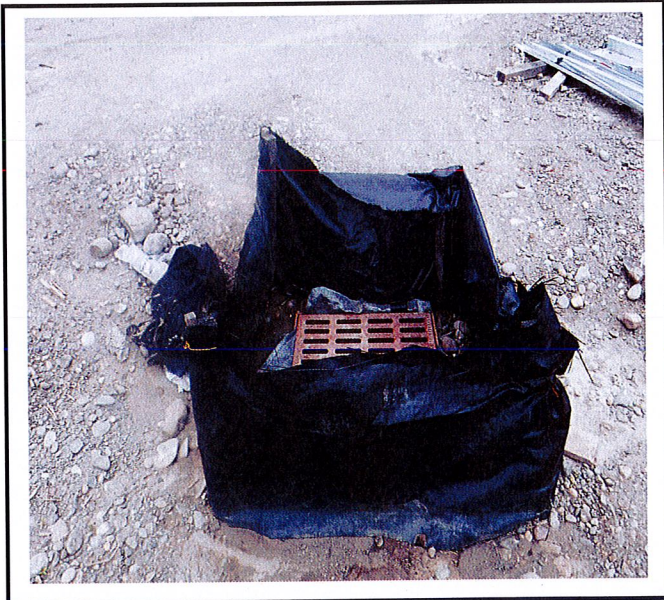
Wooden top rail not installed.
