**Chemung County Stormwater
Construction Inspection
Erosion and Sediment Control**

Project Name LECOM	Date 8-7-2019
Location Park Place, City of Elmira	Permit # NYR11E617
Weather Conditions overcast, humid	Entry Time: 9:26 am
On-Site Representative Present: None	Exit Time: 9:35 am

PROJECT: LECOM
City of Elmira
Municipal Inspection
August 7, 2019

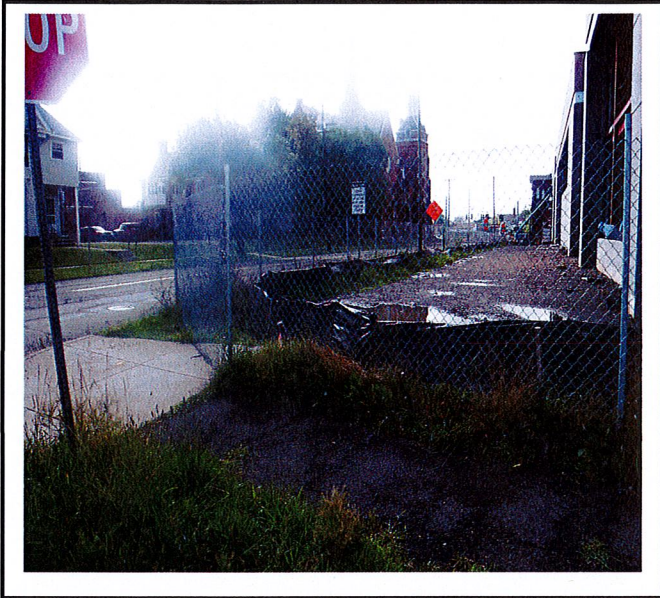
Correction made to traffic entering/exiting through this area.

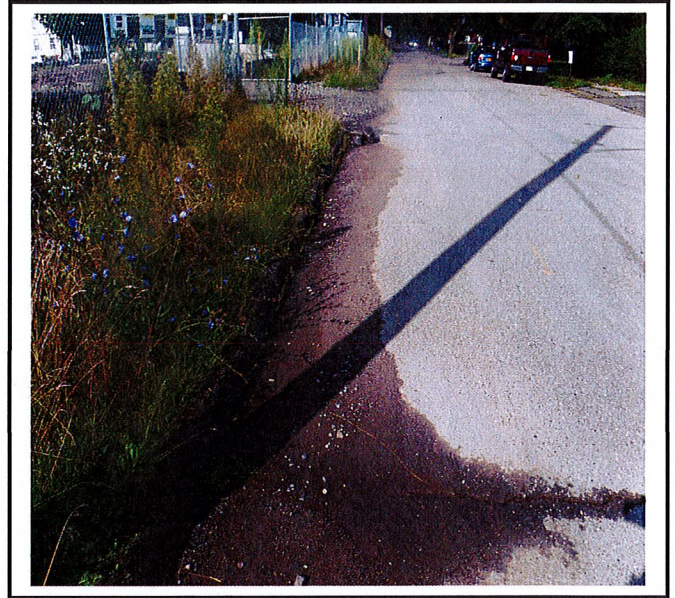
Sediment from the project is up and down W Fourth Street and Clinton Street. It needs to be cleaned up.

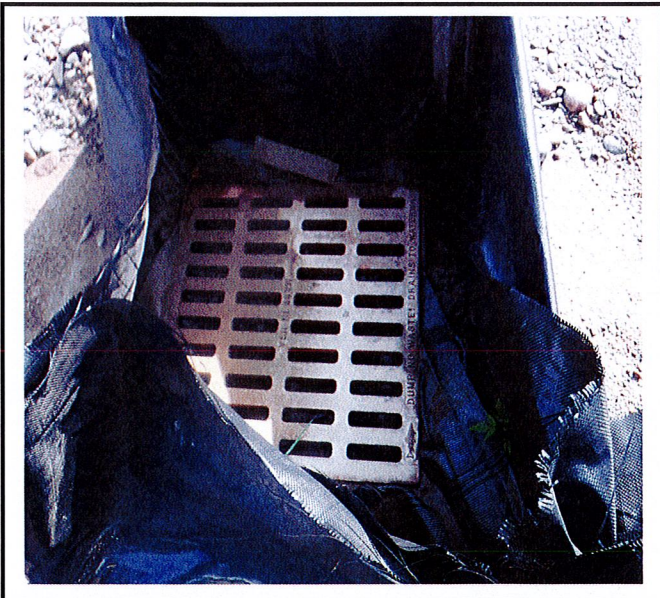
Corrections Needed:			
-C2 catch basin- The drop inlet protection is not installed correctly. There is also an insert being utilized under the cover that requires maintenance. A lot of sediment has accumulated in it.			
-There is sediment from the project up and down both W. Fourth Street and Clinton Street. These streets need to be swept. It is not the City's responsibility to clean the sediment off the road from the project.			
-Concrete washout is brand new but there are areas where it is still washed onto the ground.

Drop inlet protection is still not repaired and now there is sediment building up on the insert inside the catch basin.

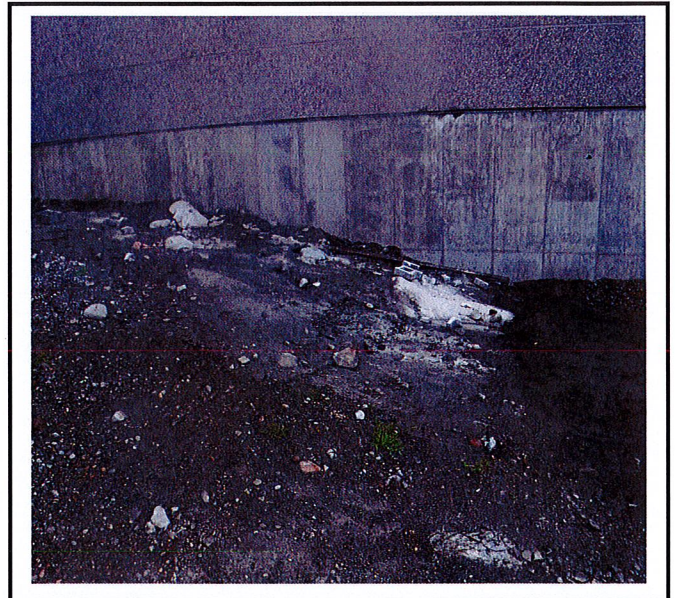
Concrete washed next to the building even though there is a functioning concrete washout.
