**Chemung County Stormwater
Construction Inspection
Erosion and Sediment Control**

Project Name LECOM	Date 8-26-2019
Location Park Place Elmira (City), NY	Permit # NYR11E617
Weather Conditions sunny, cool	Entry Time: 11:53 am
On-Site Representative Present: none	Exit Time: 12:04 pm

PROJECT:	LECOM
	City of Elmira
	Municipal Inspection
	August 26, 2019
BY:	Jessica Verrigni, CPESC, CPSWQ

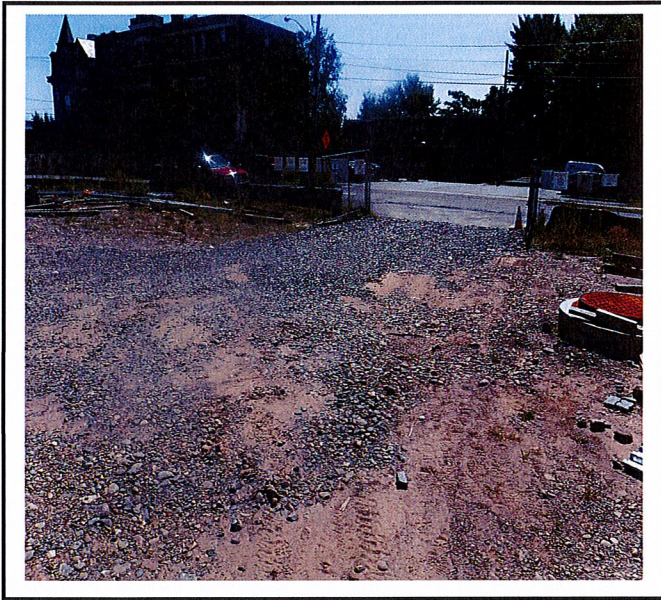
Construction entrance in fair condition although sediment from project site is tracked up Clinton Street and W. Fourth Street.

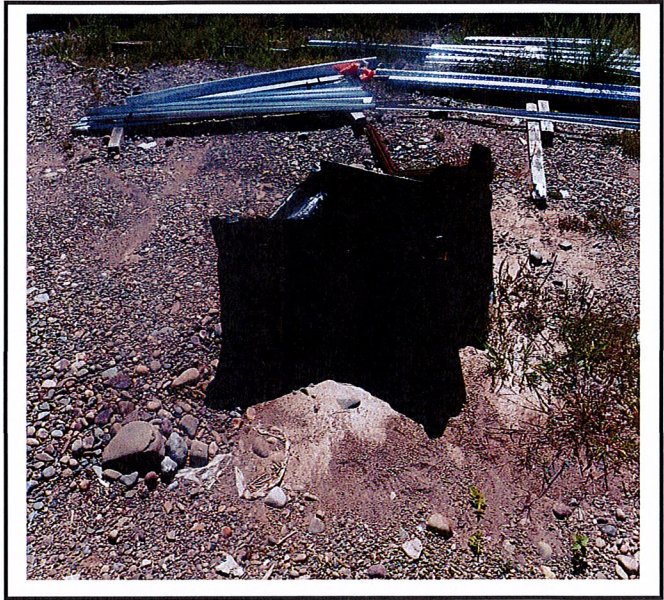
- CB-2- drop inlet protection is not installed correctly and there is an insert that requires maintenance. **This item has been mentioned multiple times on both the municipal and weekly inspection reports.**
- Sediment is getting onto both Clinton Street and W. Fourth Street. Areas along the curb line should be swept and the sediment disposed of properly. **Noted multiple times.**
- Silt fence along Clinton Street has holes in it and requires replacement.

Drop inlet protection around CB-2 remains installed incorrectly.

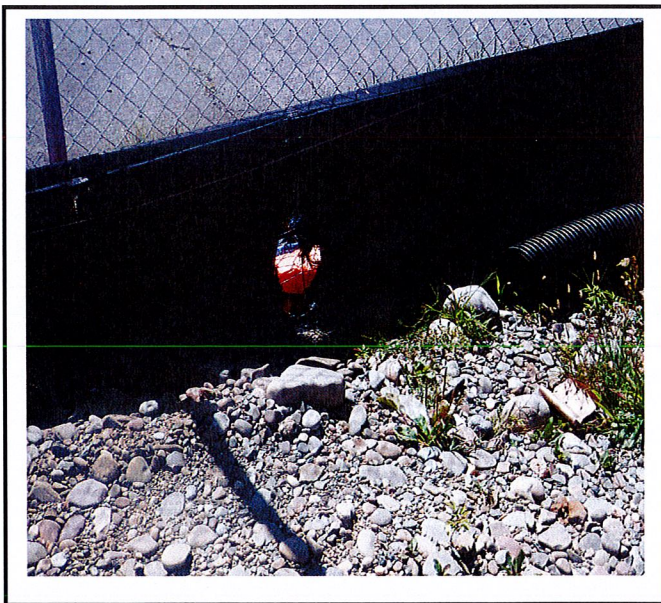
Silt fence along Clinton Street has holes and is in need of repair.

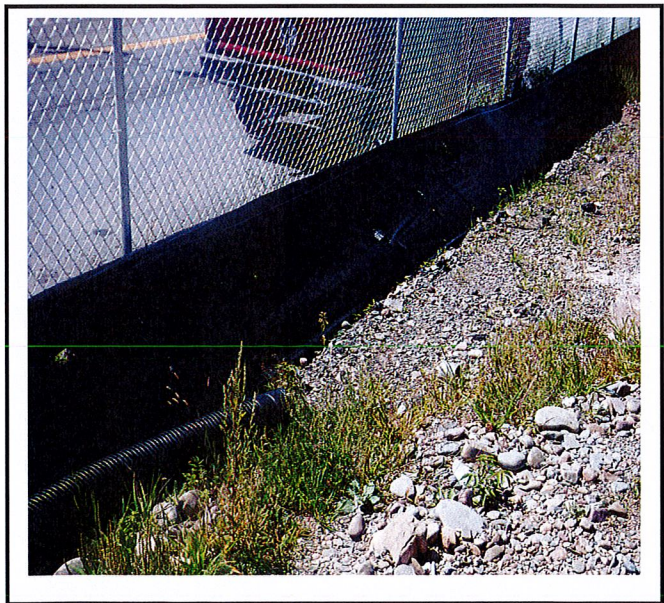
Silt fence along Clinton Street has holes and is in need of repair.
