Chemung County Stormwater
Construction Inspection
Erosion and Sediment Control

Project Name LECOM	Date 11-14-2019
Location Park Ave Elmira (City), NY	Permit # NYR11E617
Weather Conditions overcast, cold	Entry Time: 9:02 am
On-Site Representative Present: Brian Atwater	Exit Time: 9:48 am

PROJECT: LECOM
City of Elmira
Municipal Construction Inspection
November 14, 2019

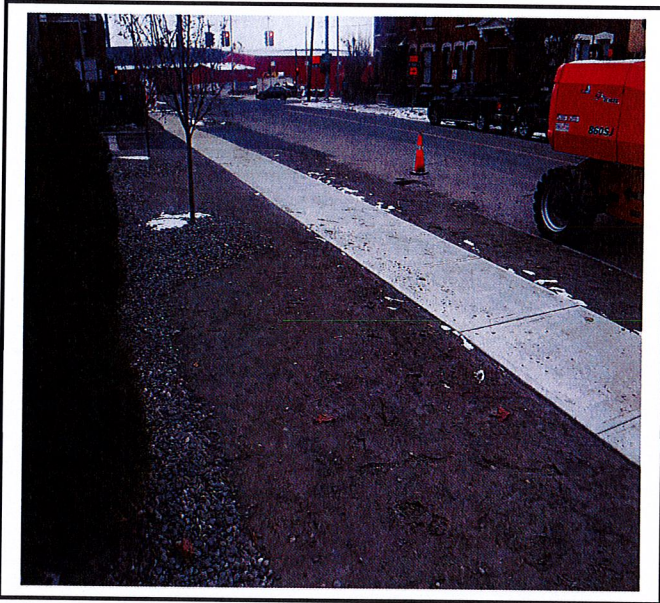
-Silt fence has been removed from the project perimeter. In areas along Clinton Street and Park Place the soil has not yet been stabilized. It is getting tracked onto municipal roads. Sweeping sediment out of street is required.

Erosion controls removed along Clinton Street. Sediment is being tracked into the road.

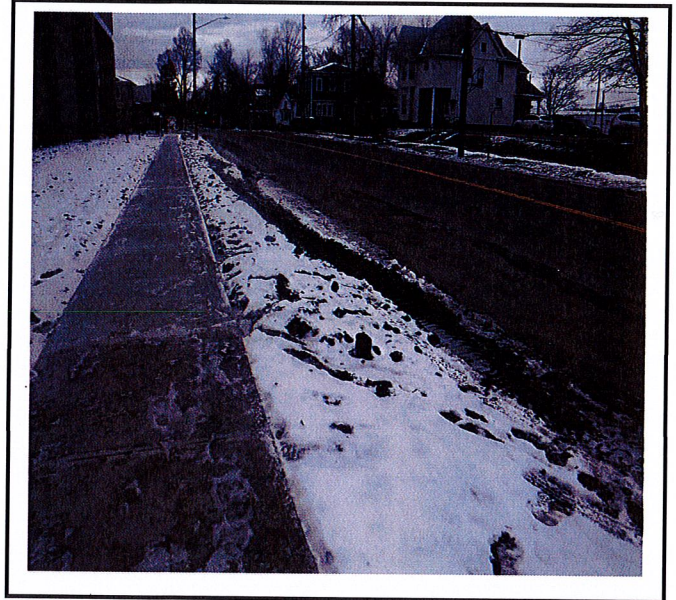
Erosion controls along Park Place have been removed. Equipment is tracking sediment into the road.

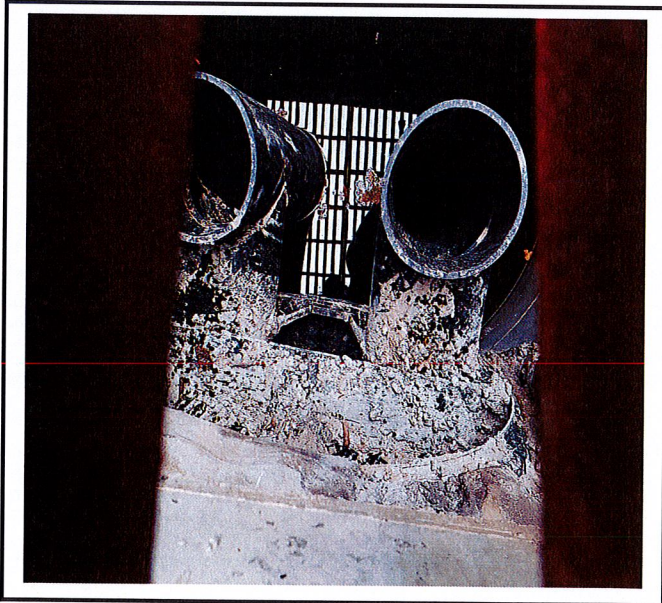
-North-east water quality unit is not sitting correctly. The pipes are not straight up and down. There is concern it is not aligned with the stormwater pipe correctly. Also, it is not grouted around the unit.

North-east water quality unit is not sitting straight up and down. It has also not been grouted correctly.

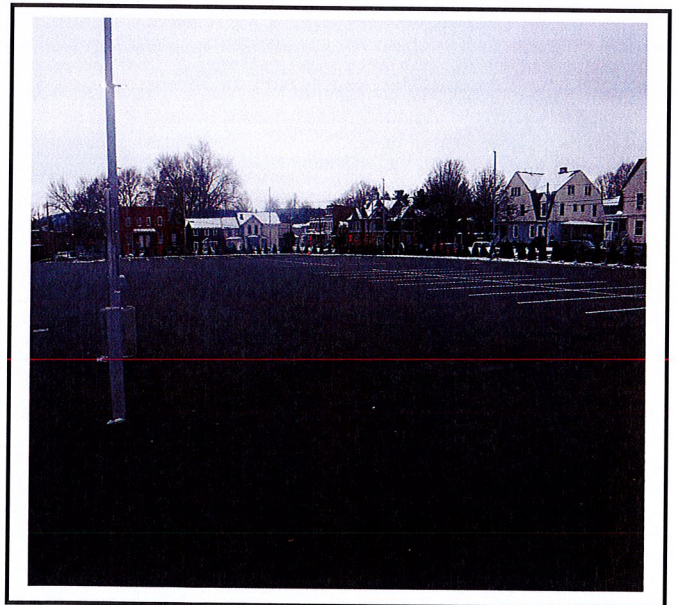
Completed parking lot where underground stormwater infiltration and water quality units are located.
