**Chemung County Stormwater
Construction Inspection
Erosion and Sediment Control**

Project Name LECOM expanded parking lot	Date 3-18-2020
Location Park Ave, Elmira (city), NY	Permit # NYR11E617
Weather Conditions sunny	Entry Time: 10:56 am
On-Site Representative Present: None	Exit Time: 11:02 am

PROJECT:	LECOM expanded parking
	City of Elmira
	Municipal Inspection
	March 18, 2020

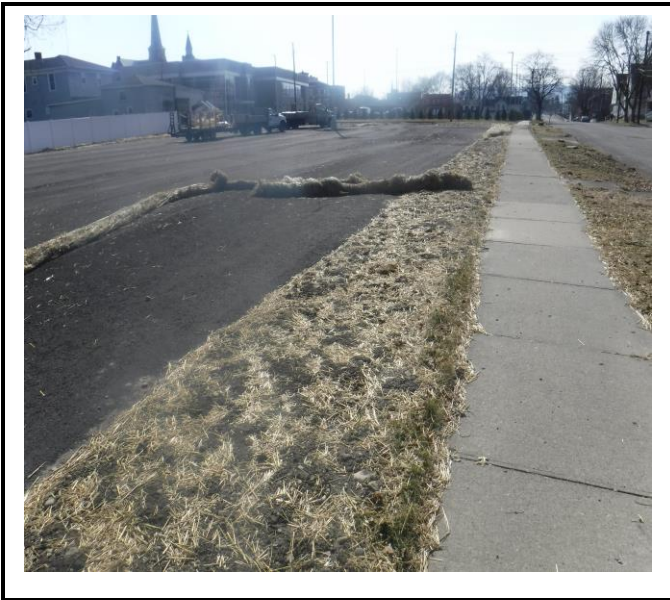
Rolled erosion control blanket has blown off the area that it was supposed to be protecting.

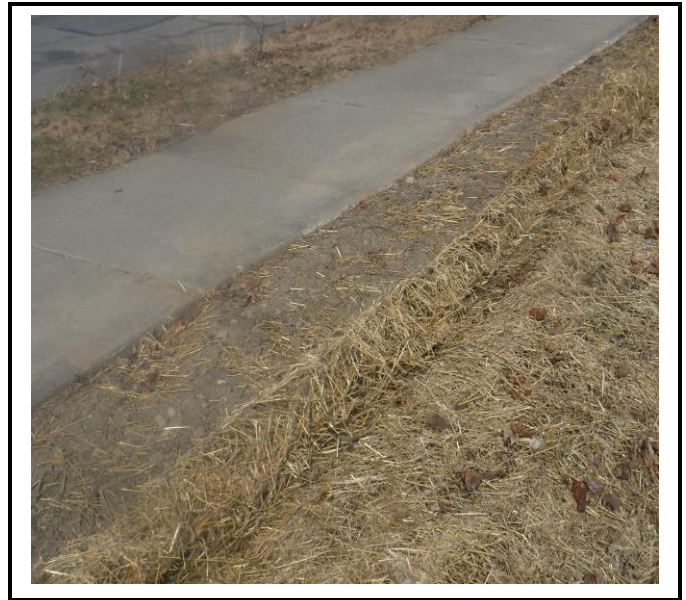
Rolled erosion control blanket was not secured properly to the soil and now has blown back. Soil is exposed and unprotected.

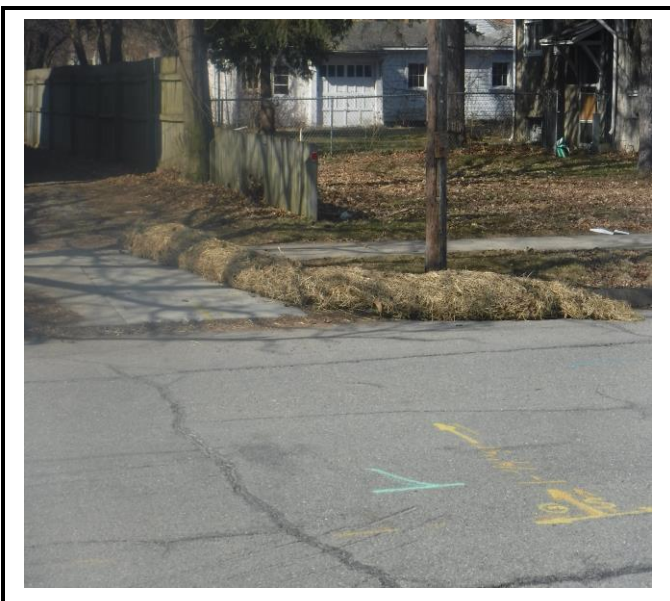
Rolled erosion control blanket was not secured properly. This photo shows a whole section blown across the street into a neighbors yard.

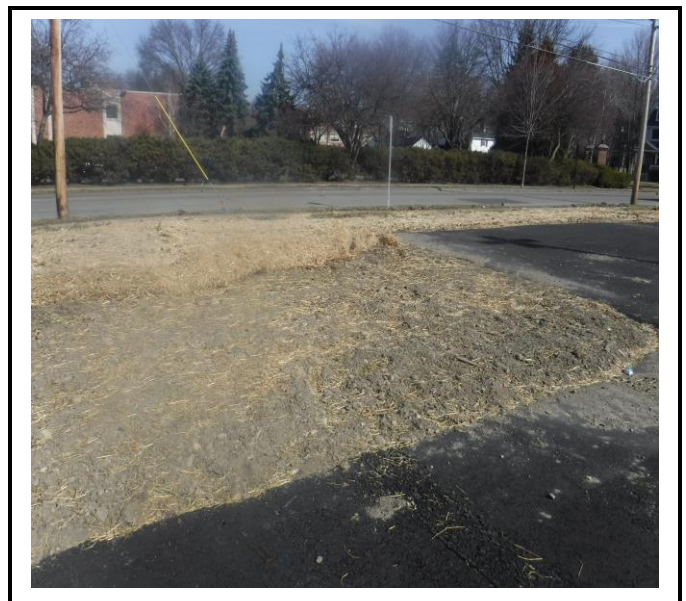
Soil is not stabilized or protected from erosion.
