**Chemung County Stormwater
Construction Inspection
Erosion and Sediment Control**

Project Name CBS MONARCH SENIOR LIVING FACILITY	Date 1-26-18
Location Maple Ave Elmira (City)	Permit # NYR11C547
Weather Conditions sunny cool	Entry Time: 9:45
On-Site Representative Present: Rick Bronson-Christa construction	Exit Time: 10:30

PROJECT: CDS Monarch Senior Living Facility
City of Elmira
Municipal Construction Inspection
January 26, 2018

BY: Jessica Verrigni, CPESC, CPSWQ

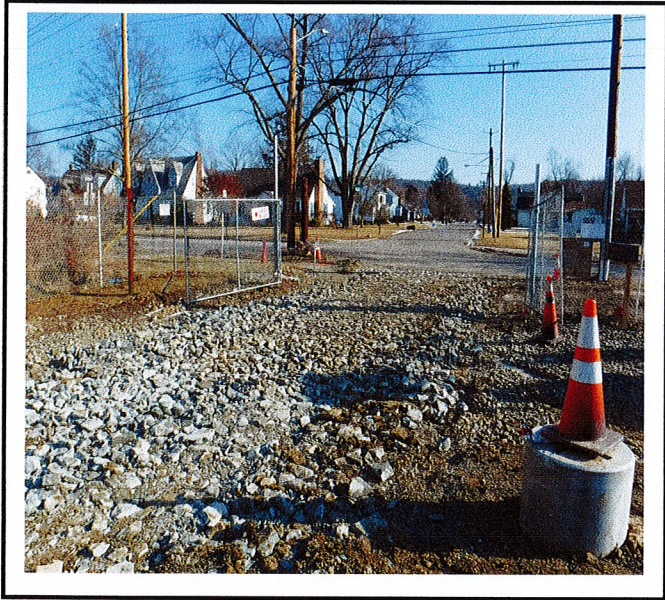
Construction entrance is worn out and mud is being tracked onto Maple Ave.

Corrections Needed:
1. Construction entrance needs to be maintained. When mud is tracked into the road it needs to be swept up not just to the side of the road. This sediment collects until it is carried to the storm sewer and that is not acceptable.
2. Water is getting under compost sock and causing erosion to occur on the side slope of inflation basin.
3. Compost sock is being destroyed by on site activities and rendering it ineffective. (dumpster and material storage- see photos)
4. Catch basin on South East end of building needs some repaired.

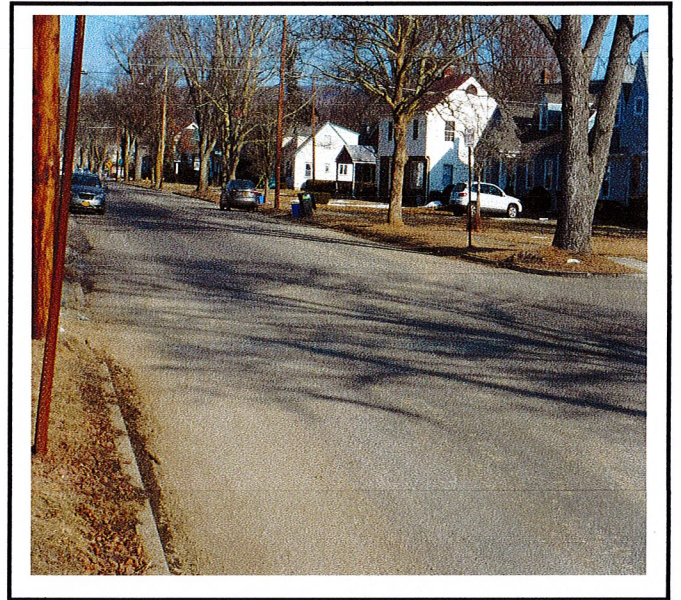
Remnants of mud tracked onto Maple Ave.

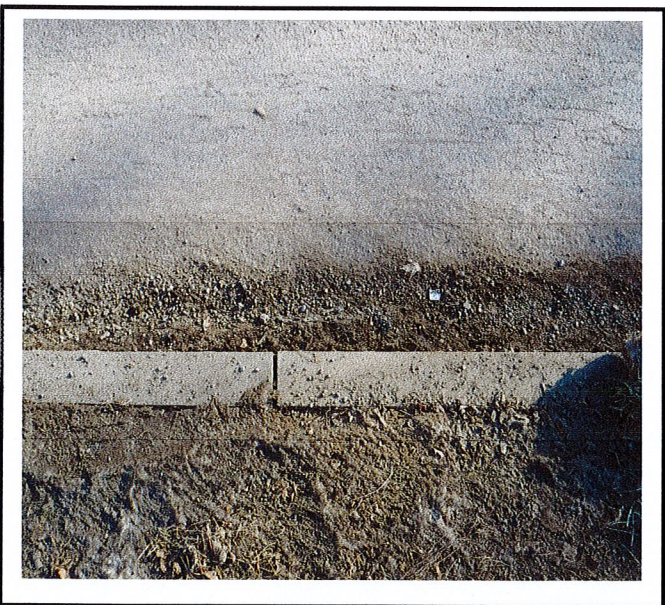
Contractor swept Maple Ave but failed to sweep up material to prevent it from getting into storm drain.

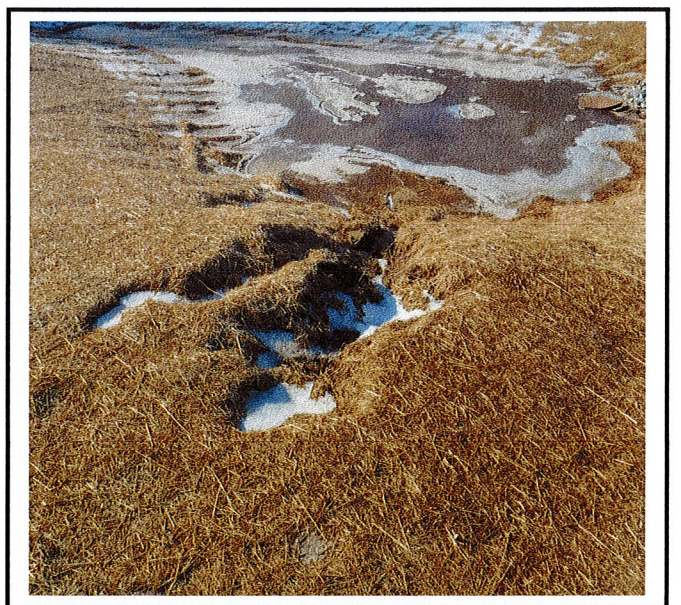
Active erosion occurring in forebay.

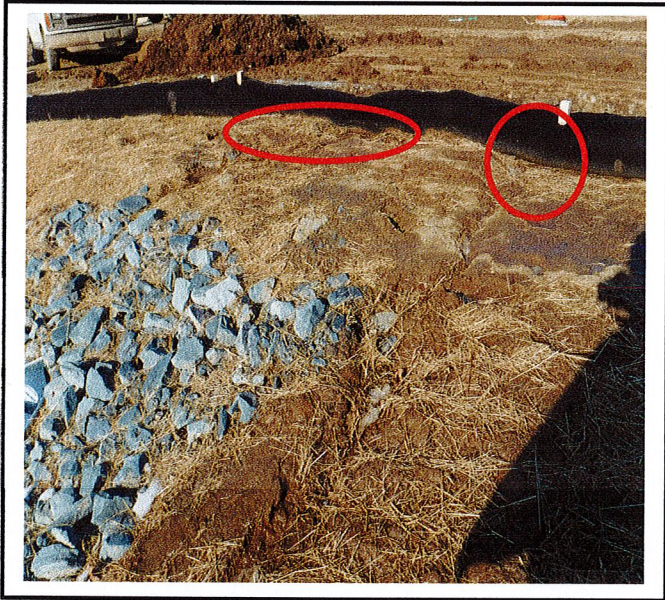
Water is getting under the compost sock and causing erosion on the side slope of the infiltration basin.

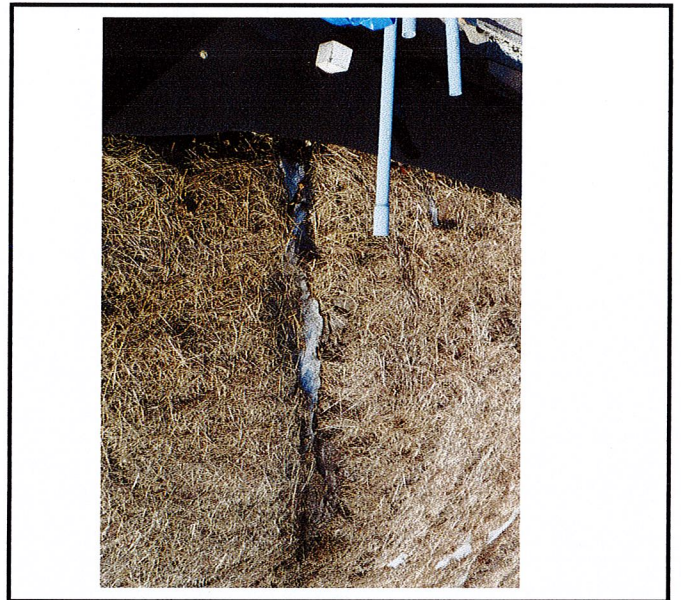
Water is getting under the compost sock and causing erosion on the side slope of the infiltration basin.

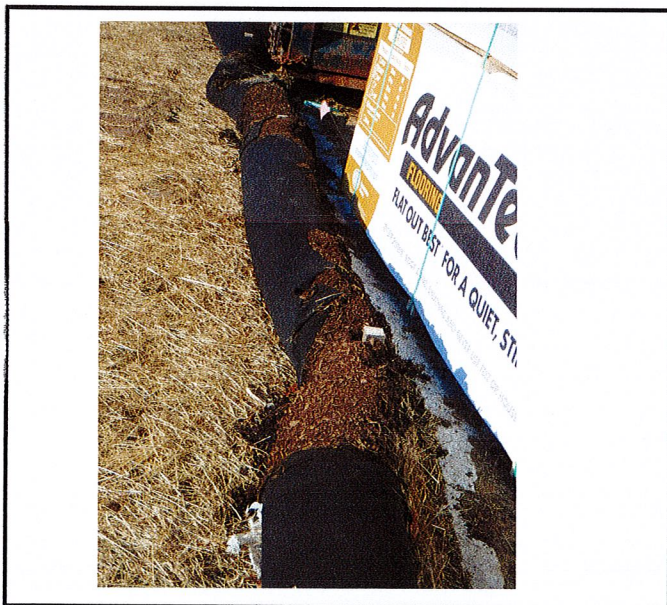
Compost sock ripped apart. This will not function once thawing occurs.

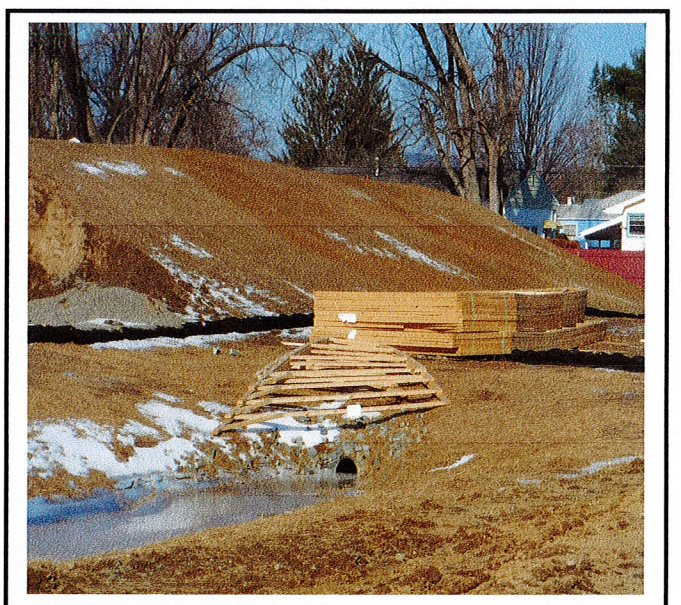
Roof trusses stored on top of the compost sock.

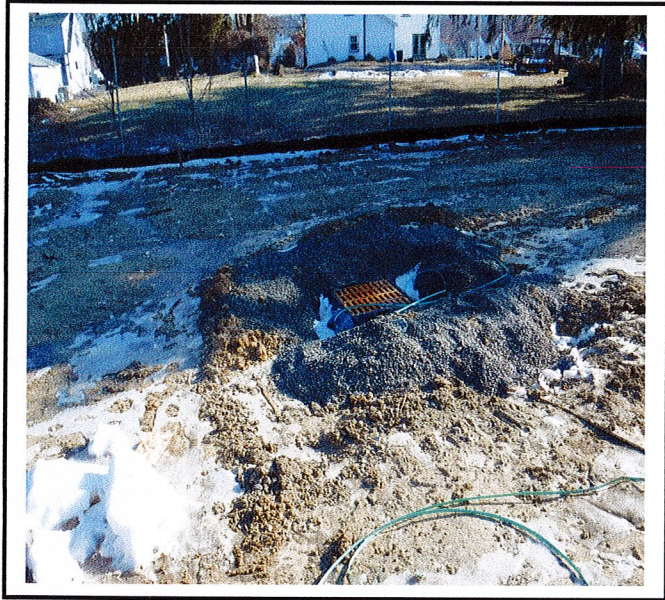
Outer stone drop inlet protection needs repair.

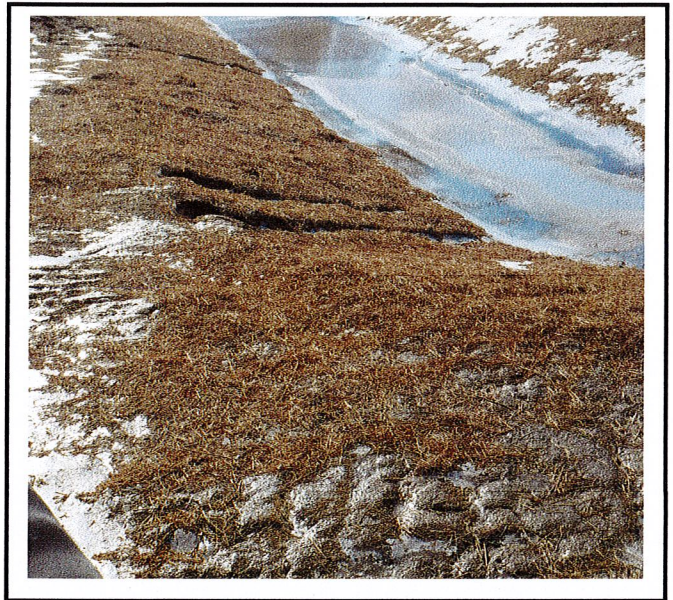
Erosion on the side slope of western most forebay (back of property).
