**Chemung County Stormwater
Construction Inspection
Erosion and Sediment Control**

Project Name CDS Monarch Senior Living Facility	Date 10-15-18
Location Maple Ave.	Permit # NYR11C547
Weather Conditions Rainy and overcast	Entry Time: 9:30 am
On-Site Representative Present: See list below	Exit Time: 10:30 am

PROJECT: CDS Monarch
City of Elmira
October 15, 2018
Municipal Construction Inspection

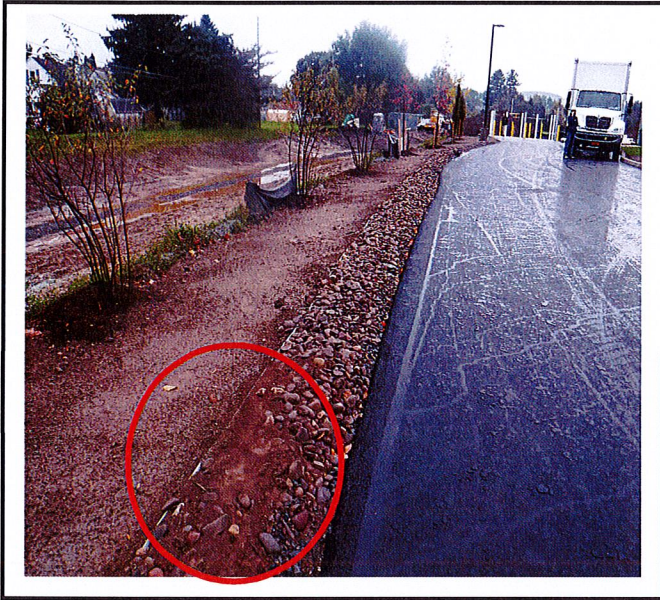
Water quality trench needs to be graded. Also, sediment has been placed on the trench.

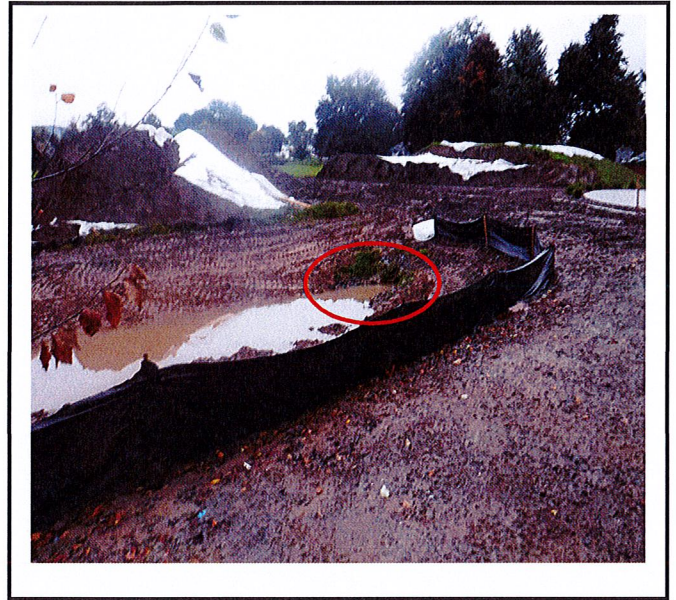
Outlet protection appears to have been removed during re-grading.

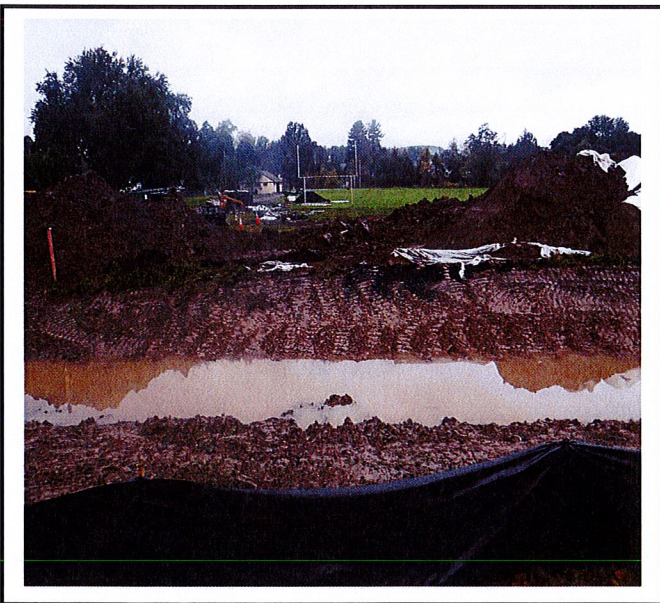
Outlet protection on roof outlet line has not been installed.
