**Chemung County Stormwater  
Construction Inspection  
Erosion and Sediment Control**

<b>Project Name</b> CDS Monarch Senior Living Facility	<b>Date</b> 12-14-18
<b>Location</b> Maple Ave City of Elmira	<b>Permit #</b> NYR11C547
<b>Weather Conditions</b> Sunny cold	<b>Entry Time:</b> 2:08 PM
<b>On-Site Representative Present:</b> NONE	<b>Exit Time:</b> 2:15 PM

<b>PROJECT:</b>	CDS Monarch Senior Living Facility City of Elmira Municipal Construction Inspection December 14, 2018
<b>BY:</b>	Jessica Verrigni, CPESC, CPSWQ

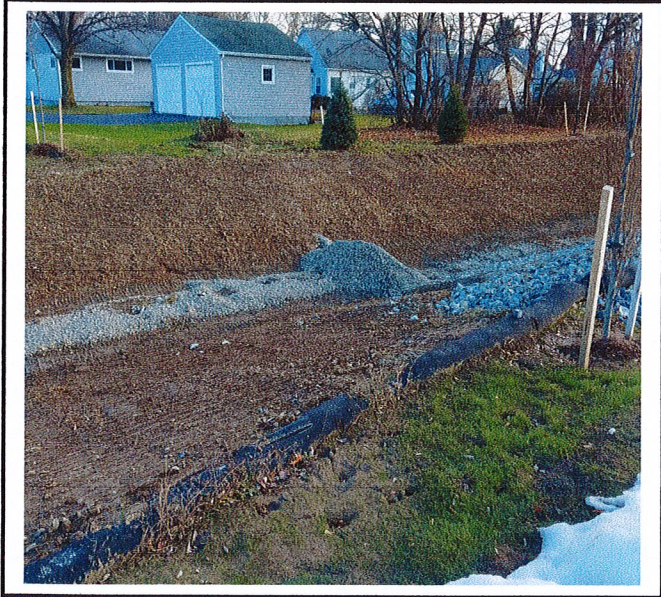
Stone berm does not appear to be installed correctly.

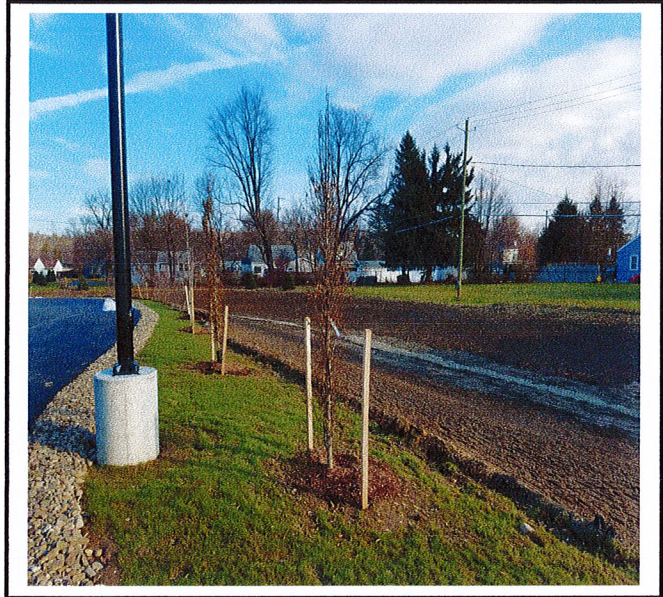
Infiltration basin has been re-graded during high soil moisture.

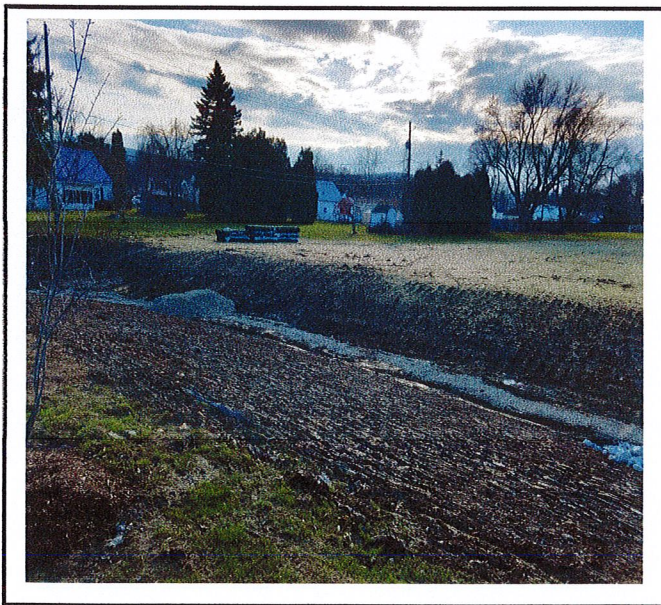
Stone berm does not appear to be installed correctly.

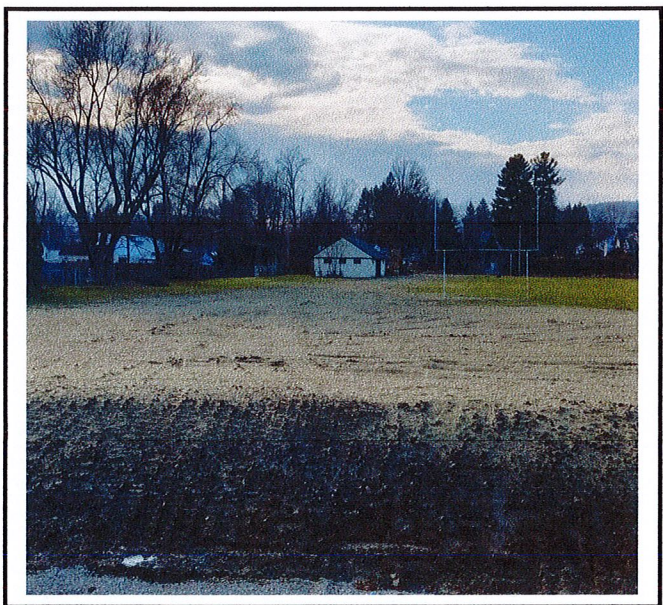
Stockpile and staging area has been graded and stabilized.
