**Construction Inspection  
Erosion and Sediment Control**

<b>Project Name</b> CDS Monarch Senior Living Facility	<b>Date</b> 4-3-19
<b>Location</b> Maple Ave. City of Elmira	<b>Permit #</b> NYR11C547
<b>Weather Conditions</b> Sunny- windy	<b>Entry Time:</b> 1:49 pm
<b>On-Site Representative Present:</b> None	<b>Exit Time:</b> 1:59 pm

**PROJECT:** CDS Monarch Senior Living Facility  
City of Elmira  
Municipal Inspection  
April 3, 2019

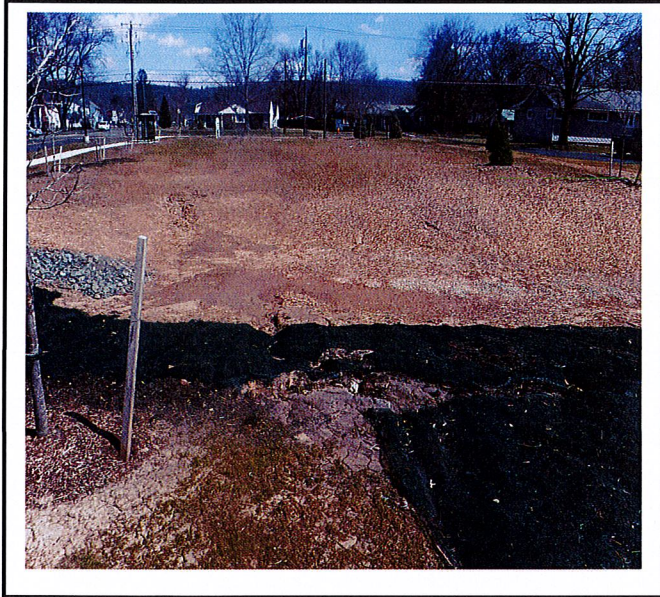
Surface runoff from parking is causing erosion down slope of stormwater basin.

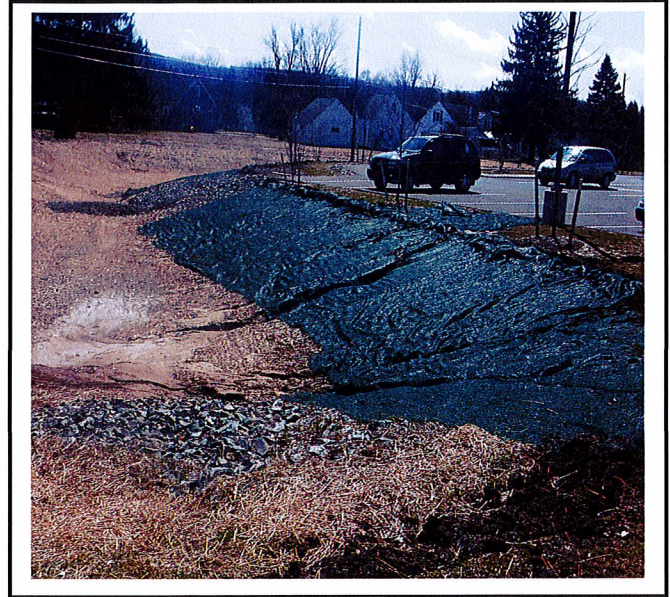
Erosion that has occurred. Check dam has not been installed correctly.

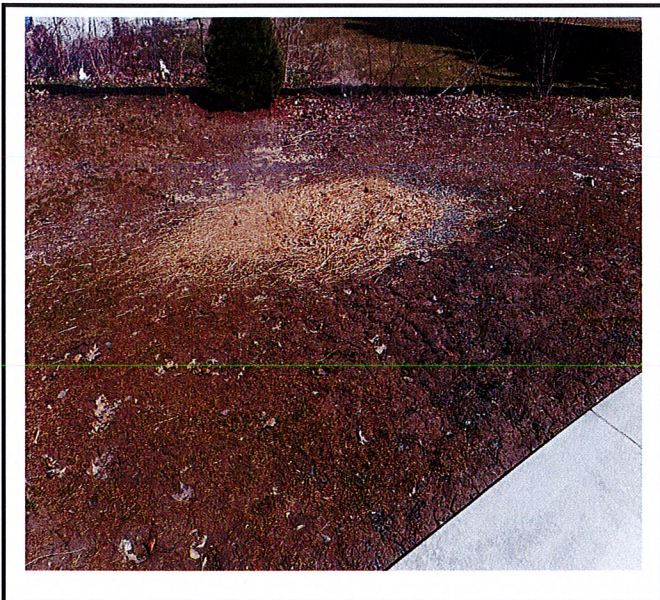
Erosion started from runoff over sidewalk to catch basin.
