**Chemung County Stormwater  
Construction Inspection  
Erosion and Sediment Control**

<b>Project Name</b> Barrington West Lot 83 & 84	<b>Date</b> 7-12-2021
<b>Location</b> Wexford Court Horseheads, NY	<b>Permit #</b> NYR11F212
<b>Weather Conditions</b> sunny clear	<b>Entry Time:</b> 11:23 am
<b>On-Site Representative Present:</b> none	<b>Exit Time:</b> 11:45 am

**PROJECT:** Barrington West Lot 83 & 84  
Town of Horseheads  
Municipal Construction Insp.  
July 12, 2021

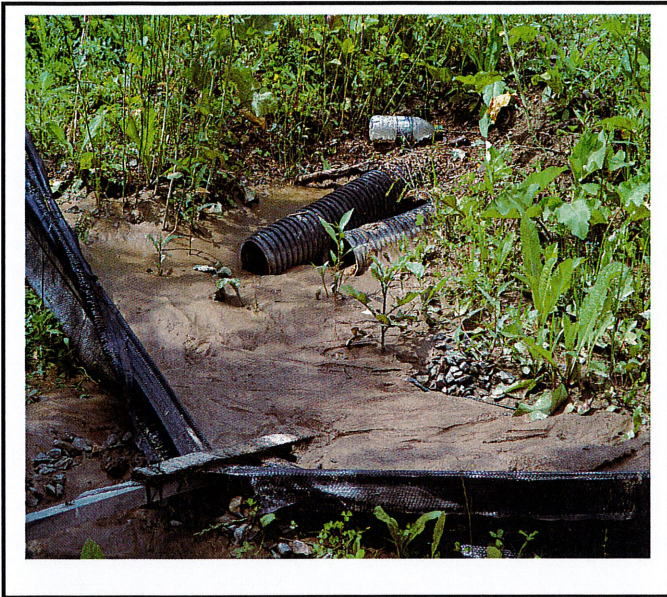
Sediment has overrun the silt fence and left the project location.

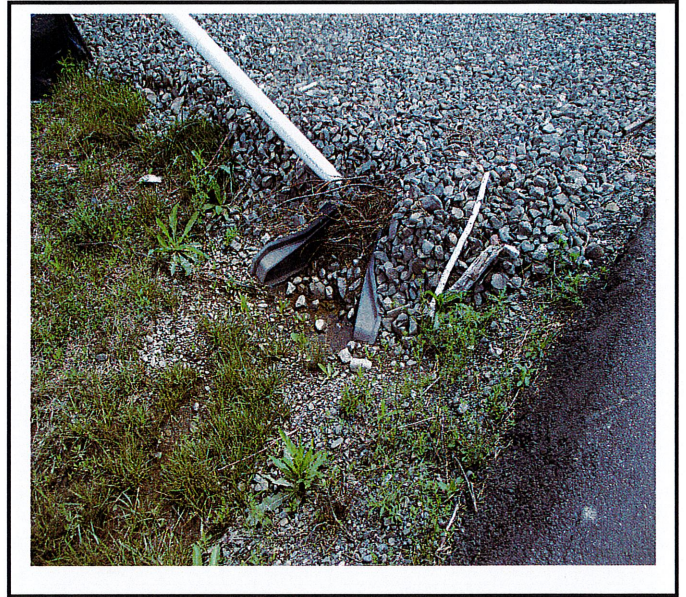
Driveway culvert pipe is blocked with stone and veg. debris. This disrupts flows from other areas of the neighborhood.

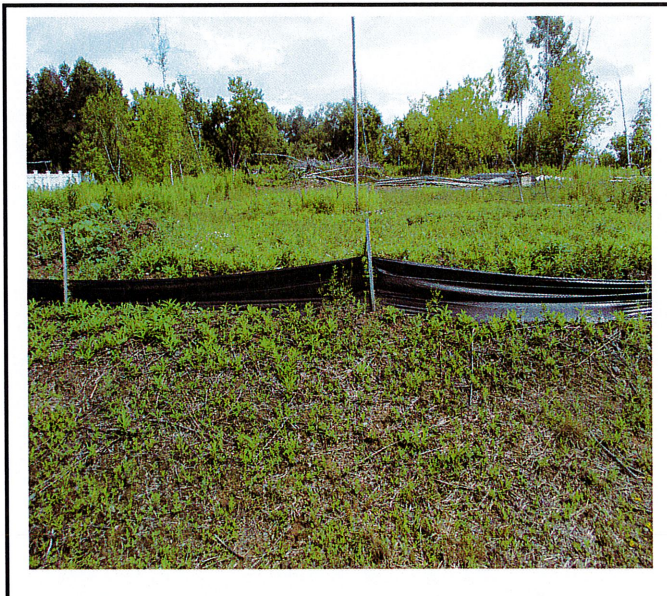
Silt fence around both lots needs to be replaced with new silt fence. Existing fence has holes and is beat up and cannot be salvaged.

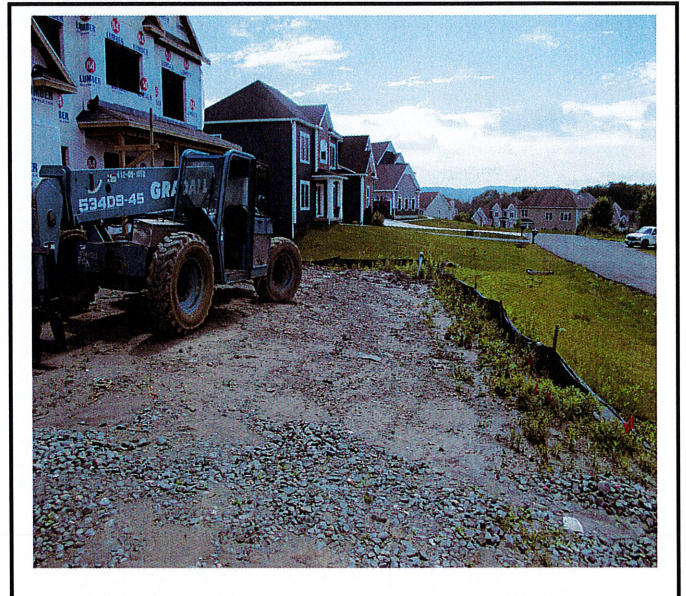
Bare soil outside of a 10' perimeter around the house needs to be temporarily stabilized. Soil is eroding and leaving the site.
