**Chemung County Stormwater
Construction Inspection
Erosion and Sediment Control**

Project Name Barrington West Lot 83& 84	Date 8/13/2021
Location Wexford Court Horseheads, NY	Permit # NYR11F212
Weather Conditions sunny, warm	Entry Time: 10:10 am
On-Site Representative Present: none	Exit Time: 10:17 am

PROJECT: Barrington West Lot 83 & 84
Town of Horseheads
Municipal Construction Inspection
August 13, 2021

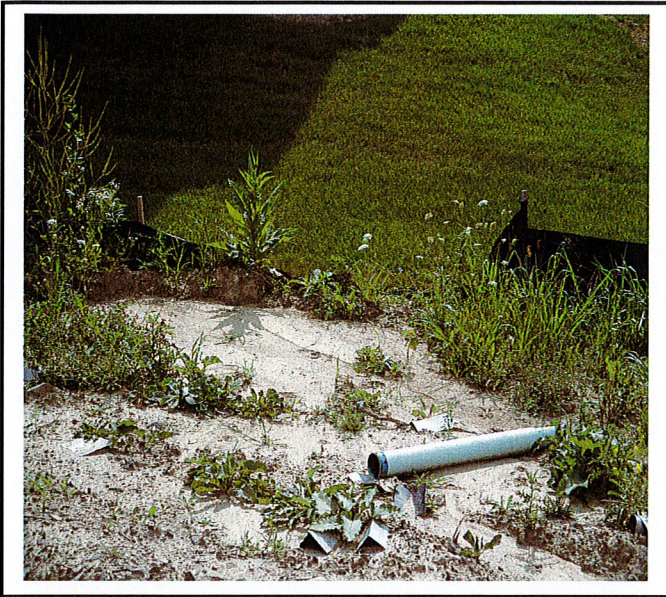
Silt fence around the entire property needs to be replaced. Sediment has overtopped it in a number of locations.

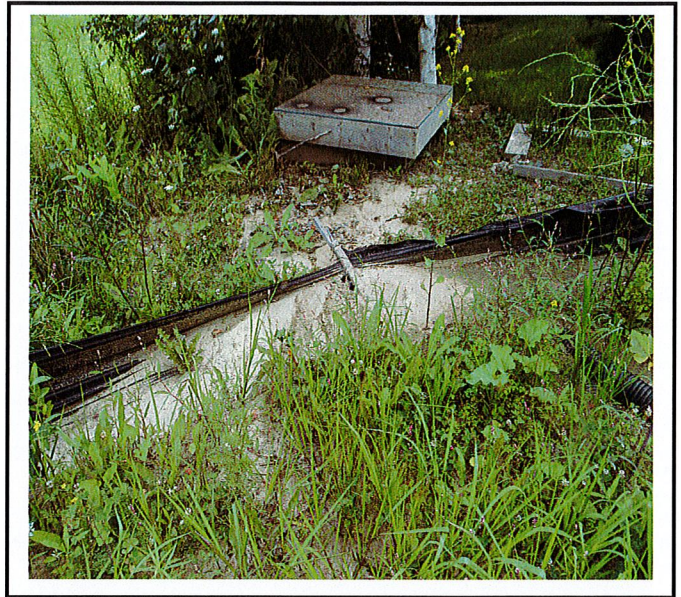
Silt fence around the entire property needs to be replaced. Sediment has overtopped it in a number of locations.

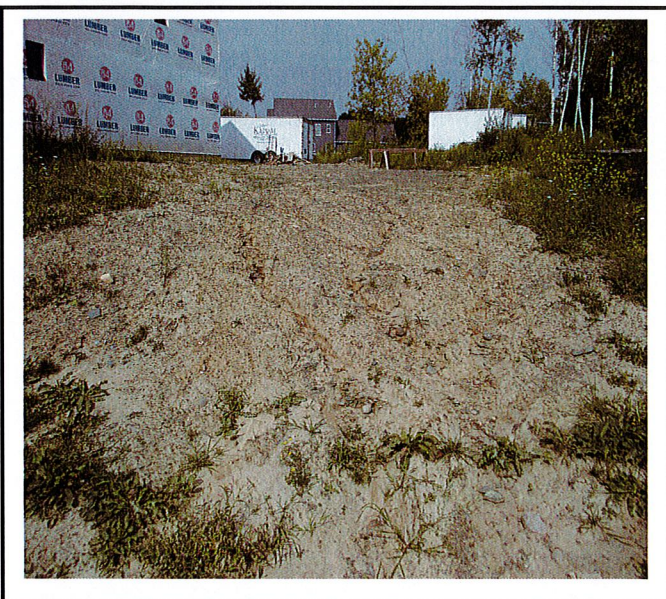
Major erosion is occurring on soils that have been left unprotected for so long.

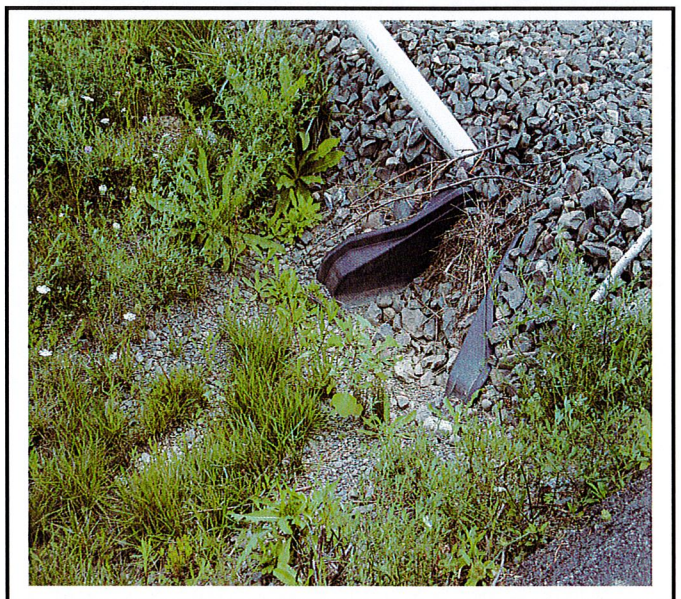
Driveway pipe is clogged with stone and debris. Water flow is impeded.
