**Chemung County Stormwater
Construction Inspection
Erosion and Sediment Control**

Project Name Barrington West Lot 54	Date 9-14-2022
Location Wexford Court, Horseheads, NY	Permit # NYR11F212
Weather Conditions sunny	Entry Time: 11:27 am
On-Site Representative Present: None	Exit Time: 11:35 am

PROJECT:	Barrington West Lot 54
	Town of Horseheads
	Municipal Inspection
	September 14, 2022
BY:	Jessica Verrigni, CPESC, CPSWQ

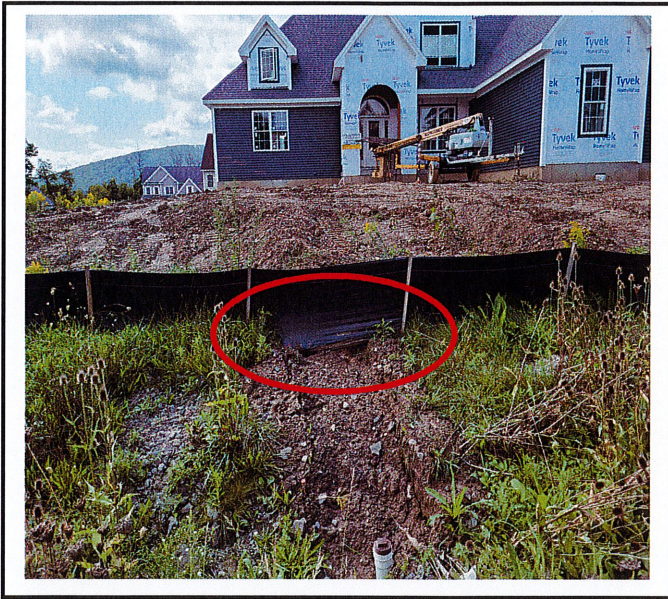
Silt fence requires repair where utilities were installed under it.

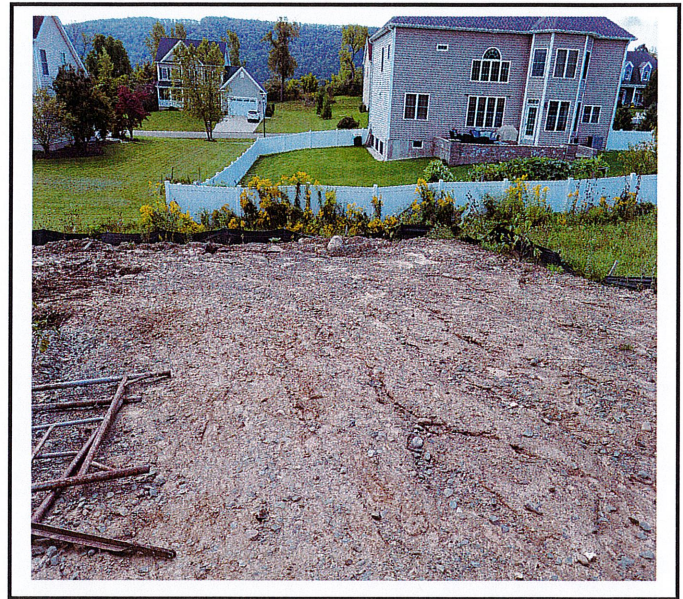
Erosion continues to be an issue because the soil has never been temporarily stabilized to prevent it from happening.

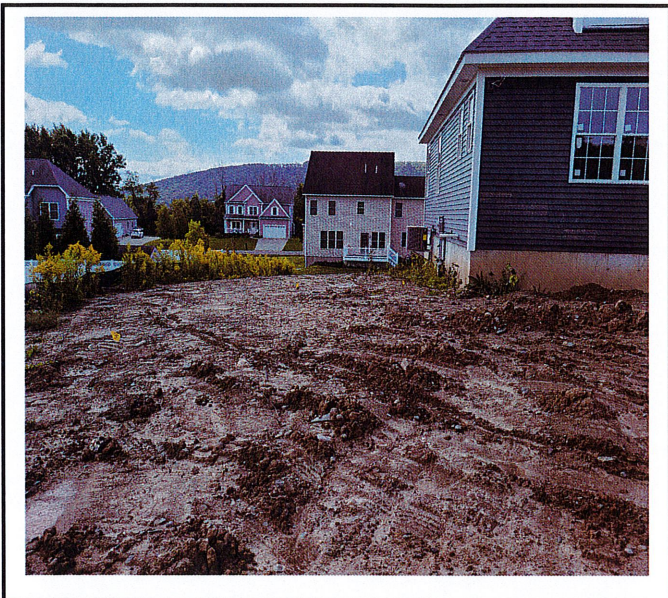
Soil heavily compacted will require decopaction and restoration prior to final topsoiling and landgrading.

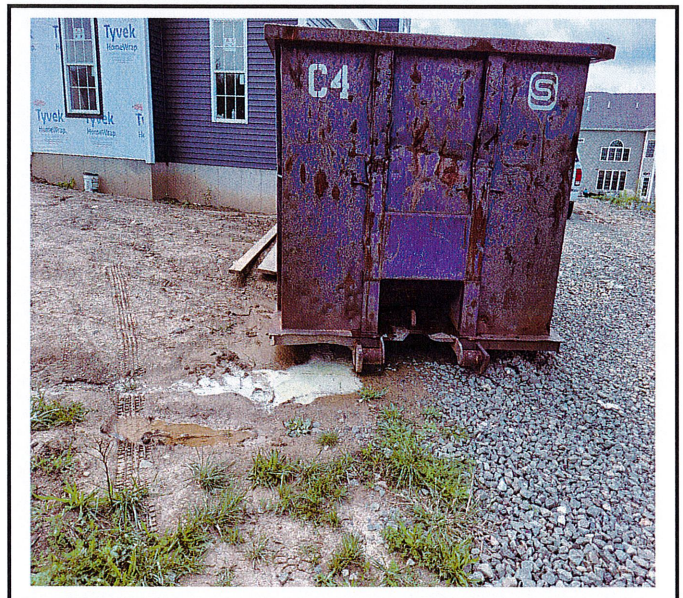
Dumpster is leaching some sort of pollutant onto the ground. This area grades towards ditch.
