**Chemung County Stormwater
Construction Inspection
Erosion and Sediment Control**

Project Name Hickory Grove Road Solar Projects	Date 9-24-20
Location Hickory Grove Road Horseheads, NY	Permit # NYR111F809
Weather Conditions sunny	Entry Time: 12:44 pm
On-Site Representative Present:	Exit Time: 1:14 pm

PROJECT: Hickory Grove Solar Farm
Town of Horseheads
MS4 Construction Inspection
September 24, 2020

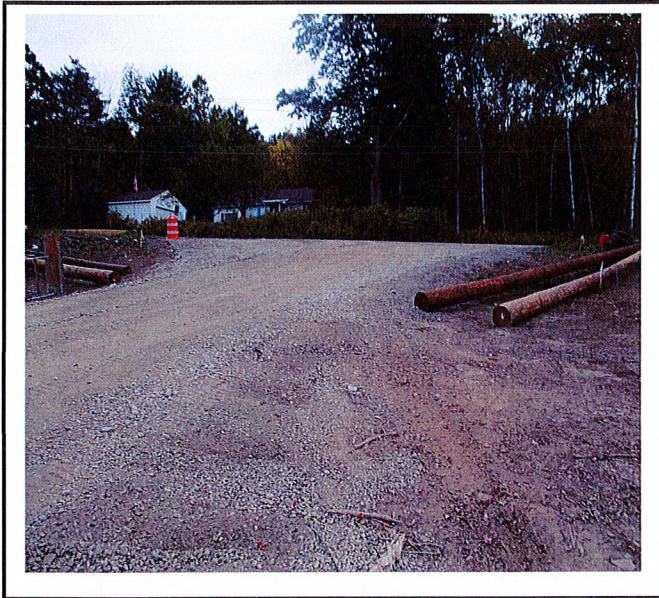
Construction entrance requires maintenance due to dust accumulation.

Corrections Needed:	
	-Construction entrance requires maintenance from dust accumulation.
	-Dust is a major concern at this time. Need to incorporate dust control practices.

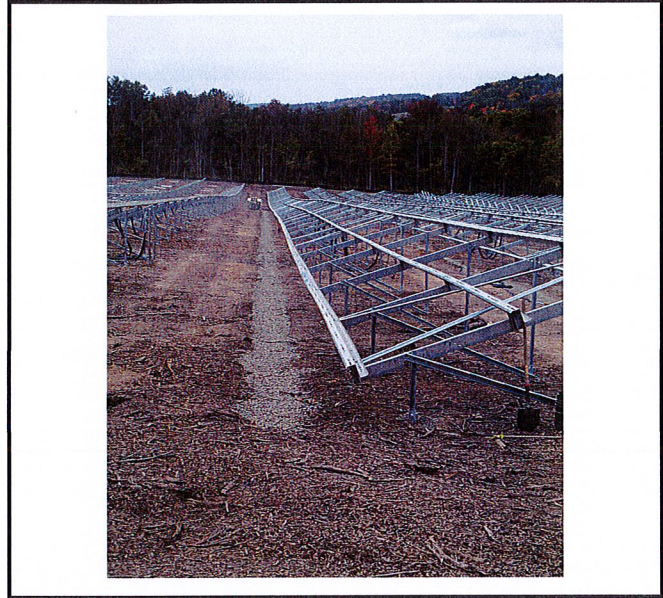
Flow diverters are being installed where they are planned.

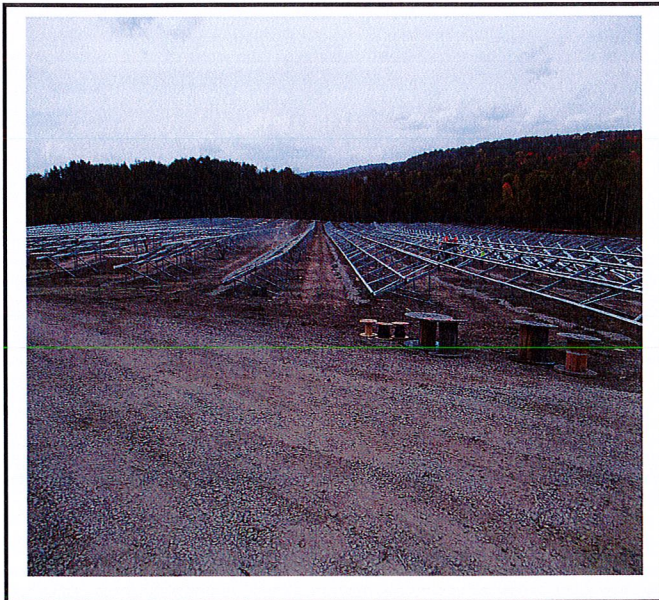
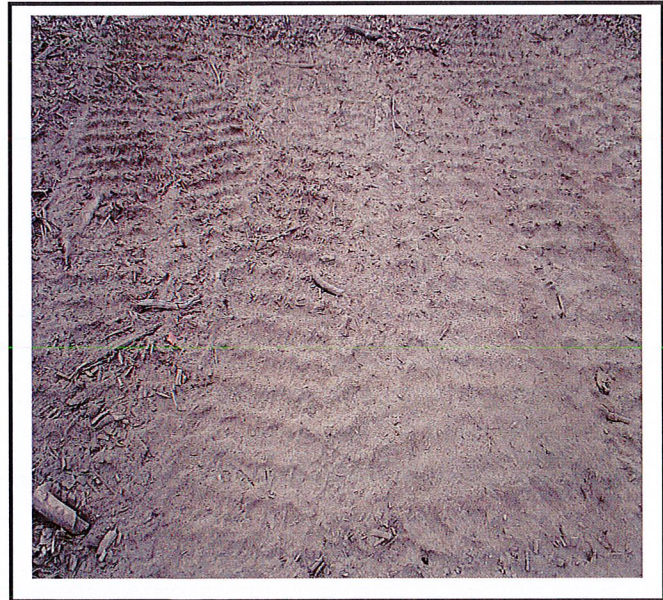
Dust is a major concern.
