**Chemung County Stormwater
Construction Inspection
Erosion and Sediment Control**

Project Name Hickory Grove Solar Project	Date 4-27-21
Location Hickory Grove Road Horseheads, NY	Permit # NYR11F809
Weather Conditions sunny	Entry Time: 1:43 pm
On-Site Representative Present: Zack Gillespie, APA	Exit Time:

PROJECT: Hickory Grove Road Solar
Town of Horseheads
Municipal Construction Inspection
April 27, 2021

BY: Jessica Verrigni, CPESC, CPSWQ

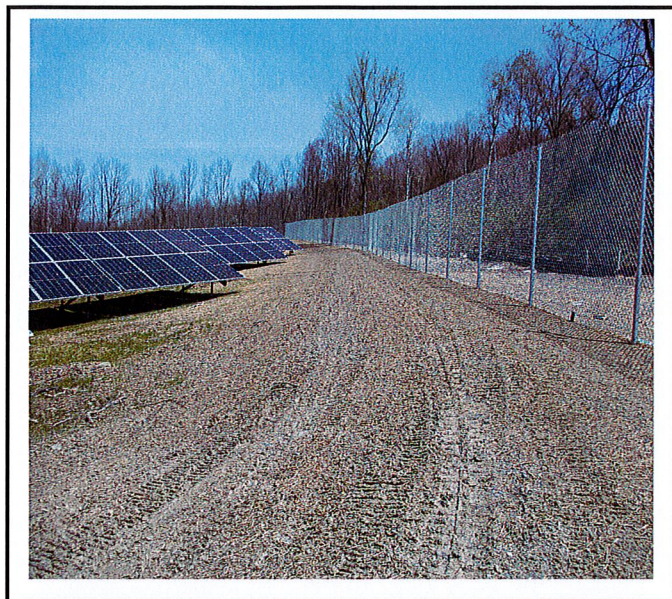
Corrections Needed:
-Restoration and decompaction has not occurred at this site. There is minimal grass growing and a major water ponding issue on the north end of the project.
-This site is not stabilized so qualified inspections are supposed to be still occurring. I have not seen a weekly inspection since October 13 th , 2020.

Severe compaction with no stabilization.

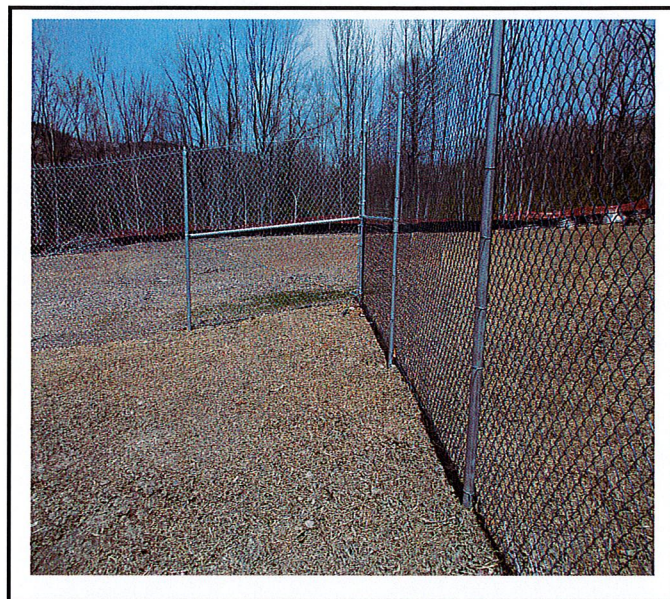
Open idle areas were left unstabilized all winter.

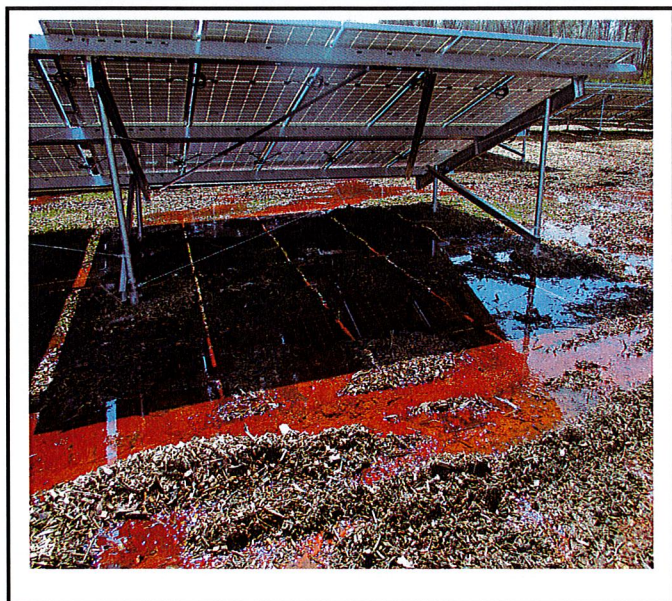
Standing water issue.

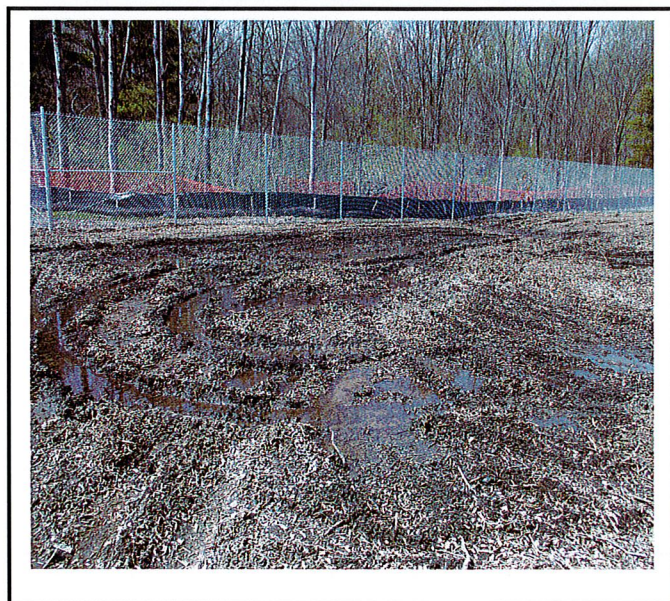
Severe compaction and standing water issue.
