**Chemung County Stormwater  
Construction Inspection  
Erosion and Sediment Control**

<b>Project Name</b> Hickory Grove Solar Farm	<b>Date</b> 8/3/2022
<b>Location</b> Hickory Grove Road Horseheads, NY	<b>Permit #</b> NYR11F809
<b>Weather Conditions</b> sunny	<b>Entry Time:</b> 1:03 pm
<b>On-Site Representative Present:</b> None	<b>Exit Time:</b> 1:27 pm

**PROJECT:** Hickory Solar Farm  
Town of Horseheads  
Municipal Inspection  
August 3, 2022

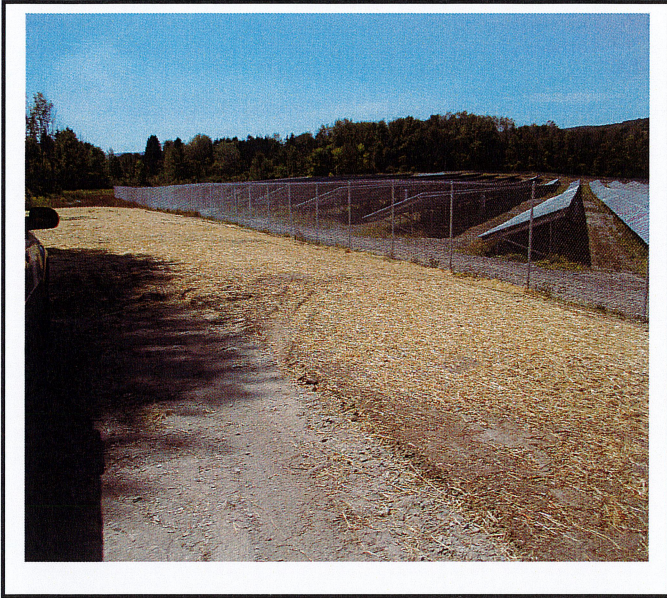
Corrections Needed:	
-Parking/Staging area from construction has been mulched. This area was not decompacted. The penetrometer would not go 1" into the ground. Decompaction was required for this entire site.	
-Drive areas within the fenced area do not appear to have been restored. Still look compacted.	
-Areas where topsoil was put down there is no seed and mulch.	
-Could not get to the area where dewatering was to occur. Inaccessible.

Parking/staging areas appear to be restored however are still compact.

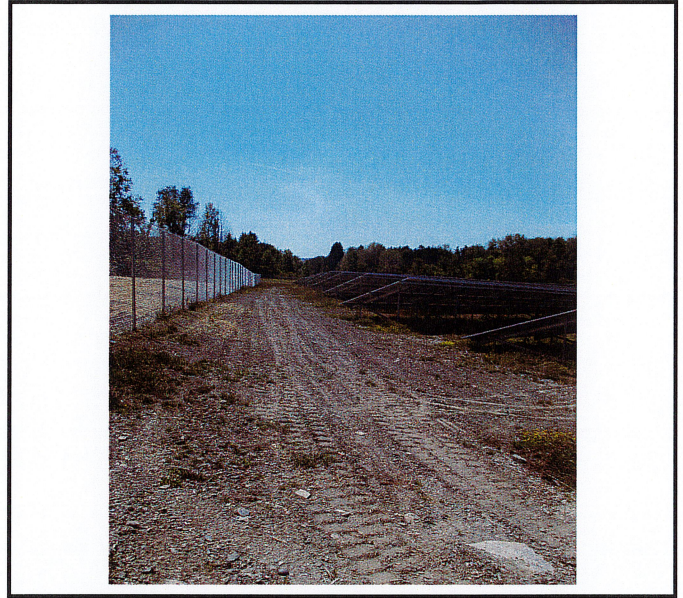
Areas driven on during construction do not appear restored.

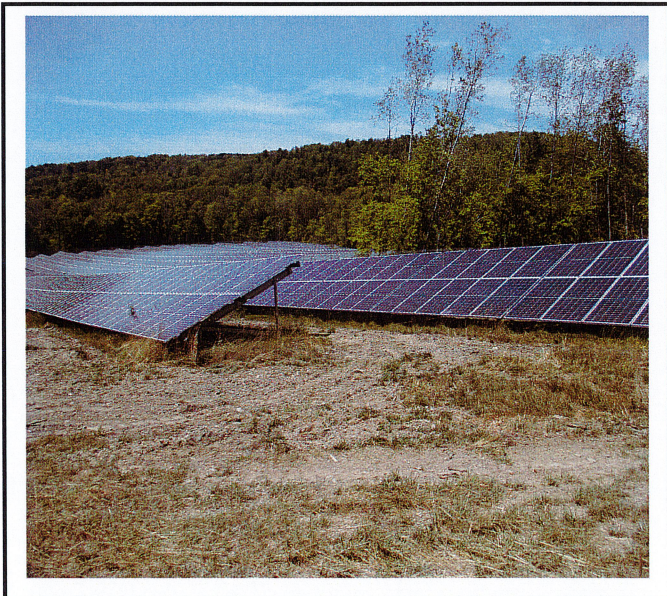
Areas restored have not been stabilized inside of the fence.

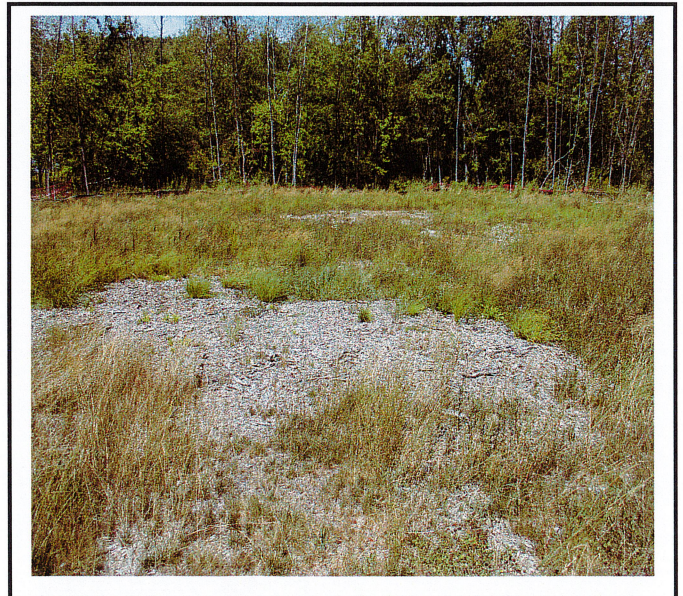
Contractor stockpile yard does not have the excessive mulch removed.
