**Chemung County Stormwater
Construction Inspection
Erosion and Sediment Control**

Project Name Hickory Grove Solar Farm	Date 9-27-2022
Location Hickory Grove Road Horseheads, NY	Permit # NYR11F809
Weather Conditions	Entry Time: 10:36 am
On-Site Representative Present: Johnathan, JHA Consulting	Exit Time: 11:47 am

PROJECT: Hickory Grove Solar
Town of Horseheads
MS4 Construction Insp.
September 27, 2022

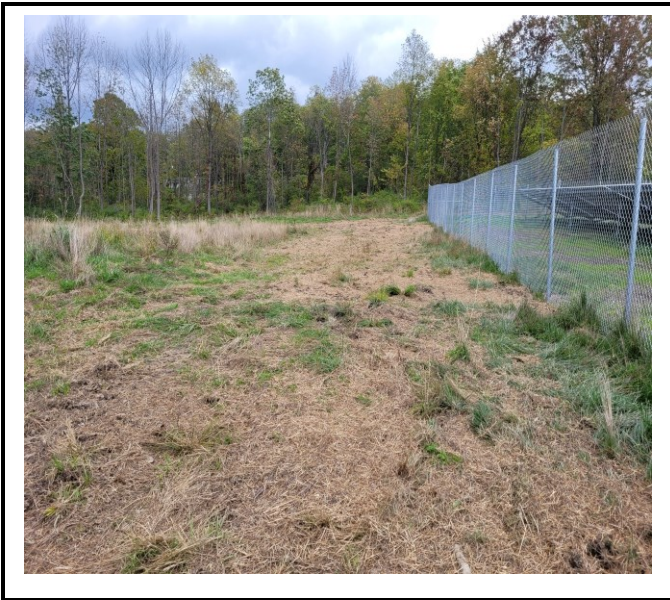
Soil restoration/decompaction and compost sock removal has been performed in some areas.

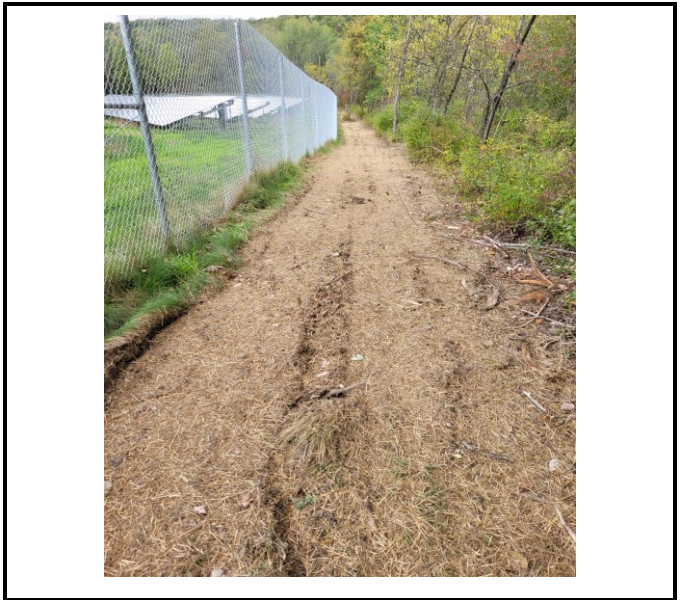
Soil restoration/decompaction and compost sock removal has been performed in some areas.

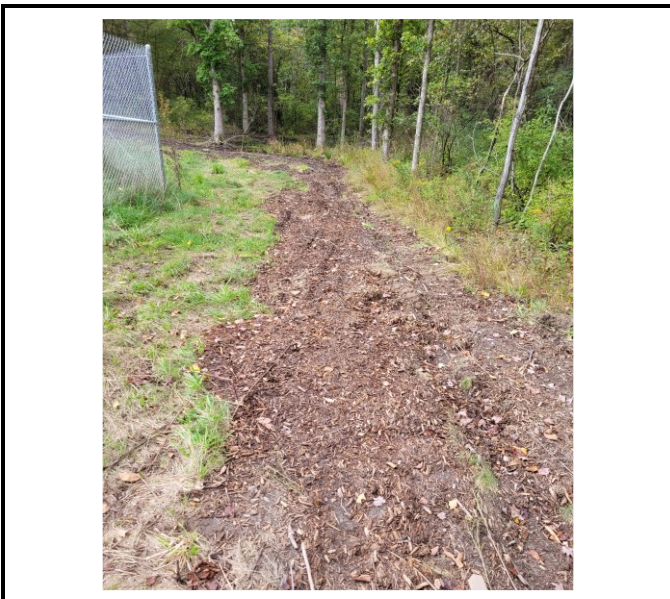
Areas where compost sock removed but not yet restored due to moisture.

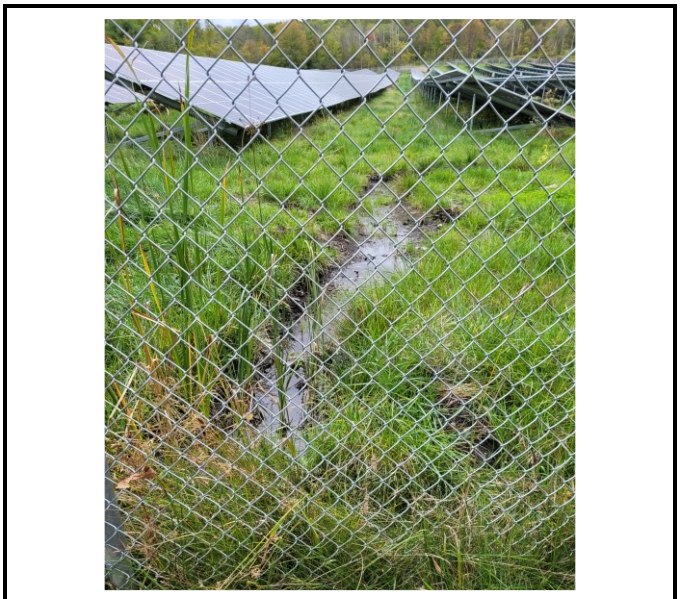
Standing water is still an issue on lower part of project inside of the fence. Now that it is raining again it is visible.
