**Chemung County Stormwater  
Construction Inspection  
Erosion and Sediment Control**

<b>Project Name</b> Dollar General	<b>Date</b> 11-14-19
<b>Location</b> Old Ithaca Road Horseheads (T), NY	<b>Permit #</b> NYR11F379
<b>Weather Conditions</b> overcast, cold	<b>Entry Time:</b> 11:39 am
<b>On-Site Representative Present:</b> none	<b>Exit Time:</b> 11:48 am

**PROJECT:** Dollar General Old Ithaca Road  
Town of Horseheads  
Municipal Construction Inspection  
November 14, 2019

**BY:** Jessica Verrigni, CPESC, CPSWQ

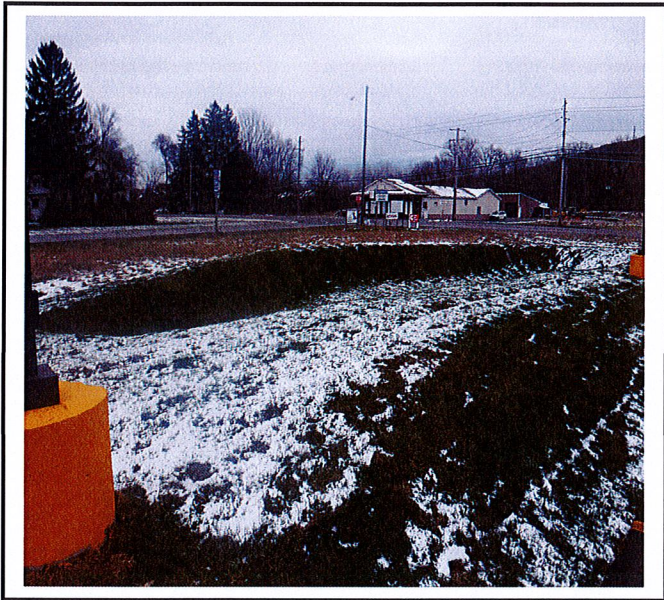
Infiltration basin has been completed and sod placed for stabilization.

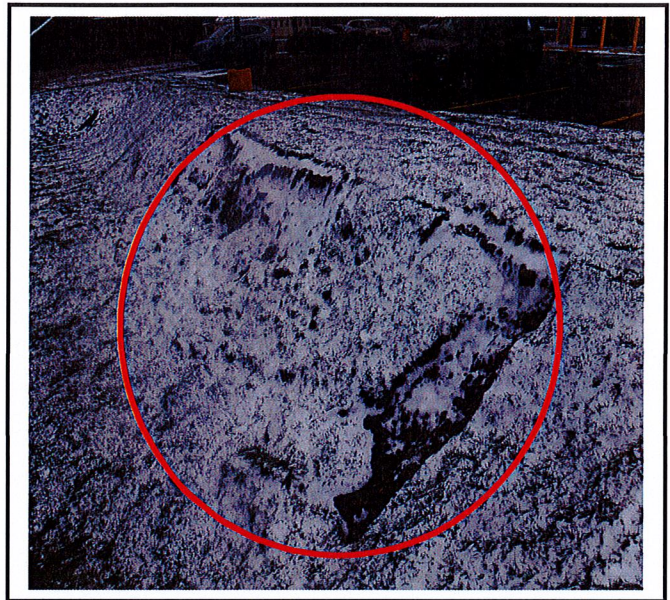
Corrections Needed:
Stormwater Infiltration Basin (large one)- There is side slope slumping, erosion or the sod has not been applied correctly. This will cause major issues if not corrected. See photos.

There is an issue with the slope sliding or the sod is not attached correctly in the infiltration basin.

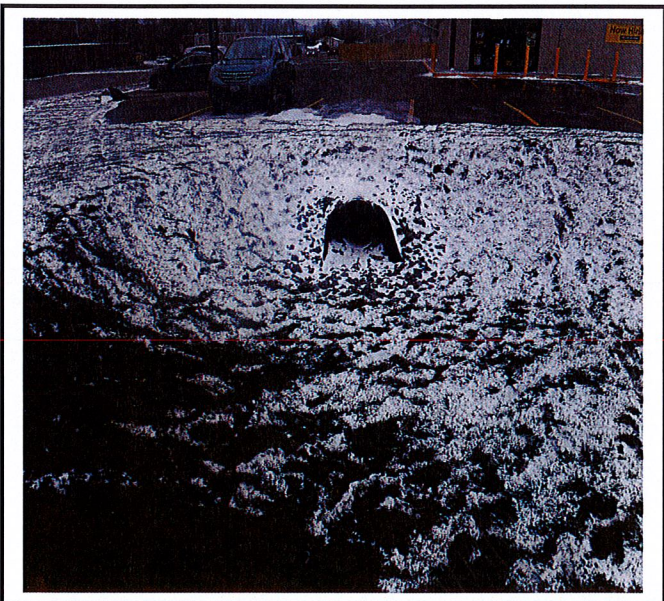
Inlet into the infiltration basin.

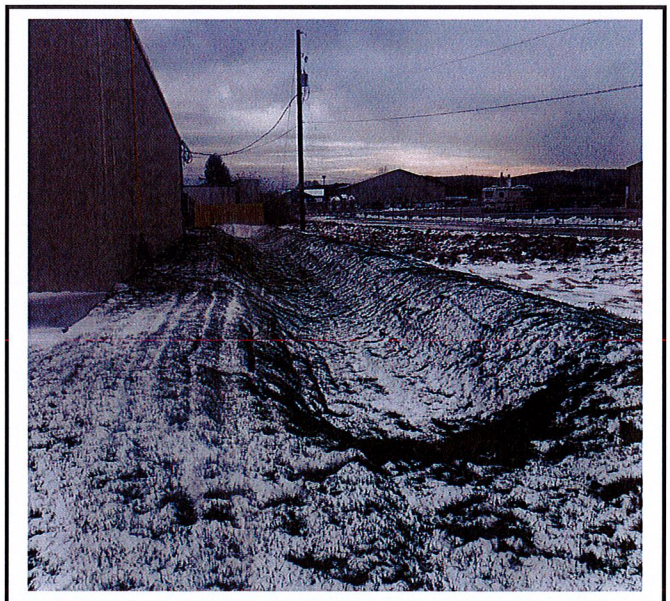
Rear stormwater basin is complete and has been sodded for stabilization.
