**Chemung County Stormwater
Construction Inspection
Erosion and Sediment Control**

Project Name Scotch Pine Lane Subdivision	Date 5-30-2018
Location Scotch Pine Lane Horseheads, NY	Permit # No Permit
Weather Conditions Sunny, hot	Entry Time: 2:45 pm
On-Site Representative Present: None on site	Exit Time: 3:02 pm

PROJECT:	Scotch Pine Lane Subdivision Town of Horseheads MS4 Construction Inspection May 30, 2018
BY:	Jessica Verrigni, CPESC, CPSWQ

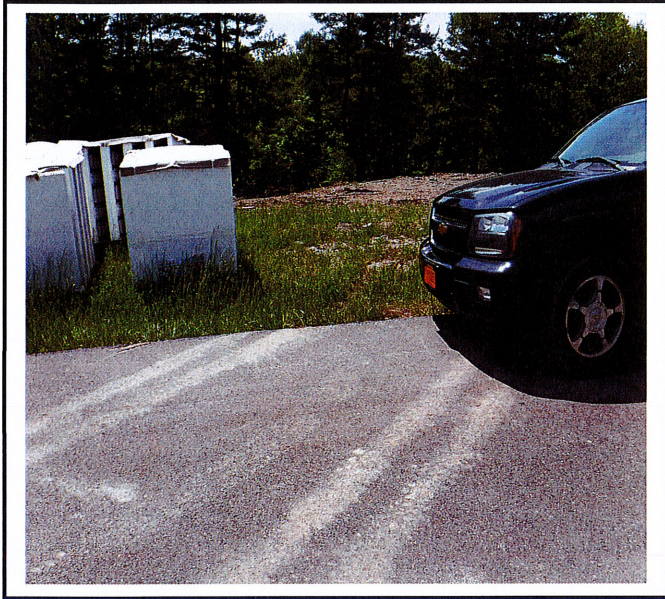
Construction entrance has not been installed on the project and trucks are entering through municipal drainage ditch.

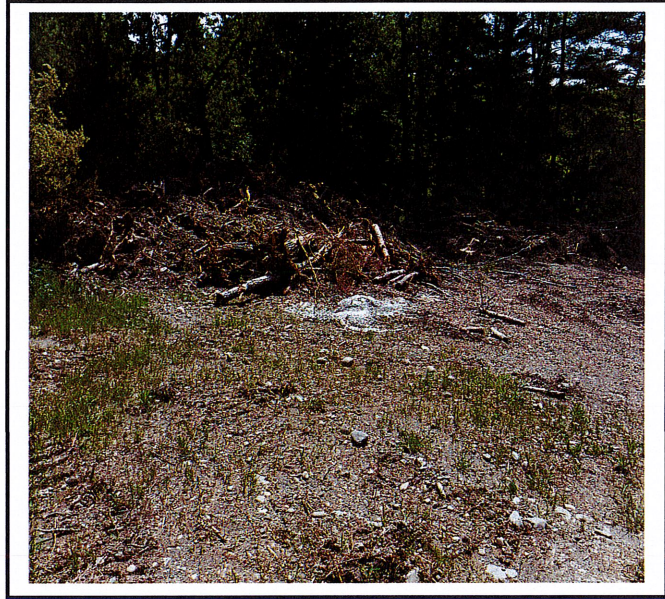
Concrete washed onto the ground. Concrete washout not installed.

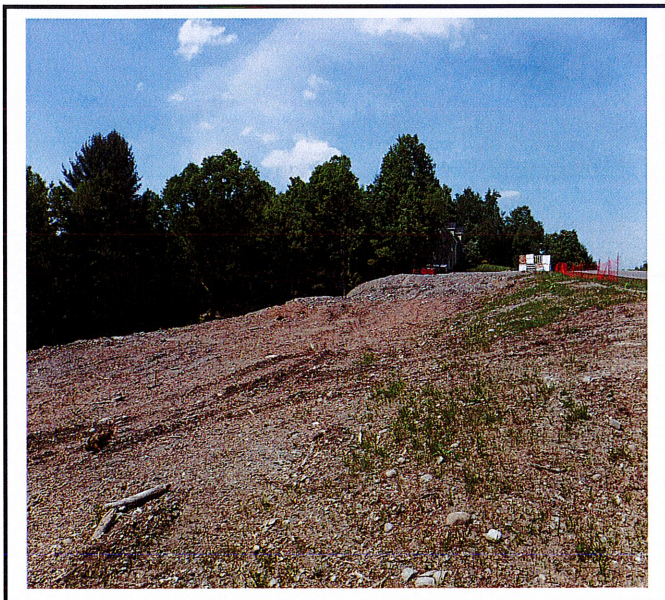
Large area of soil on a steep grade is opened up and not stabilized. No equipment is on site so it is sitting idle.

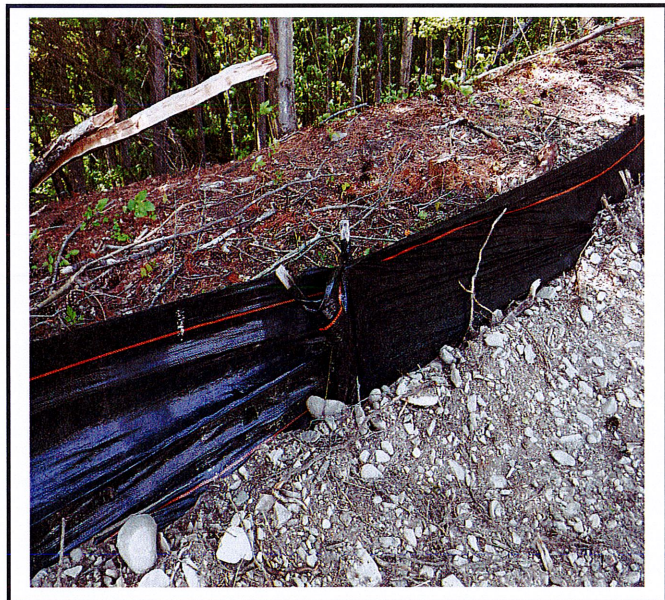
Silt fence requires repair in a number of areas. The silt fence is not installed along the entire length of open disturbed soil.
