**Chemung County Stormwater  
Construction Inspection  
Erosion and Sediment Control**

<b>Project Name</b> Scotch Pine Lane Housing Development	<b>Date</b> 6-26-18
<b>Location</b> Scotch Pine Lane Horseheads, NY	<b>Permit #</b> NYR11D756
<b>Weather Conditions</b> Sunny, warm	<b>Entry Time:</b> 11:05
<b>On-Site Representative Present:</b> No contractor on site	<b>Exit Time:</b> 11:20

**PROJECT:** Scotch Pine Housing Development  
Town of Horseheads  
Municipal Construction Inspection  
June 26, 2018

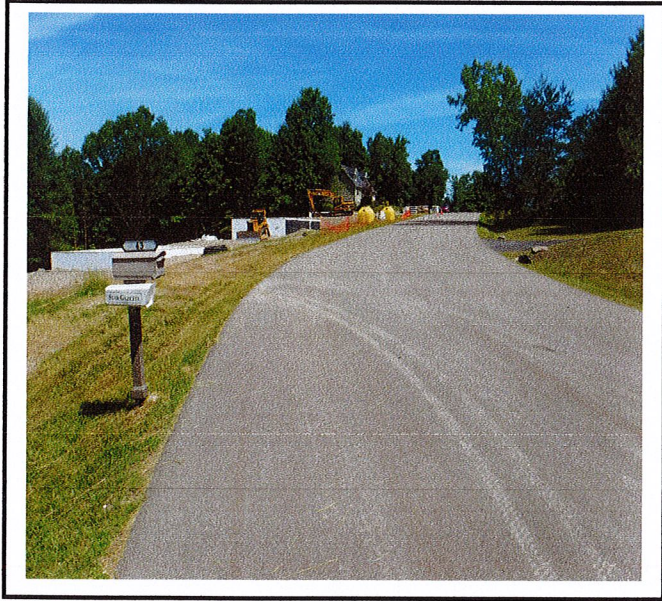
-Construction entrance is installed but does not appear to be being used. Traffic is still entering through a municipal ditch-this is not acceptable.

Construction traffic continues to access property through a municipal drainage ditch. This is unacceptable.

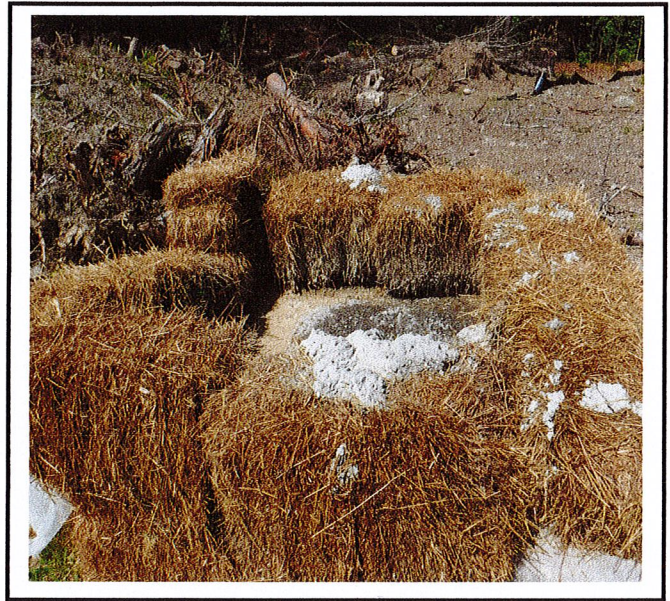
-Concrete washout is at capacity and requires maintenance.

Concrete washout is at capacity- it is above the plastic liner on first row of bales.

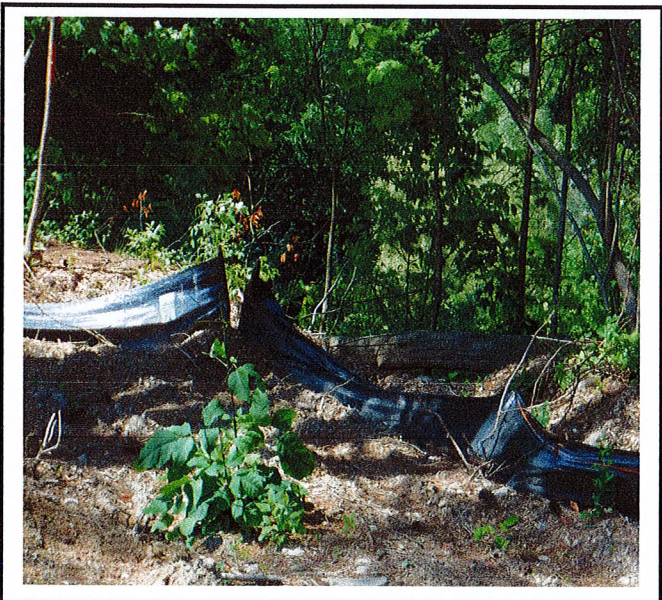
-Silt fence requires maintenance in many locations. It is knocked over and not spliced correctly.

Silt fence requires maintenance in many locations.

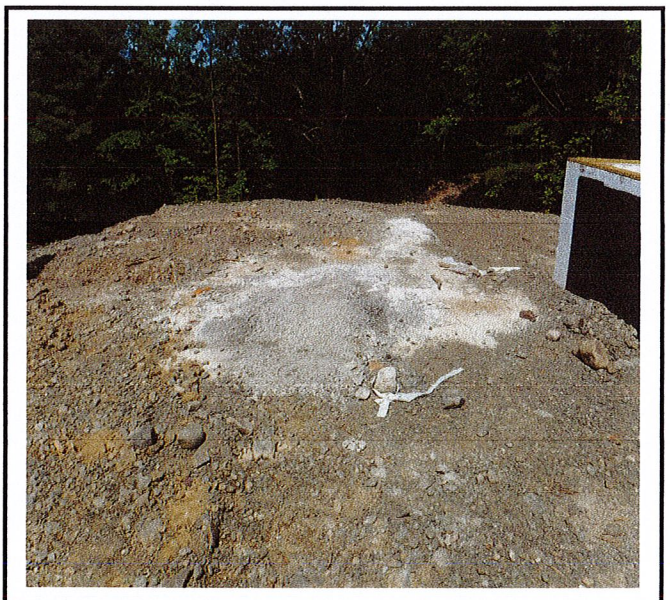
-Concrete has been washed out onto the ground and onto the construction entrance.

Concrete washed out onto the ground at Lot #16. Concrete has also been washed onto the construction entrance.
