**Chemung County Stormwater
Construction Inspection
Erosion and Sediment Control**

Project Name Scotch Pine Lane Housing Development	Date 9-4-18
Location Scotch Pine Lane Horseheads, NY	Permit # NYR11D756
Weather Conditions Sunny, hot, humid	Entry Time: 11:17 am
On-Site Representative Present: None	Exit Time: 11:30 am

PROJECT: Scotch Pine Housing Development
Town of Horseheads
Municipal Construction Inspection
September 4, 2018

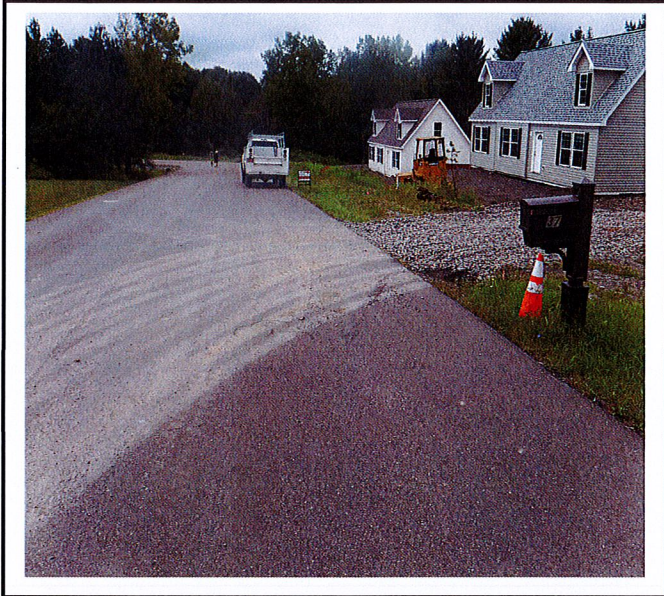
Construction entrance in place but mud is being tracked into the road.

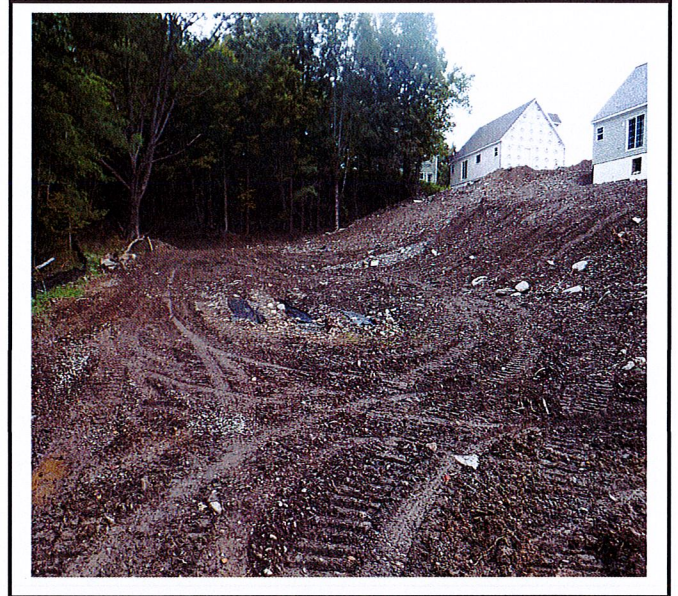
Areas behind house open with no stabilization.

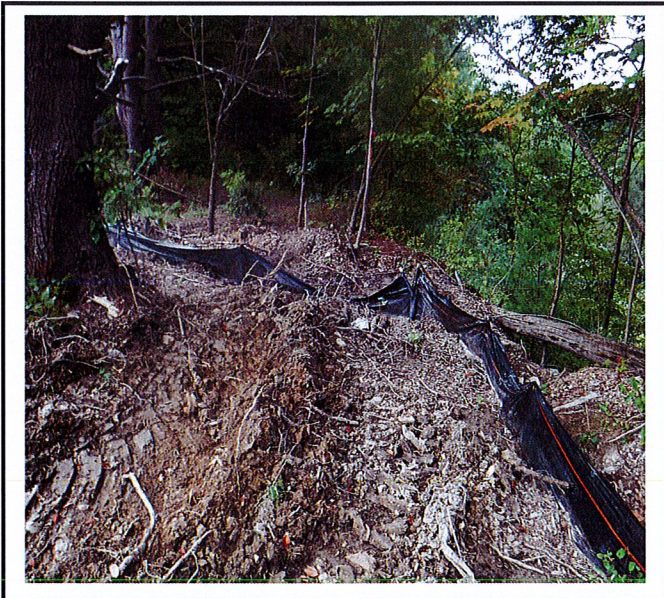
Silt fence still requires attention.

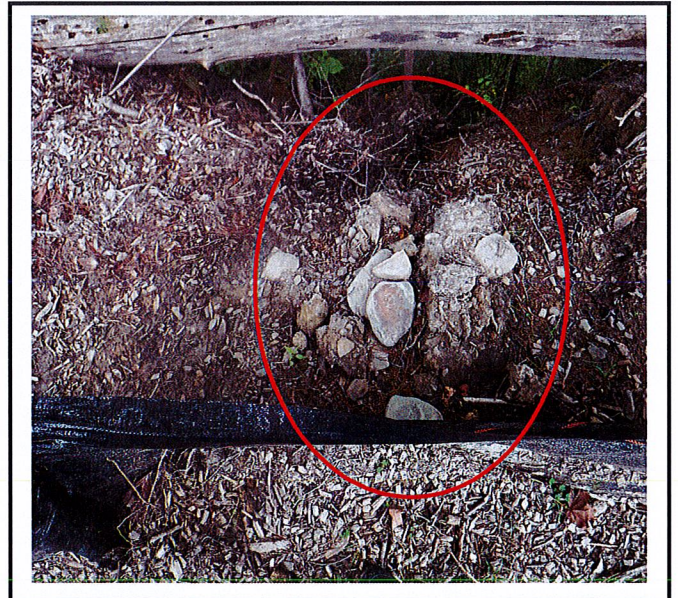
Water went over the silt fence and is causing erosion down to the stream.
