**Chemung County Stormwater  
Construction Inspection  
Erosion and Sediment Control**

<b>Project Name</b>	Glad Tidings Building Exp	<b>Date</b>	4-30-2018
<b>Location</b>	116 Breesport Rd Horseheads, NY	<b>Permit #</b>	NYR11C743
<b>Weather Conditions</b>	Overcast, cool	<b>Entry Time:</b>	10:09
<b>On-Site Representative Present:</b>	Paul Owens, Bella Facia	<b>Exit Time:</b>	10:30

<b>PROJECT:</b>	Glad Tidings Church Town of Horseheads Municipal Construction Inspection April 30, 2018
<b>BY:</b>	Jessica Verrigni, CPESC, CPSWQ

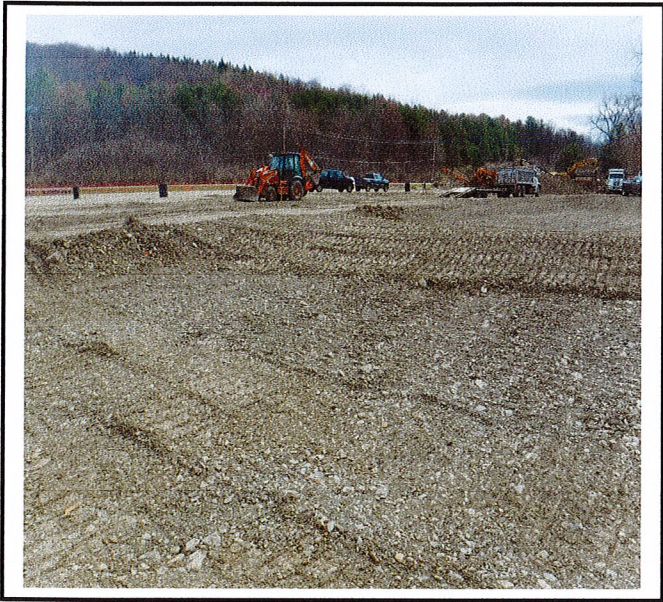
Sediment trap/forebay.

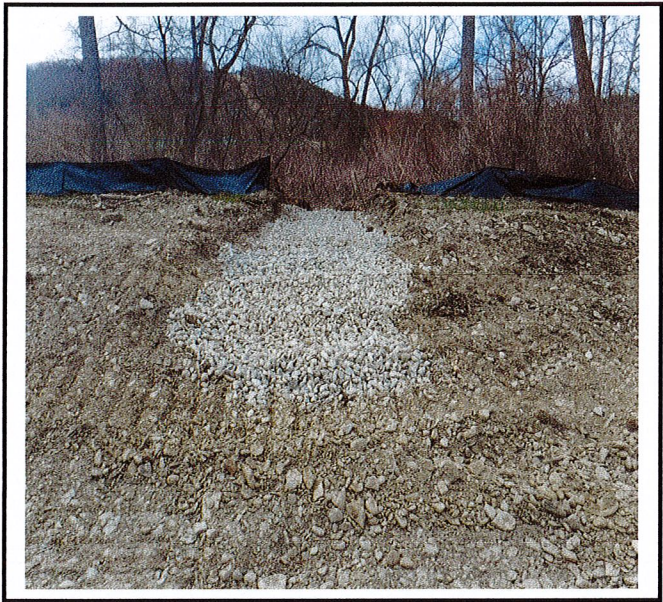
-Stone Outlet Sediment Trap- Outlet is not constructed correctly. Wrong stone Size was utilized.

Stone outlet sediment trap is not constructed correctly and the correct stone size. The standard calls for small rip rap 4-8 inches in size.

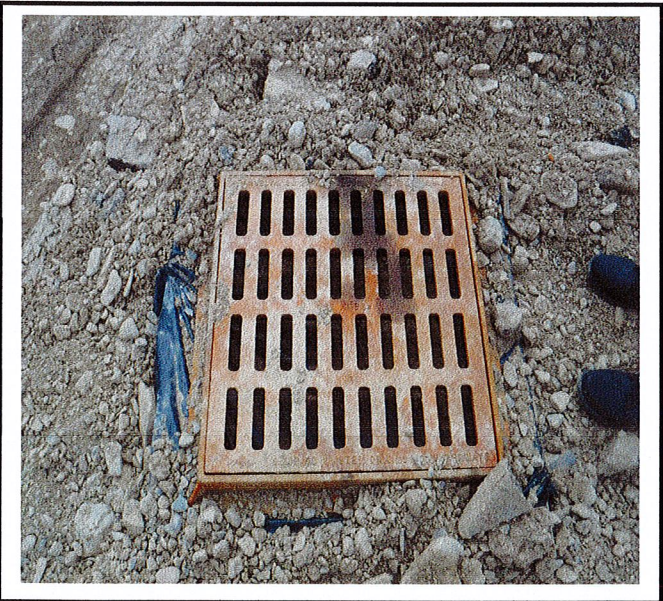
-Catch basins have fabric under the lid. This is not an approved protection practice.

All catch basins have filter fabric under thelids. This is not an acceptable catch basin protection.

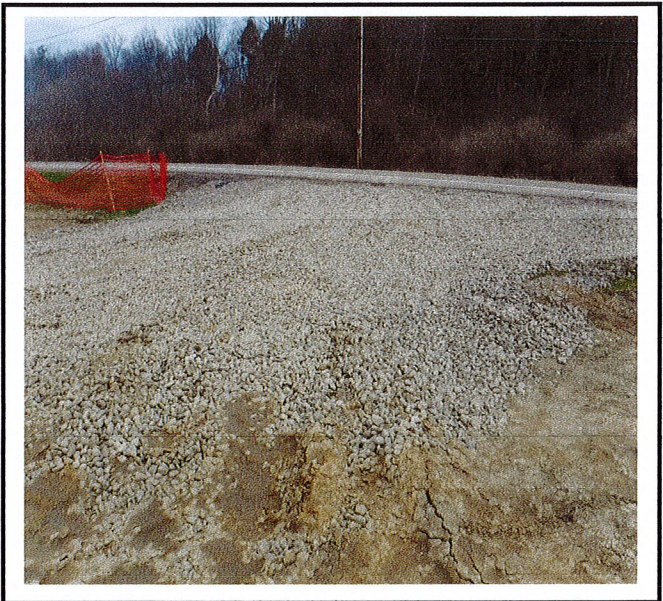
Construction entrance does not appear to be the 50 foot length.

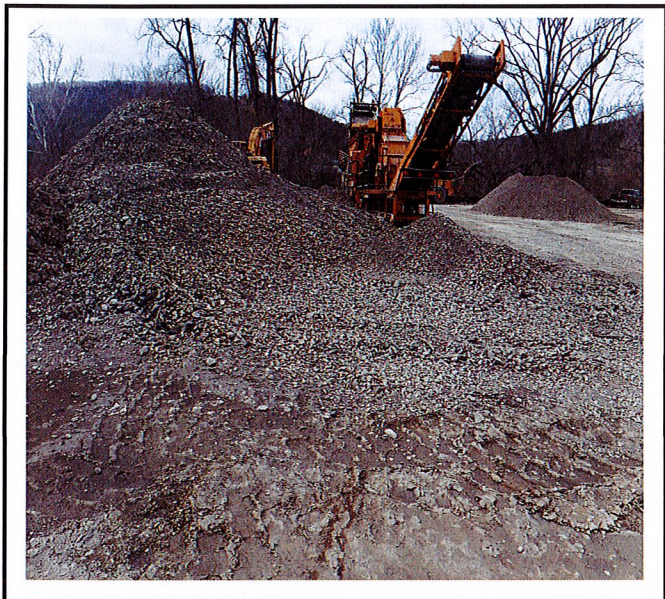
- Drainage swale along east side of property has not been installed.

Gravel equipment located where drainage swale is to be constructed.

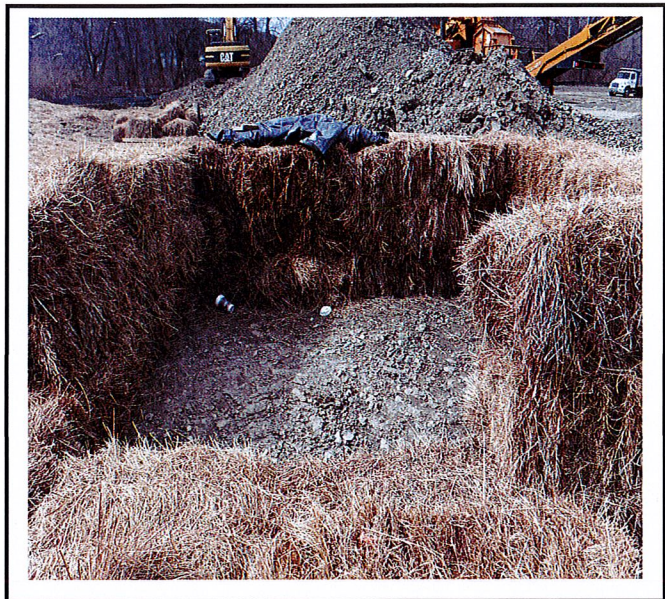
-Concrete washout is not lined. No trucks have washed out into it yet though.

Concrete washout does not have liner.

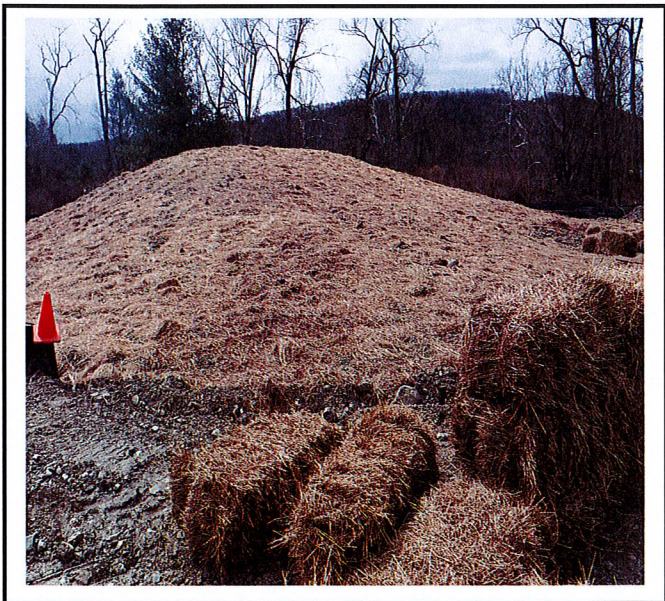
Soil topsoil pile seeded and mulched.
