**Chemung County Stormwater
Construction Inspection
Erosion and Sediment Control**

Project Name Fairport Ridge	Date 5-21-20
Location Prospect Hill Rd Horseheads, NY	Permit # NYR11B689
Weather Conditions Overcast	Entry Time: 1:00 pm
On-Site Representative Present:	Exit Time: 1:17 pm

PROJECT: Fairport Ridge
Town of Horseheads
Municipal Inspection
May 21, 2020

BY: Jessica Verrigni, CPESC, CPSWQ

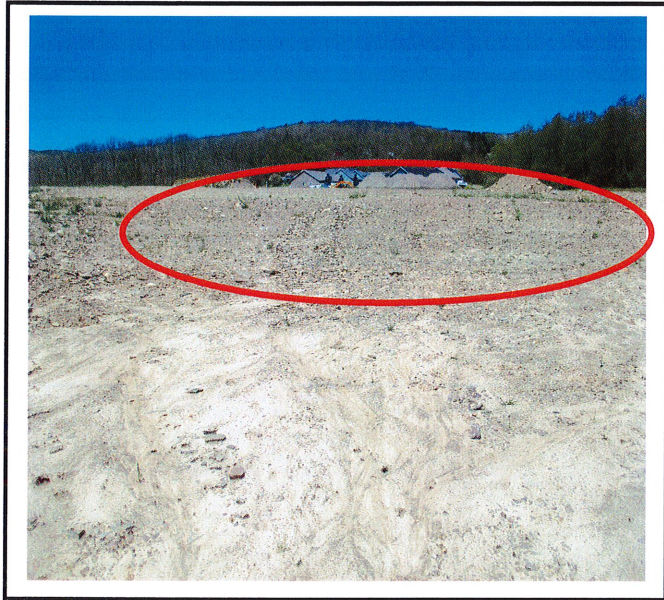
Erosion of the basin side slopes are causing sediment to gather on the floor of the basin. Stabilization is needed.

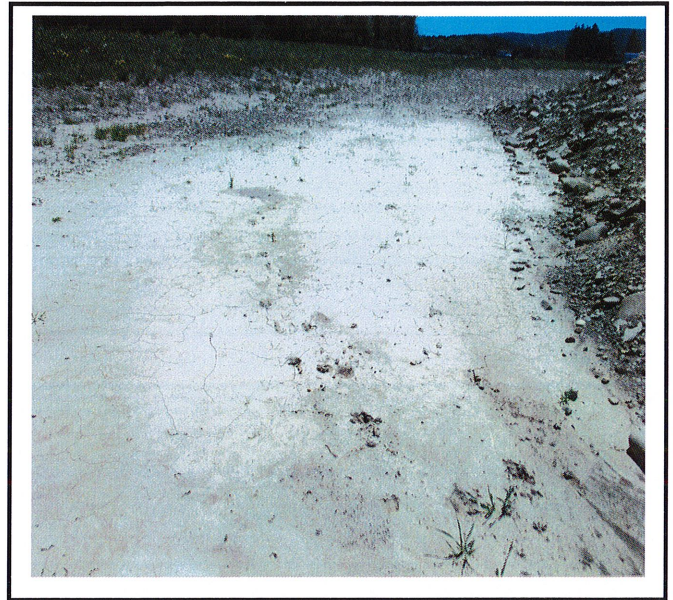
Sediment build up from eroded slopes.

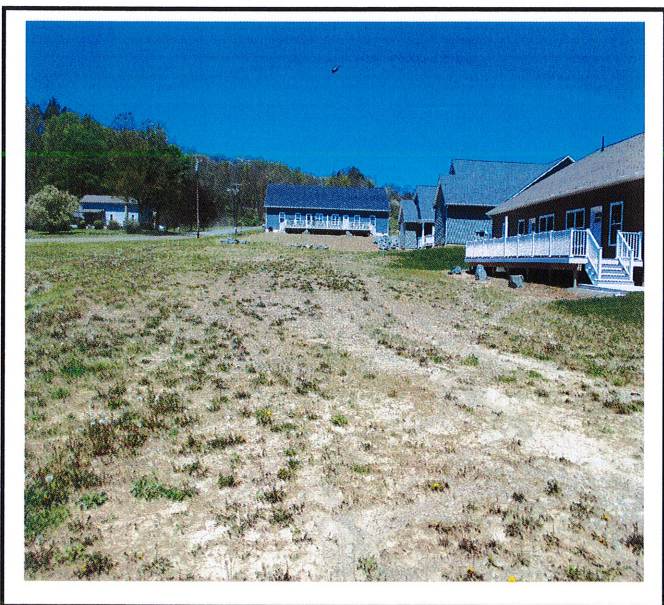
Stabilization of these areas is needed. The soil is heavily compacted and decompaction may be necessary to accomplish 80% cover.

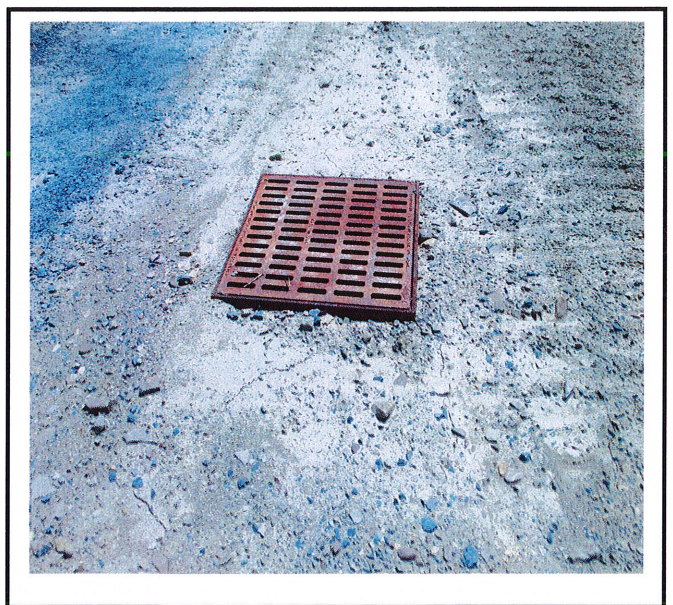
Catch basins at grade in open exposed soil areas require inlet protection.
