**Chemung County Stormwater  
Construction Inspection  
Erosion and Sediment Control**

<b>Project Name</b> Hunter's Run Subdivision	<b>Date</b> 3-18-2020
<b>Location</b> Hunter's Run, Horeseheads (T), NY	<b>Permit #</b> NYR11F984
<b>Weather Conditions</b> overcast, mild	<b>Entry Time:</b> 2:10 pm
<b>On-Site Representative Present:</b> none	<b>Exit Time:</b> 2:20 pm

**PROJECT:** Hunter's Run  
Town of Horseheads  
Municipal Inspection  
March 18, 2020

**BY:** Jessica Verrigni, CPESC, CPSWQ

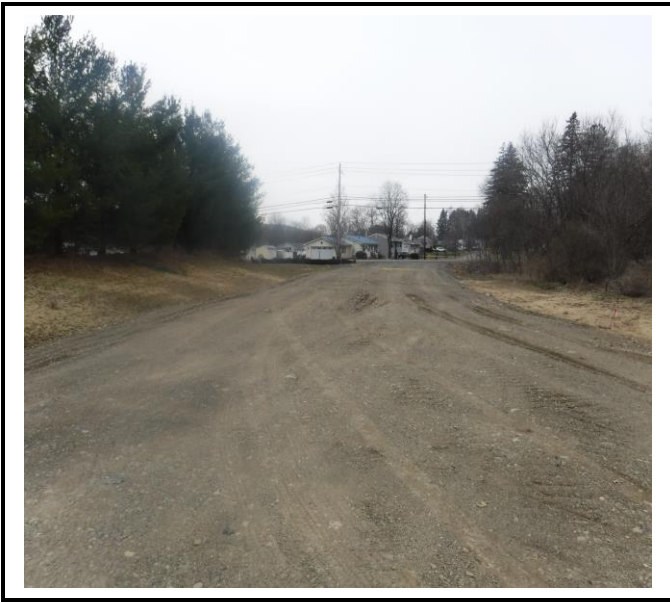
Construction entrance is working order.

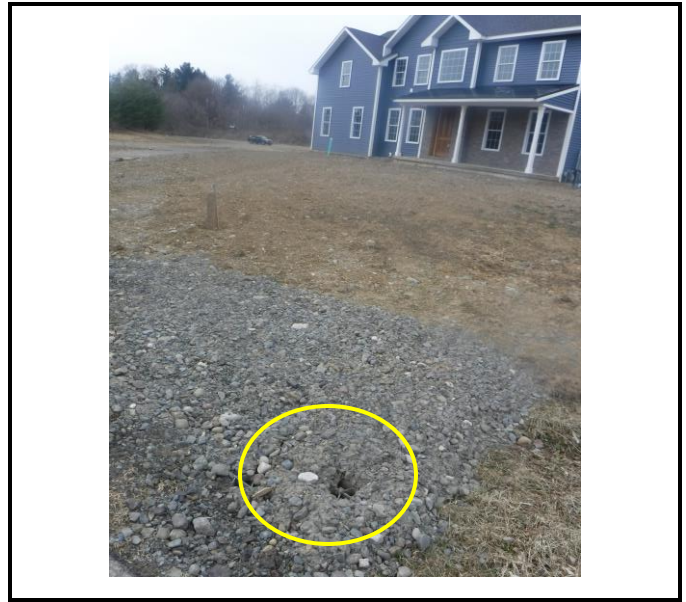
House lot that is under construction needs stabilization. The catch basin at the front of the house has been buried in stone.

Corrections Needed:			
-Catch basin in front of the house under construction is buried by stone. You can barely make out that a drainage structure is located here. The stone material covering catch basin needs to be removed, the drainage structure needs to be inspected and cleaned out to ensure it is functioning and drop inlet protections are to be added.			
-Stabilization of soil around the house that is constructed is required. Whether it is temporary or permanent, it is needed.

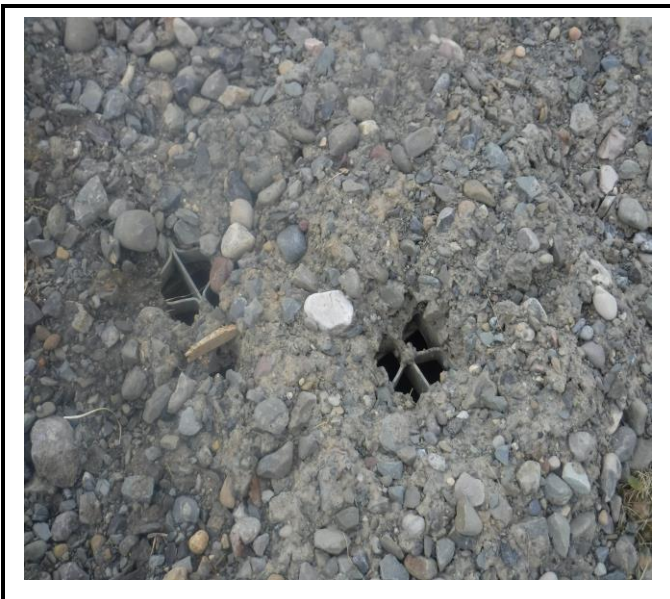
Only a small portion of this drainage structure is seen. Stone needs to be removed and proper inlet protection is to be installed.

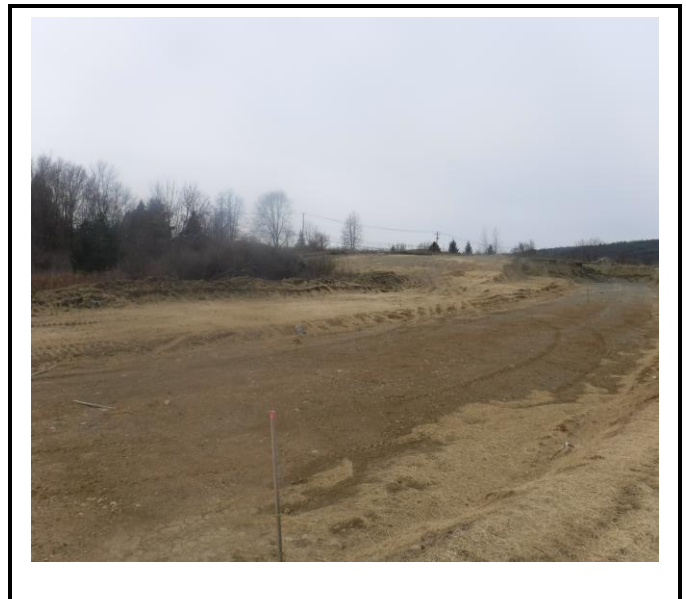
All open soil, except the house, has been stabilized.
