**Chemung County Stormwater  
Construction Inspection  
Erosion and Sediment Control**

<b>Project Name</b> Hunter's Run	<b>Date</b> 10-25-2021
<b>Location</b> Steeple Chase Horseheads, NY	<b>Permit #</b> NYR11F984
<b>Weather Conditions</b> sunny, cool	<b>Entry Time:</b> 10:50 am
<b>On-Site Representative Present:</b> None	<b>Exit Time:</b> 11:06 am

**PROJECT:** Hunter's Run  
Town of Horseheads  
Municipal Inspection  
October 25, 2021

**BY:** Jessica Verrigni, CPESC, CPSWQ

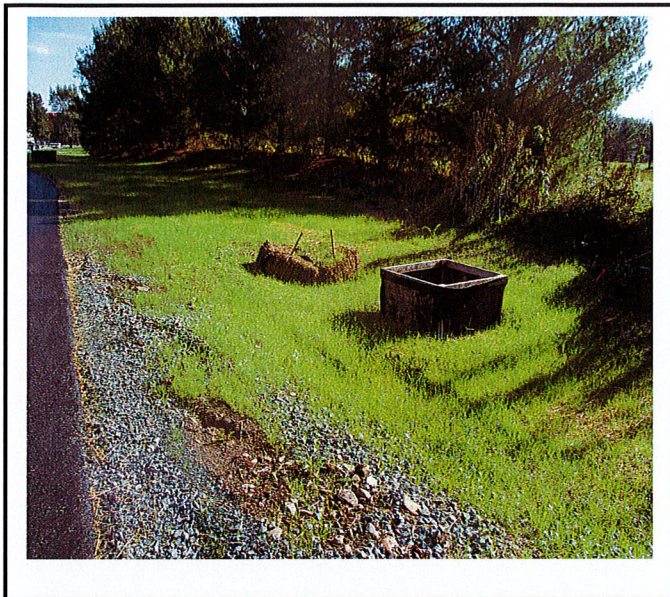
-Storm sewer that is supposed to be attached to ST-10E is daylighted and not installed into the structure. Why was it installed this way?

Storm sewer daylights where it should not. Straw bales in a concentrated flow is not an accepted practice.

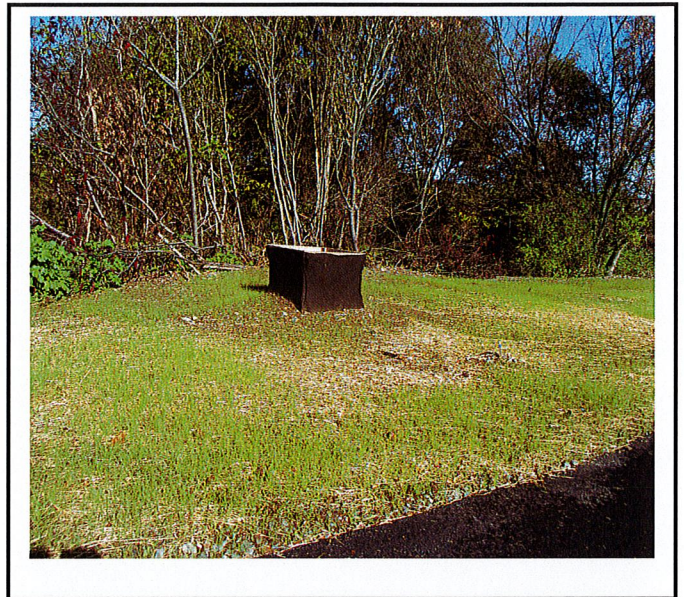
-Grading of areas around drainage structures including the grading of ST-10B will need to be checked. ST-10B appears to sit high above the road.

STA-10B- Structure sits so much higher than the road how will water make its way into the structure?

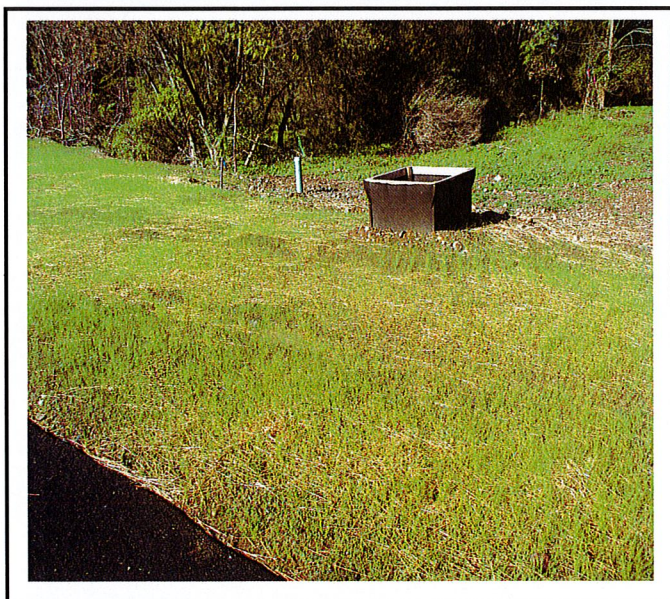
-Some stormwater drainage structures are supposed to have concrete aprons installed to promote drainage from the road. These aprons have not been installed yet.

A number of stormwater structures are missing the concrete apron that directs water to drain to them.

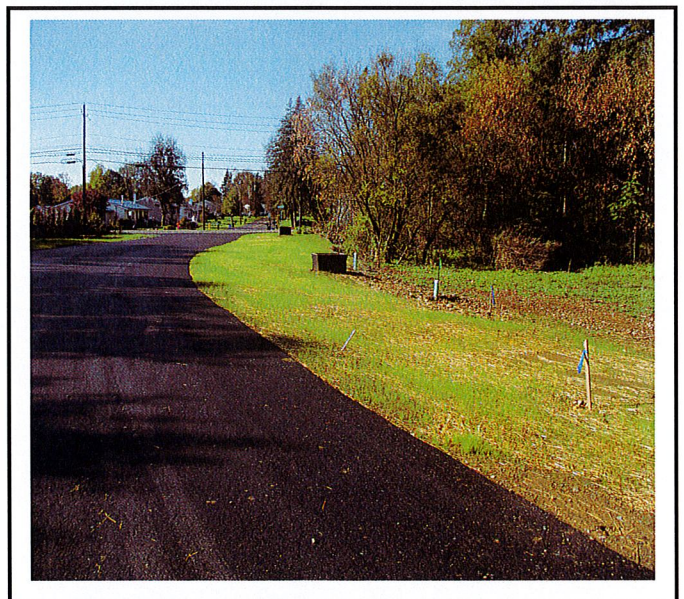
Open areas have been seeded and mulched and are growing grass.
