Project Name UHAUL		Date 4-13-17
Location State Route 14 Horseheads, NY		Permit #NYR11A438
Weather Conditions Sunny		Entry Time: 9:56
On-Site Representative Present: L. Crooker, Welliver D. Reynolds, Edger		Exit Time: 10:48
Construction Site Notes:		
-parking lot grading and inside building work occurring at site.		
REMINDER		
Contractor is responsible for walking the site daily to ensure swppp compliance.		
Yes	No	N/A
	X	All erosion and sediment control measures installed/constructed
	X	All erosion and sediment control measures maintained properly
	X	Are there currently more than 5 acres disturbed w/o prior approval
	X	Have stabilization measures been initiated in inactive areas
X		Are permanent stormwater control measures being implemented
	X	Was there a discharge into the receiving water on the day of inspection
	X	Evidence of turbidity or oil in the receiving waters
X		Are weekly inspections being performed?

PROJECT:	UHaul
	Town of Horseheads
	Municipal inspection
	April 13, 2017
BY:	Jessica Verrigni, CPESC, CPSWQ

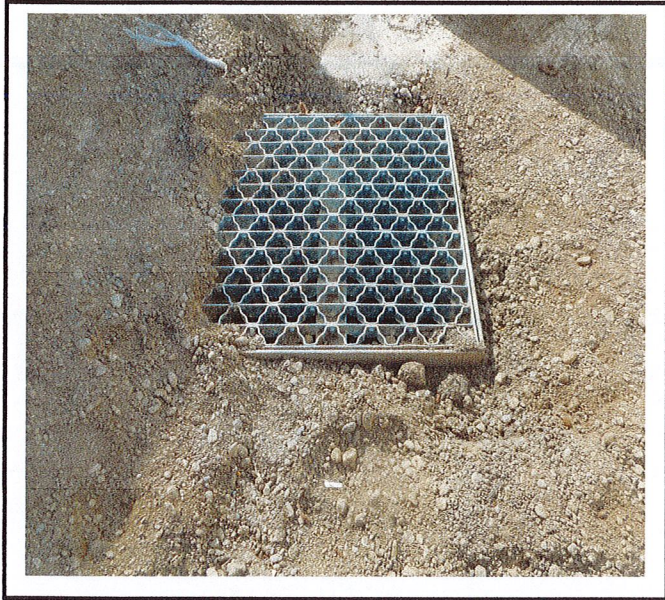
6 drop inlet structures have no protection. Grade is being brought up and the material is going into basin.

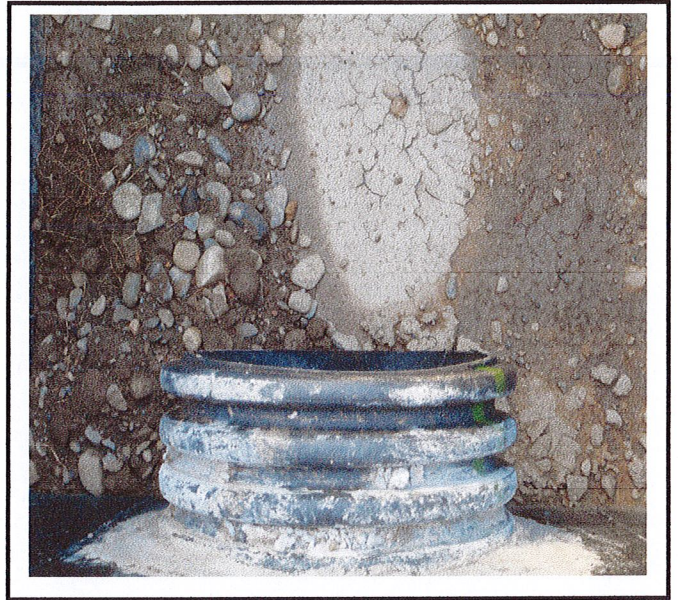
This is what the inside of them look like.

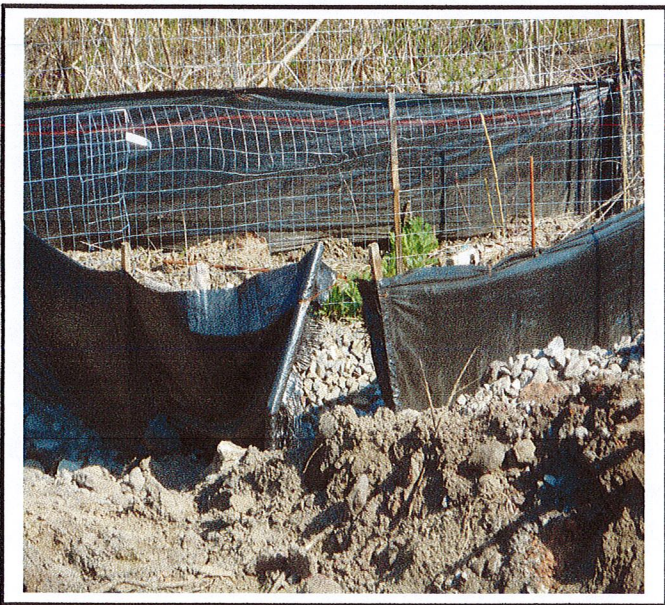
Silt fence requires maintenance in many places.

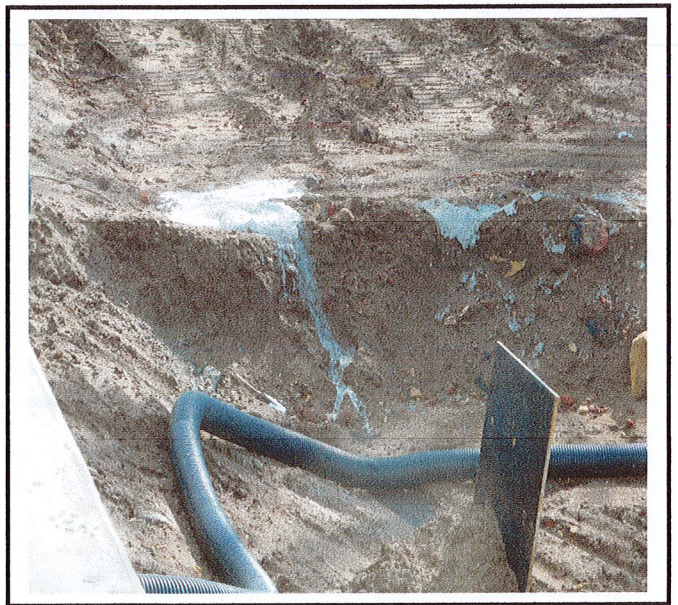
Concrete washed all over project due to lack of washout area.

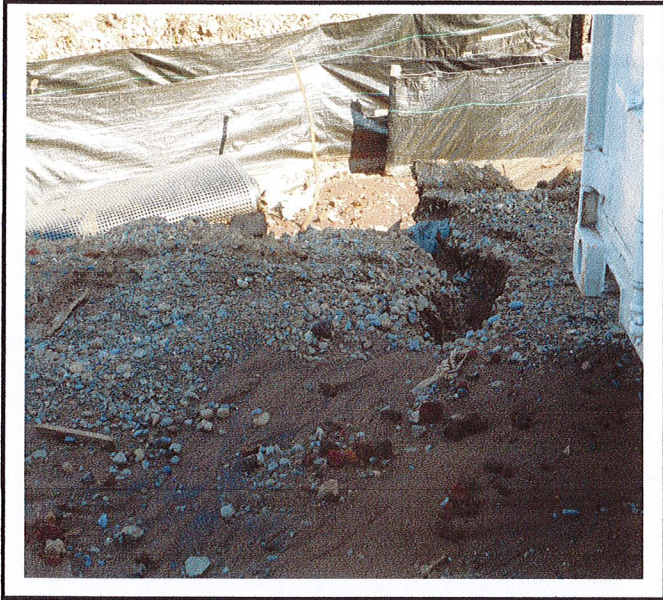
Contractor flow tested hydrant onto ground and cause major erosion.

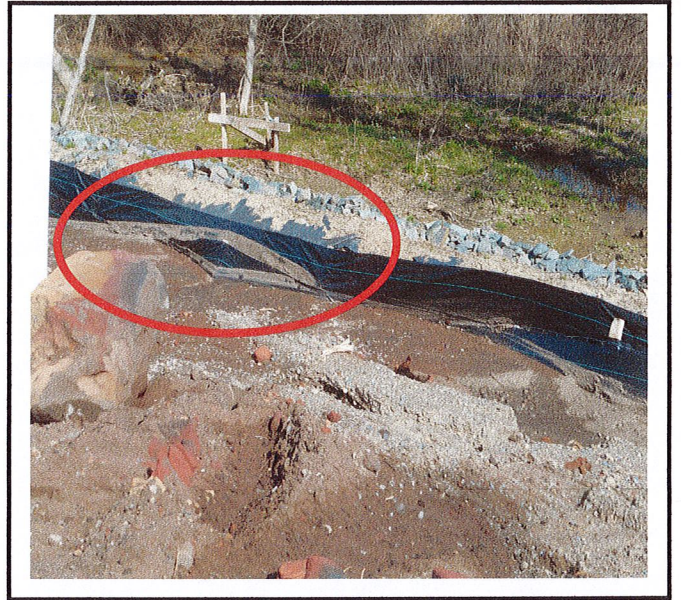
You can see sediment from flow test buried first row of silt fence and came close to going over second fence into stream.

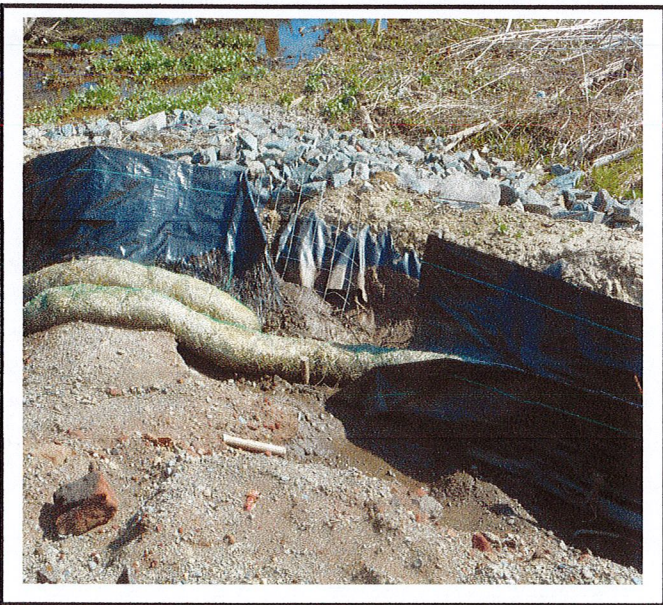
Lack of maintenance

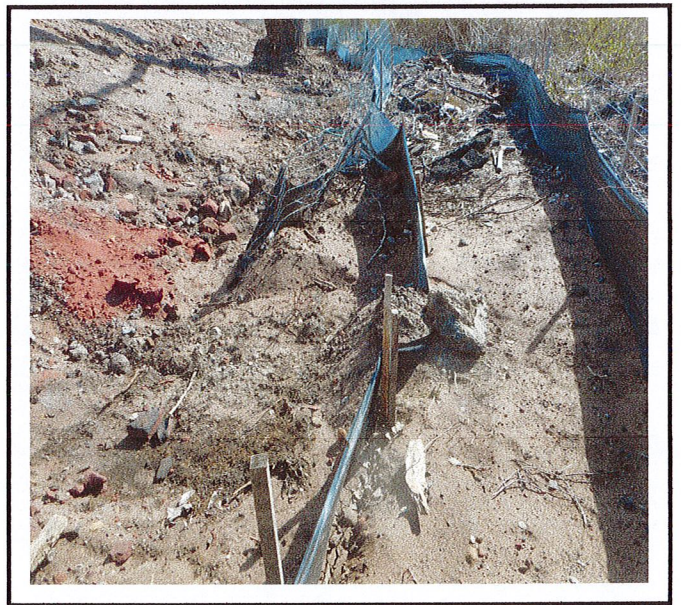
Lack of maintenance

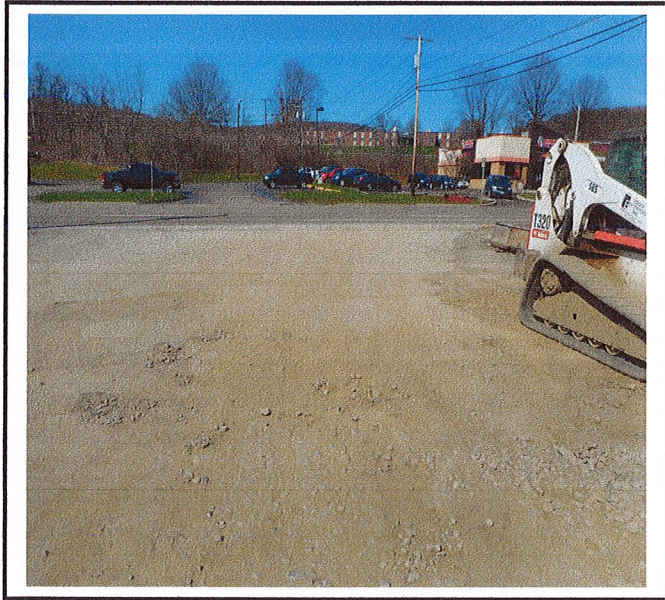
Entrance will require maintenance before tracking onto road occurs.

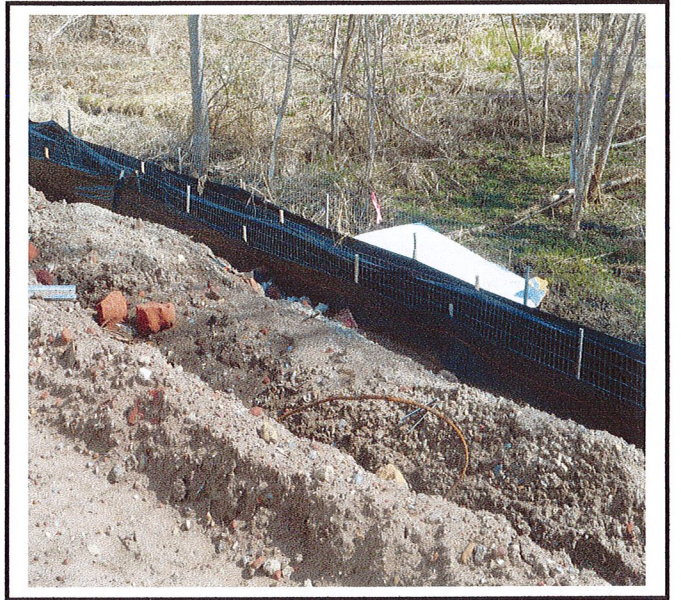
Construction garbage/debris needs to be stored properly. There are a few areas where it is outside of the project area.

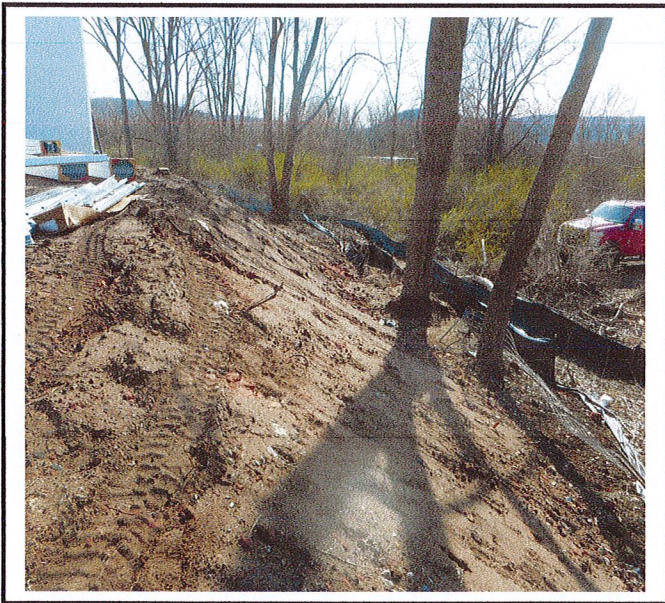
Soil has been bare longer than 14 days on all slopes surrounding project.
