**Chemung County Stormwater
Construction Inspection
Erosion and Sediment Control**

Project Name Dollar General	Date 10-15-19
Location Pennsylvania Ave- Southport	Permit # NYR11F148
Weather Conditions sunny	Entry Time: 10:51 am
On-Site Representative Present: Frank- L. Squared Construction	Exit Time: 12:05 pm

PROJECT: Dollar General Southport
 Town of Southport
 Municipal Inspection
 October 15, 2019

BY: Jessica Verrigni, CPESC, CPSWQ

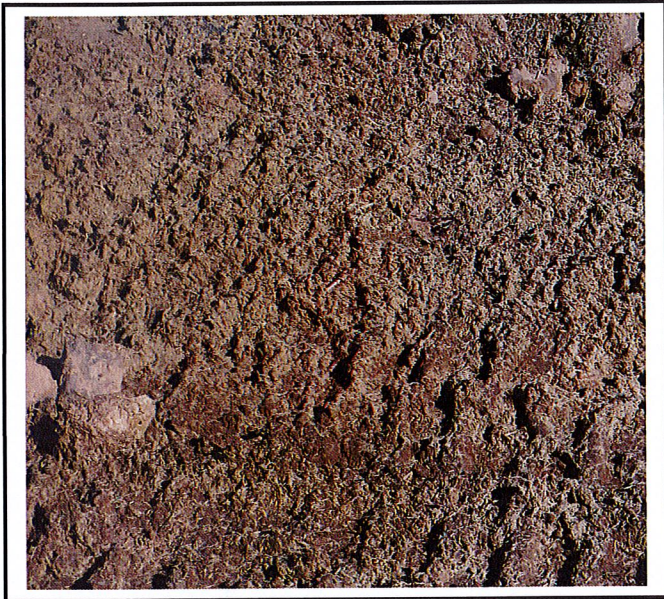
Hydroseeding that was sprayed does not provide the soil coverage required. The soil is to be protected. In this photo you see more soil than mulch.

Corrections Needed: -Site has been hydroseeded but the amount of mulch doesn't meet mulching standard. Too much soil is exposed.

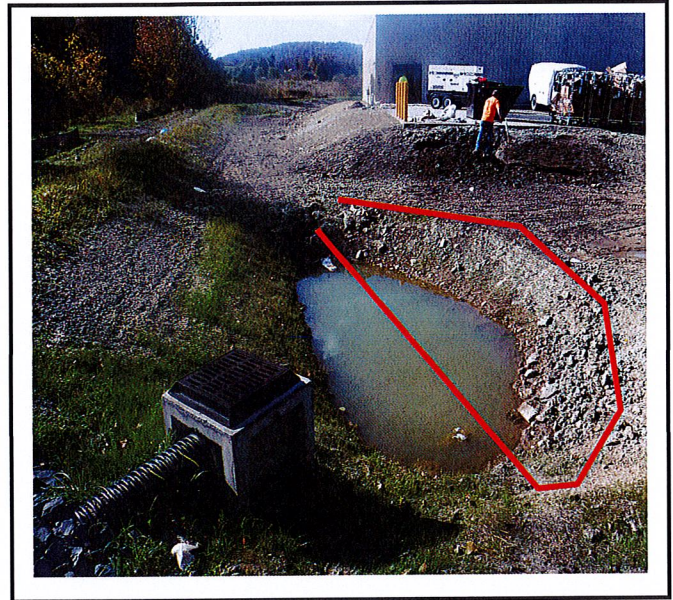
Erosion control blanket does not appear was installed in this area. Electricians digging in side slope of wetland, who will repair and regrade this?

-Erosion control blanket in the 3 deep pools of the wetland has issues. There are areas not stapled and falling in the water, areas where blanket was not placed, and areas where it is rolled up from not being installed correctly.

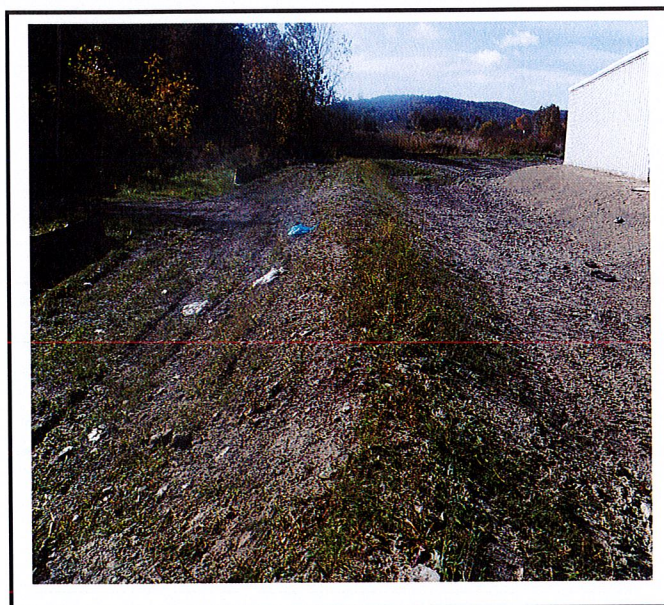
Trash and debris is blowing all around the site.

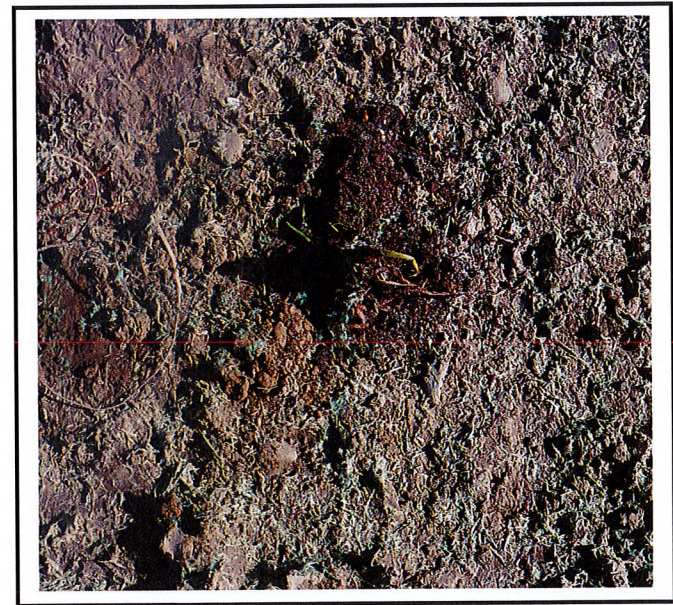
Wetland planting lying on top of ground and not planted. Also note hydroseeding mulch sparse.

-Wetland plants are hard to find and some are just laying on top of the ground. Marking them would make easier to locate and ensure they were installed correctly.

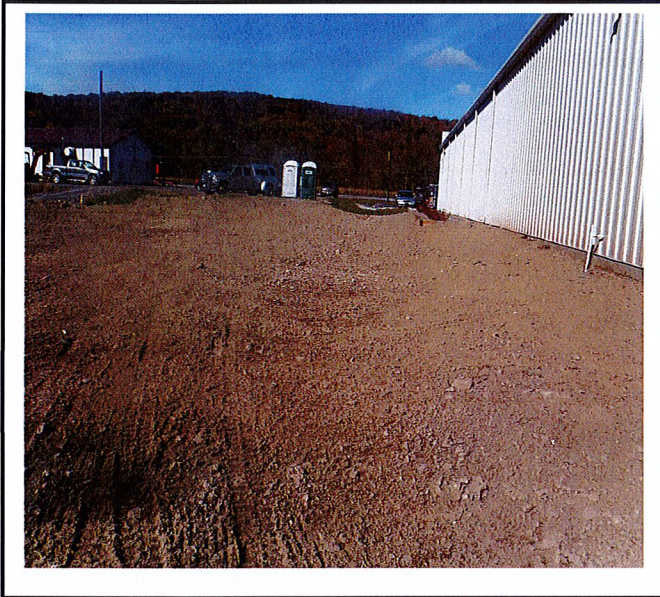
Areas where rocks were not picked out and fine grading did not happen. Hydroseeding does not meet mulching requirement.

-Decompaction/soil restoration doesn't appear to have been completed. The ground is severely compacted on the South end of property. Also, the areas still have large clumps of soil and rocks which will make mowing impossible.

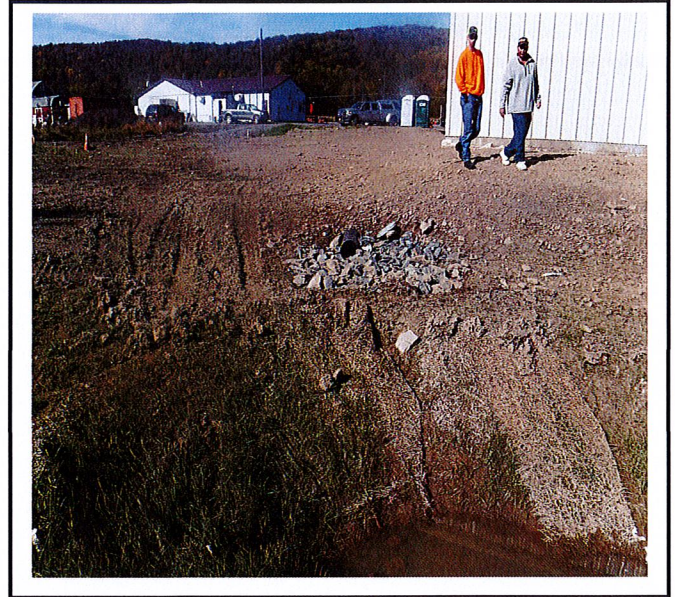
Animal guard not installed on end of 8 in. pipe.
Erosion control blanket not installed correctly because it is not stapled down.

-Tree planter box- the downspouts are not connected to it. The 8" outlet pipe doesn't have the animal guard.

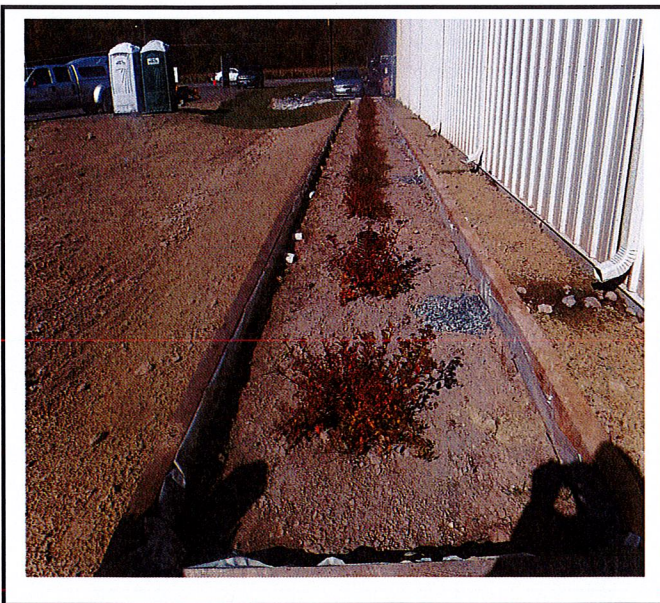
Downspouts are to be connected to the tree planter box.
