**Chemung County Stormwater
Construction Inspection
Erosion and Sediment Control**

Project Name Villa's at Gardner Road	Date 5-30-2019
Location Off Lyndhurst Drive Horseheads, NY	Permit # NYR11A108
Weather Conditions overcast, mild	Entry Time: 10:57 am
On-Site Representative Present: none	Exit Time: 11:10 am

PROJECT:	Villa's at Gardner Road Village of Horseheads Municipal Construction Inspection May 30, 2019
BY:	Jessica Verrigni, CPESC, CPSWQ

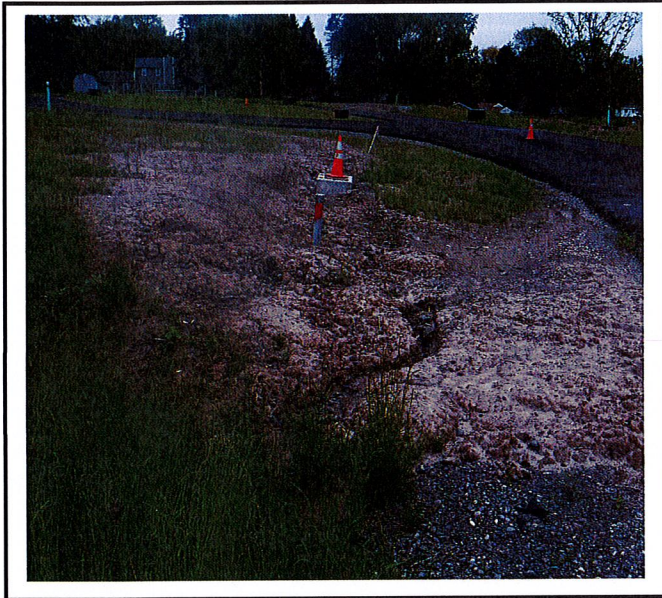
Erosion is occurring in all areas not properly stabilized.

Corrections Needed:
-Major erosion is still occurring at CB-3. This situation is not improving and requires correction.
-Many areas where there is bare open soil are now eroding. That soil is being carried to the stormwater system which will need to be cleaned out if this continues much longer.
-The slope behind lots 7,8 and 9 has been protected with an erosion control blanket, which is good. However no vegetation is growing under the blanket. Note-Vegetation needs to be established here before the blanket biodegrades.
-Outlet protection has not been installed on the pipe outleting into the stormwater forebay.
-Drainage swale leading to the stormwater forebay is majorly eroded. This requires repair and all sediment will need to be removed from the stormwater forebay.
-Prior to any construction starting the silt fence will need to be removed and replaced. Silt fence has a 1 year life span and this has been up much longer than that.

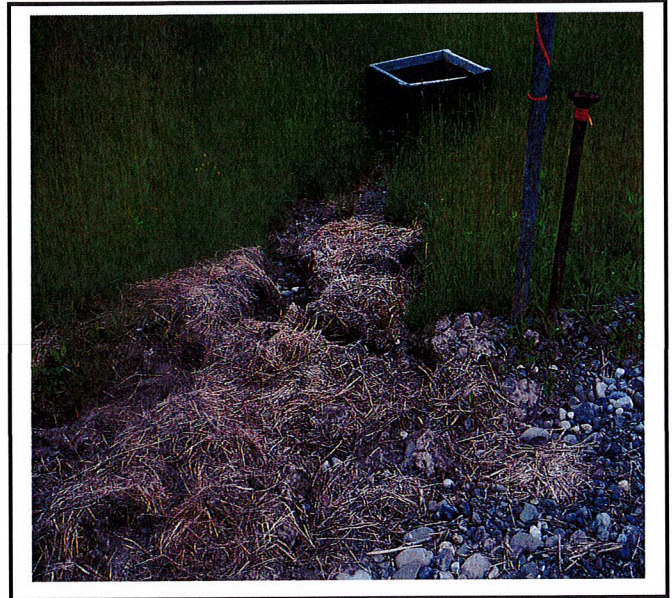
CB 3- Erosion has been occurring here for months. It is not improving but getting worse. Correction is required.

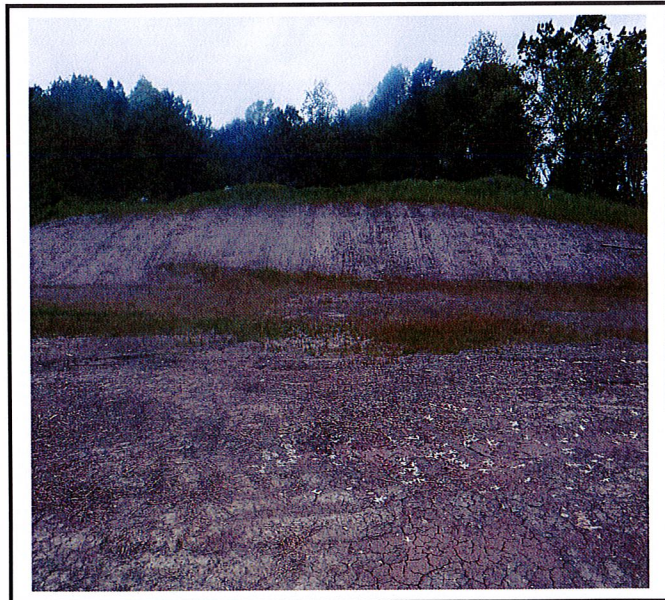
This slope has been stabilized with erosion control blanket but the vegetation is not growing. This slope needs to have grass growing on it because these blankets will biodegrade over time.

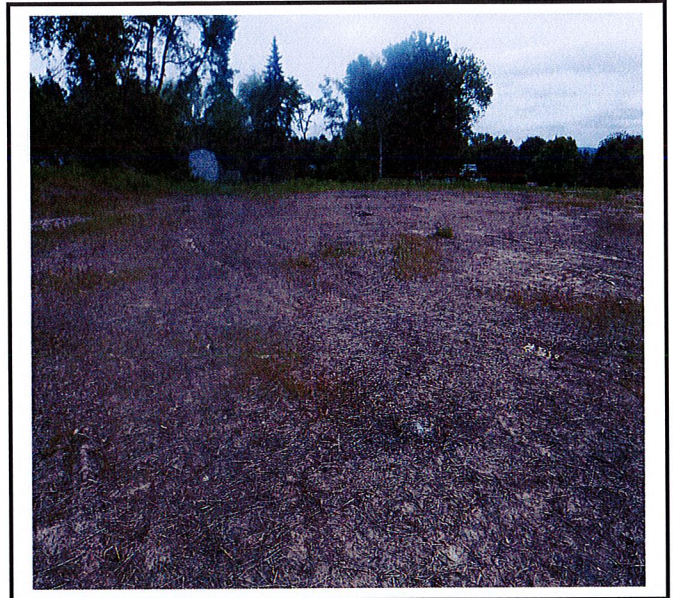
Many areas that were stabilized last fall are not growing grass and mulch is no longer there. These areas need to be re-stabilized.

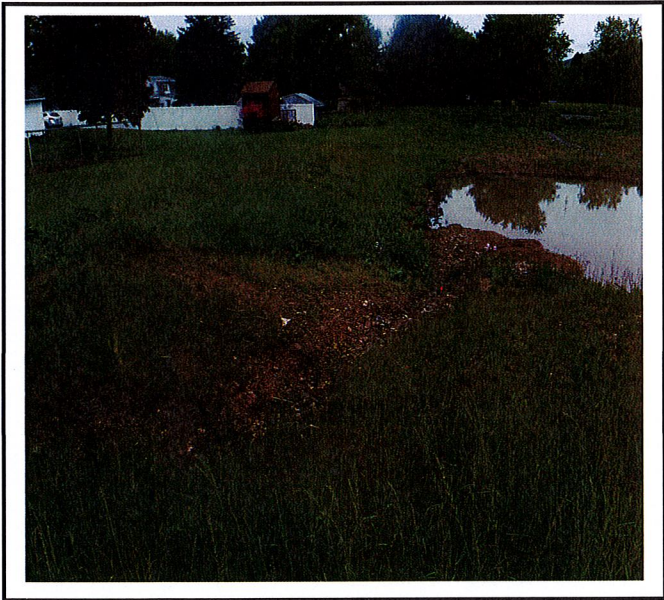
Erosion in drainage swale down to stormwater basin. This erosion needs to be repaired and all of the sediment in forebay needs to be removed.

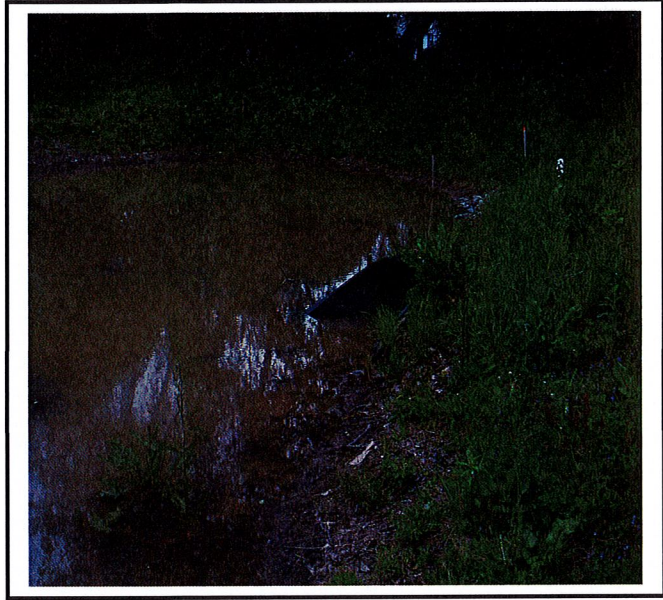
Rock outlet protection not installed on the end of this pipe.
