**Chemung County Stormwater
Construction Inspection
Erosion and Sediment Control**

Project Name Villa's at Gardner Road	Date 5-18-20
Location Lynhurst Ave Horseheads (V), NY	Permit # NYR11P662
Weather Conditions Overcast	Entry Time: 1:38 pm
On-Site Representative Present:	Exit Time: 1:47 pm

PROJECT: Villa's at Gardener Road
Village of Horseheads
Municipal Inspection
May 18, 2020

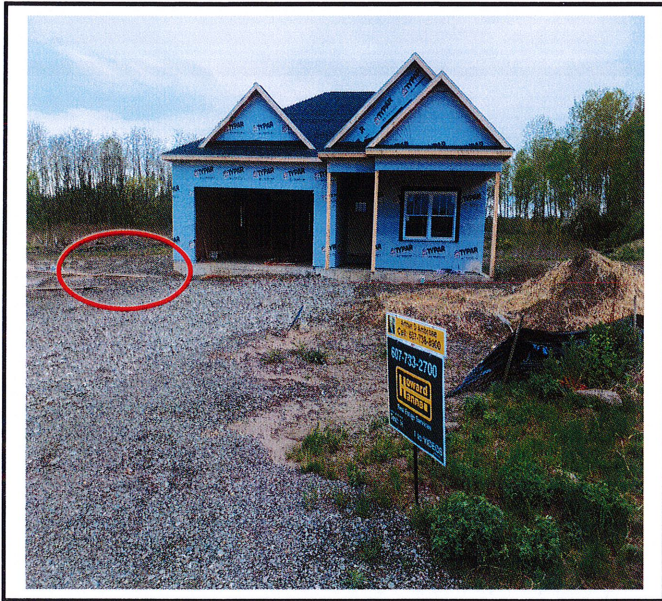
Bare soil requires stabilization.

-Soil stabilization is needed on all bare soil. There are many areas that have been stabilized but there is more needed. I have circled the locations in red on my photos. When soil is properly protected it should not move all over the site.

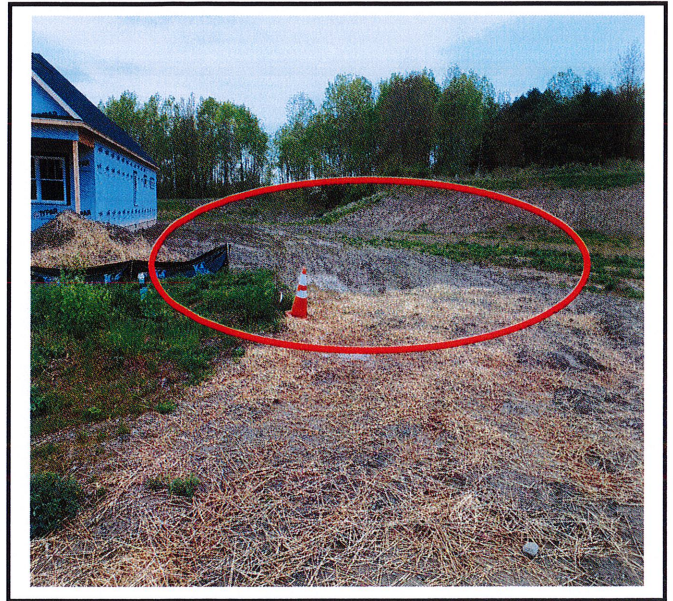
Bare soil requires stabilization.

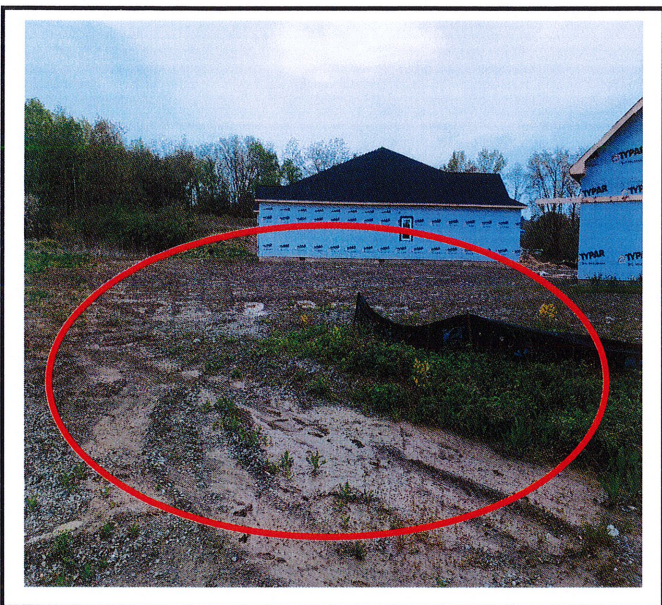
Bare soil requires stabilization. Silt fence should extend further in this area so that sediment does not leave lot.

-Silt fence needs repair on sections falling down and silt fence needs to be added to the rear of lot one to prevent sediment from leaving the lot.
