**Chemung County Stormwater  
Construction Inspection  
Erosion and Sediment Control**

<b>Project Name</b> Villa's at Gardner Road	<b>Date</b> 6/28/2021
<b>Location</b> Lynhurst Ave. Horseheads (V)	<b>Permit #</b> NYR11A108
<b>Weather Conditions</b> hot	<b>Entry Time:</b> 10:34 am
<b>On-Site Representative Present:</b> none	<b>Exit Time:</b> 10:42 am

**PROJECT:** Villa's at Gardner Road Lot #6  
Village of Horseheads  
Municipal Inspection  
June 28, 2021

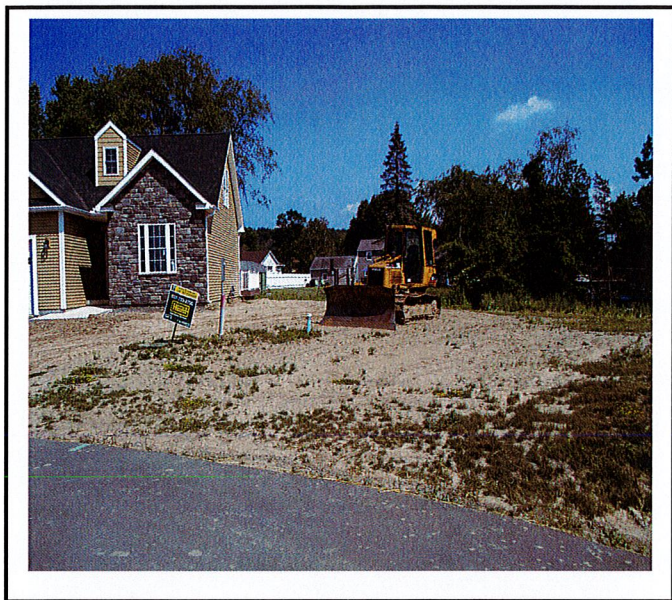
Open soil areas need to be stabilized. BEFORE final stabilization soil restoration and topsoiling is necessary

**Stabilization-** Lot #6 will require full soil restoration and topsoil prior to final stabilization. Soil needs to be protected from erosion.

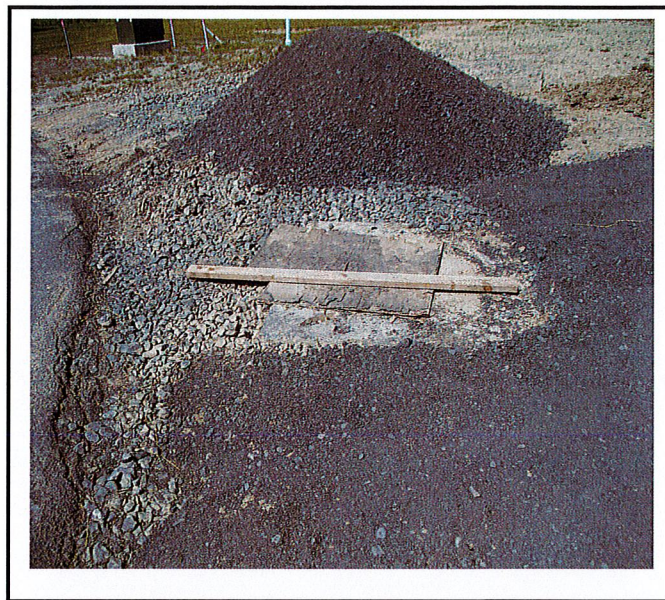
Catch basin is not protected from sediment runoff. DO NOT PAVE UNTIL HIGHWAY SUPERINTENDENT gives authorization.

**Catch Basin-** Lot #6 placed their driveway directly around an existing catch basin. Approval from the Village Highway Superintendent is required BEFORE paving is to occur.

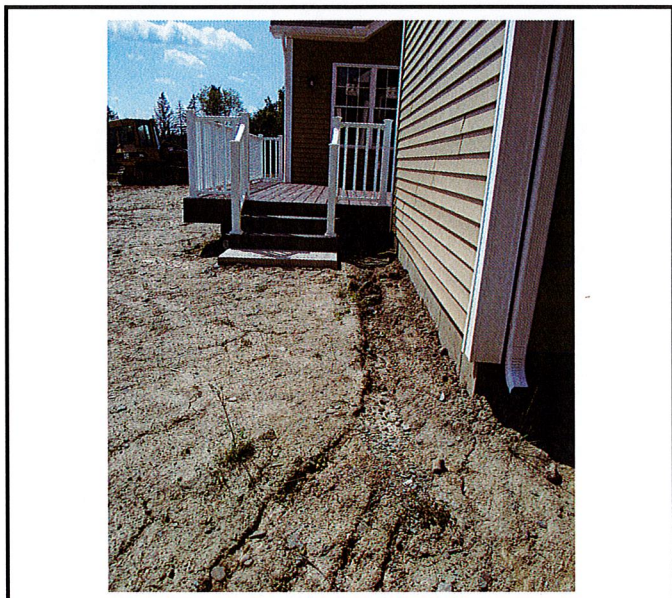
Roof gutters are causing erosion. Contractor will want to install splash pads to prevent erosion from continuing to occur.

**Roof Drains-** gutters on Lot #6 are causing erosion. These need to have flow diffusers or splash pads to stop the erosion from occurring.

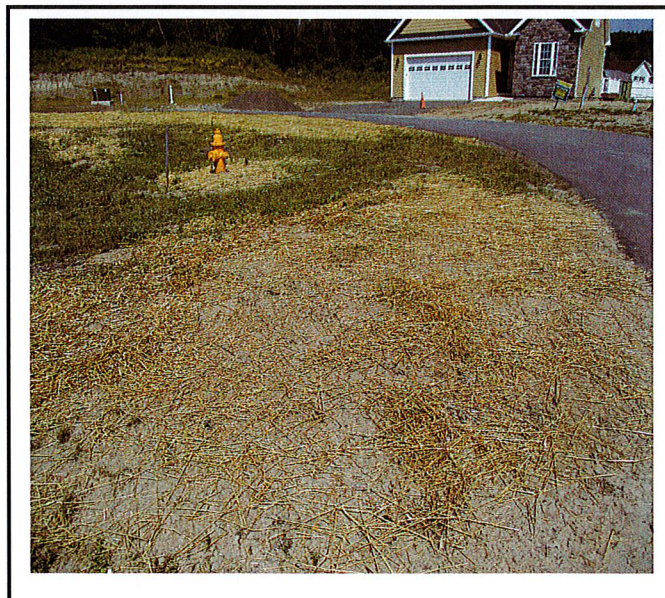
Some areas have been mulched while other areas have been left bare. See inspection report.

Common areas such as Cul De Sac and slope behind the lots are not stabilized appropriately. Severe erosion is occurring on rear slope. These areas need to be addressed immediately.
