**Chemung County Stormwater
Construction Inspection
Erosion and Sediment Control**

| Project Name Hilliard Warehouse Expansion | Date 6-2-2022 |
| Location College Ave, City of Elmira | Permit # NYR111586 |

PROJECT: Hilliard Warehouse
City of Elmira
Municipal Construction Insp.
June 2, 2022

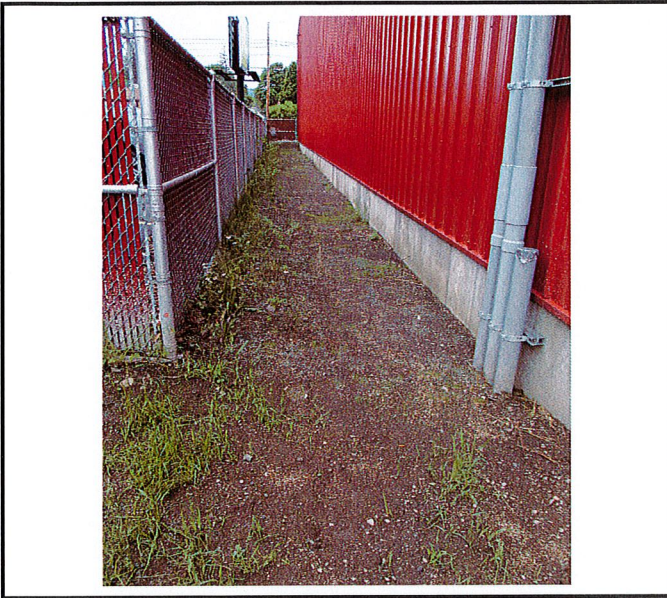
Area along south end of building requires soil stabilization. Soil needs to be covered with mulch.

| 1. Soil Stabilization along South end of the building is necessary. It is bare soil. The seeding that was done is inconsistent and may not get 80% vegetation (see photos). Soil is to be protected with mulch. |

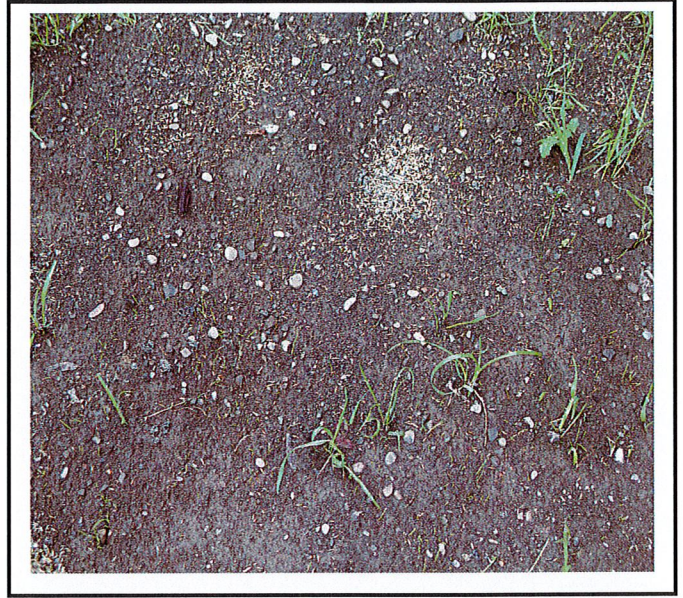
Seeding rate along south end of building will not establish 80% vegetative cover.

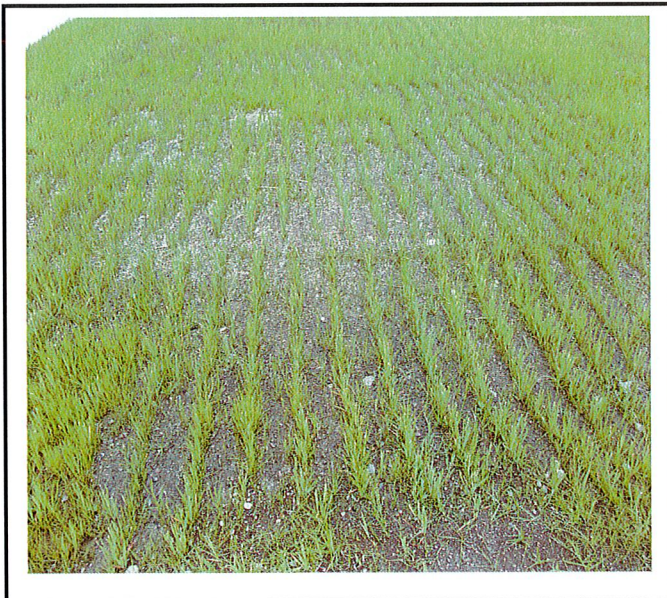
80% vegetation is not established. 80% cover you will barely be able to see soil.

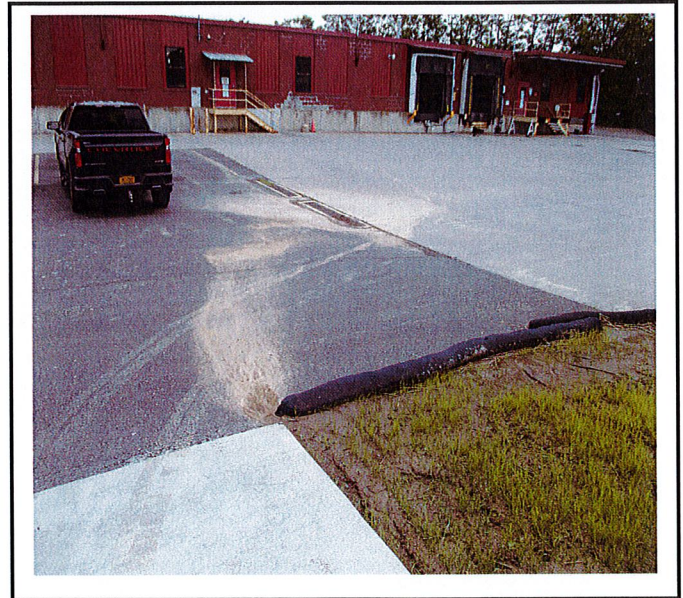
Sediment barrier needs to be wrapped up towards concrete to hold back sediment. Sediment filled trench drain in parking lot.

| 2. Erosion has occurred at the North end of the building. Compost sock needs to be placed so that sediment stays within its barrier (see photos). Eroded sediment has filled trench drain in parking lot. This drain needs to be cleaned out. |

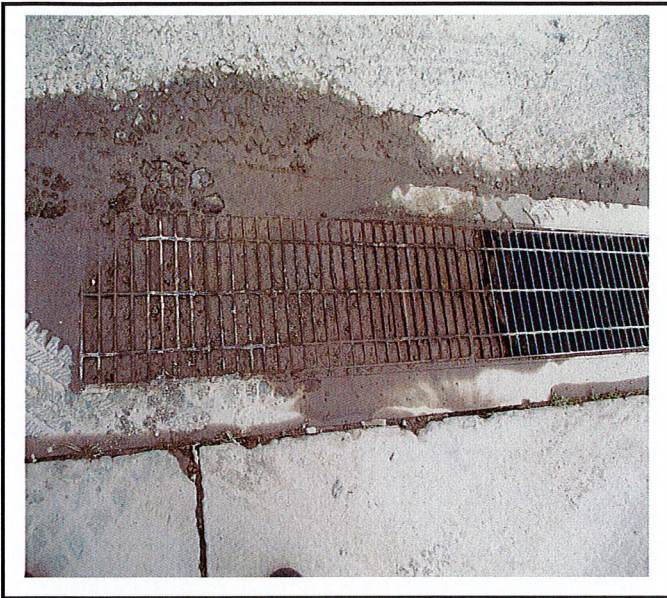
Trench drain in parking area is filled with sediment from project erosion/runoff.

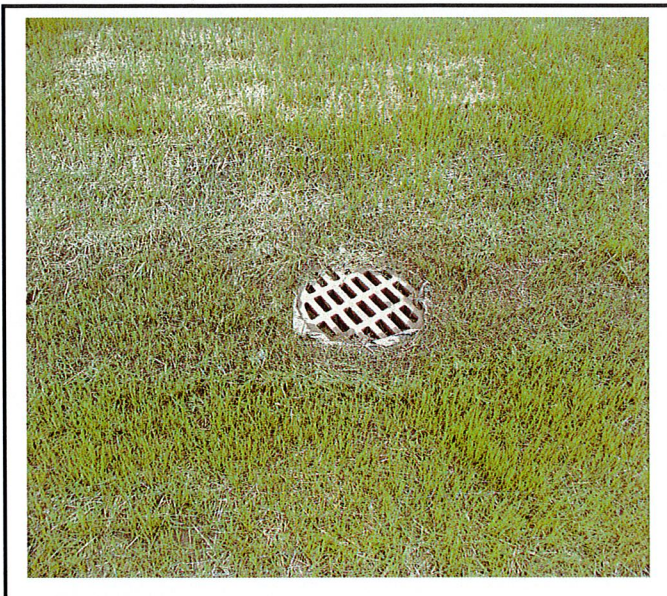
Sediment bag insert will need to be removed from the south dry well in swale along College Ave. once 80% vegetation is established.

| 3. Insert will need to be removed from the dry well at the south end of the swale along College Ave. when 80% vegetation is achieved. |
