**Chemung County Stormwater
Construction Inspection
Erosion and Sediment Control**

Project Name Hilliard Warehouse	Date 6-28-2022
Location College Ave Elmira, NY	Permit # NYR111586
Weather Conditions	Entry Time: 9:54 am
On-Site Representative Present: None	Exit Time: 10:07 am

PROJECT: Hilliard Warehouse
City of Elmira
Municipal Inspection
June 28, 2022

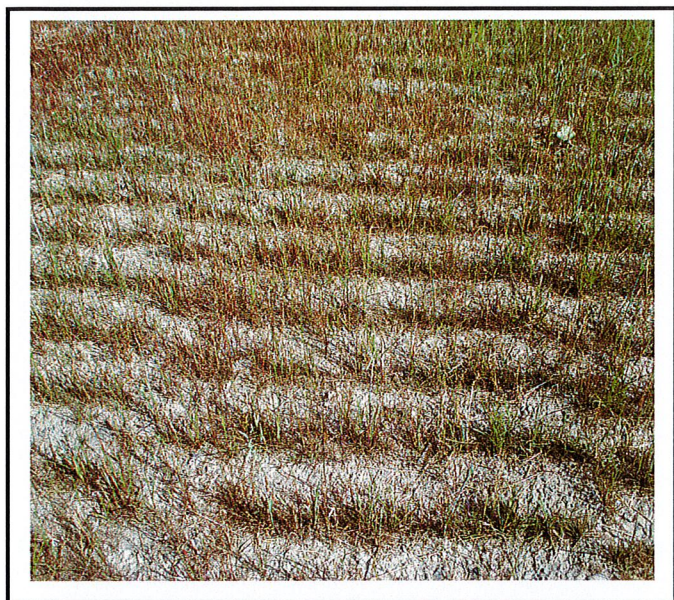
80% stabilization may not be achievable due to the compaction at the site.

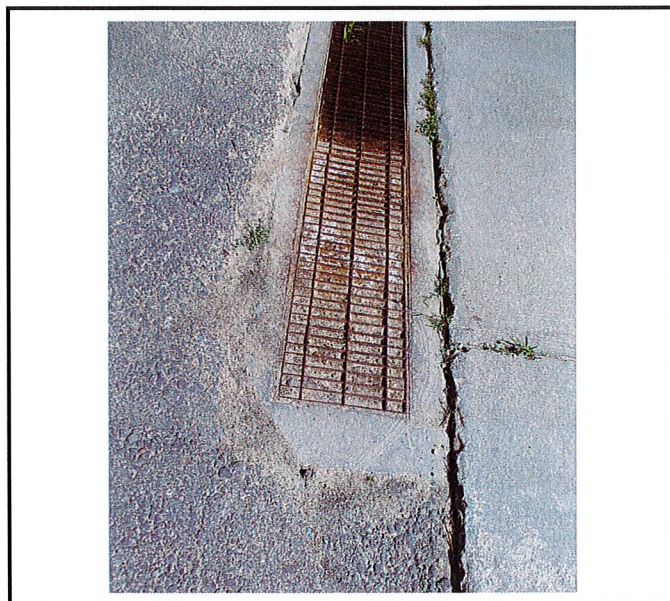
Sediment from erosion at new building has filled trench drain in parking area.

Corrections Needed:	
	-Project is completed and awaiting final stabilization. Not sure that site will make the 80% due to compaction.
	-Erosion at the North End of the new building needs to be corrected. Trench drain in the employee parking should be cleaned out.
	-South end of the building needs to be stabilized.
