**Chemung County Stormwater
Construction Inspection
Erosion and Sediment Control**

COUNTY OF CHEMUNG
Chemung County Stormwater Coalition
851 Chemung Street
Horseheads, New York 14825
Ph. 607.796.2216

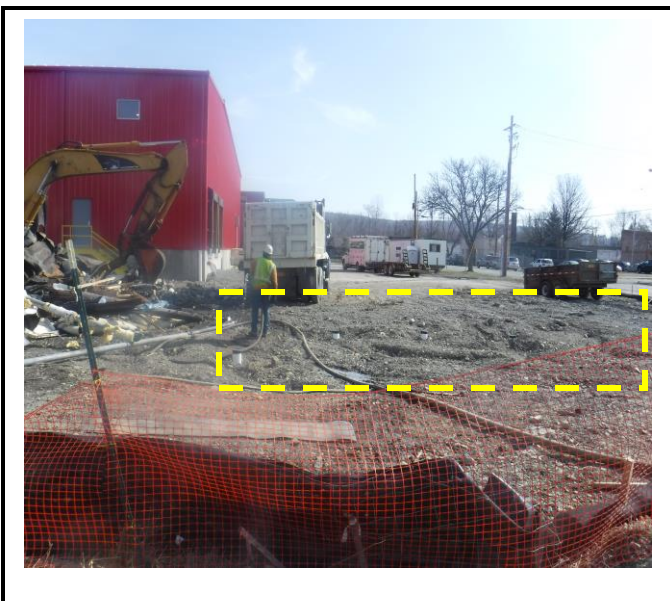
Dashed area represents the approximate location of the underground infiltration system. Dump truck hauling material out is directly on top of the system.

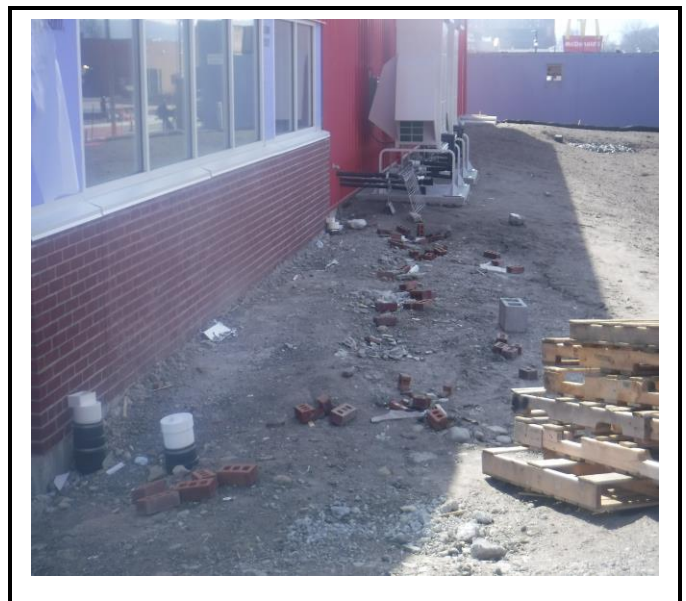
Building debris and trash is not being picked up on the site. A pollution prevention plan is part of the approved SWPPP and needs to be followed.
