**Chemung County Stormwater
Construction Inspection
Erosion and Sediment Control**

Project Name CDS Monarch Senior Living Facility	Date 6-26-18
Location Maple Ave. City of Elmira	Permit # NYR11C547
Weather Conditions Sunny, warm	Entry Time: 10:10
On-Site Representative Present: Jeff & Justin Bellinger, Christa	Exit Time: 10:28

PROJECT: CDS Monarch Senior Living
City of Elmira
Municipal Construction Inspection
June 26, 2018

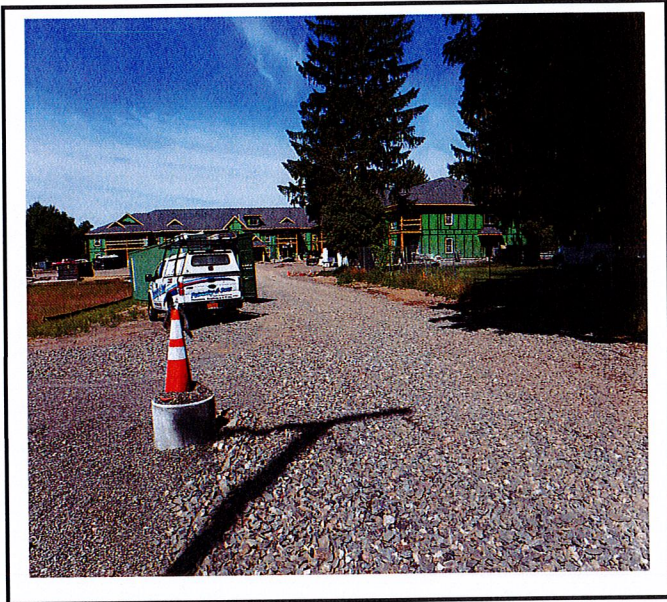
Construction entrance is in good shape.

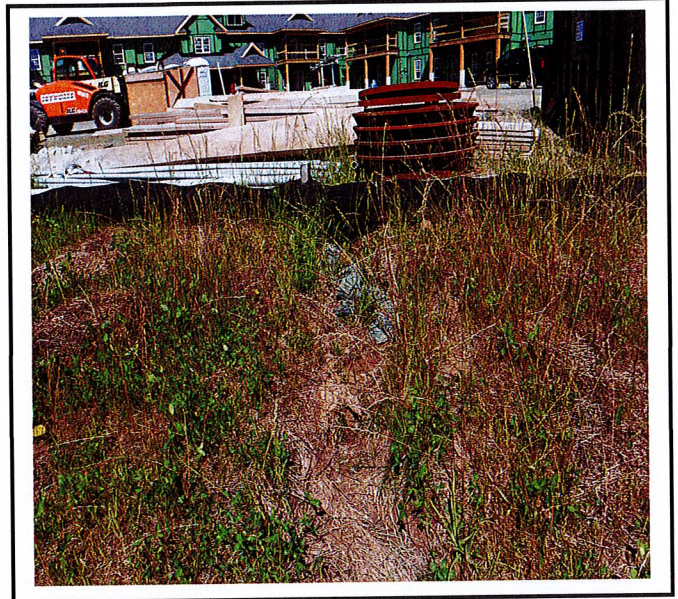
-Water is getting under the compost sock. Rock has been used to plug the eroded area but water is still causing issues.

Water is getting under compost sock. Rock has been placed in eroded area but water is still cutting around it.

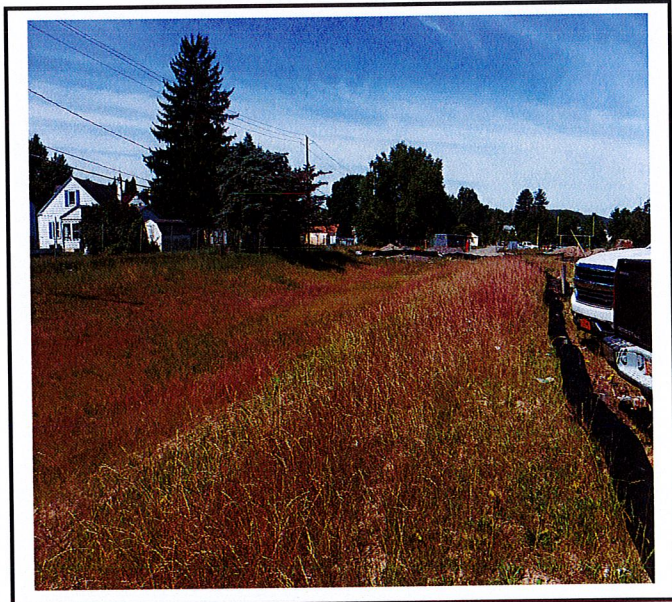
Infiltration basin has good grass cover.

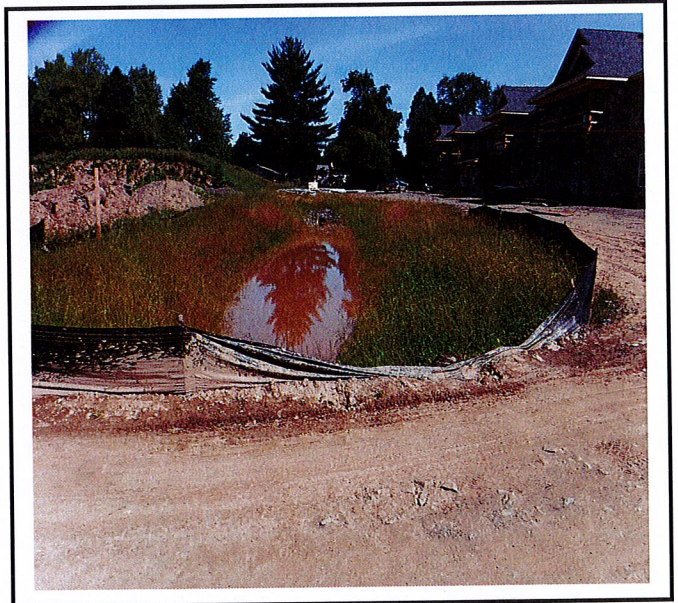
-Silt fence at rear entrance has been overwhelmed by sediment and water. The water has undercut the silt fence. Replacement is required.

Silt fence at rear entrance point has been overwhelmed by sediment and water. Water has undermined the fence. Fence needs replacement.

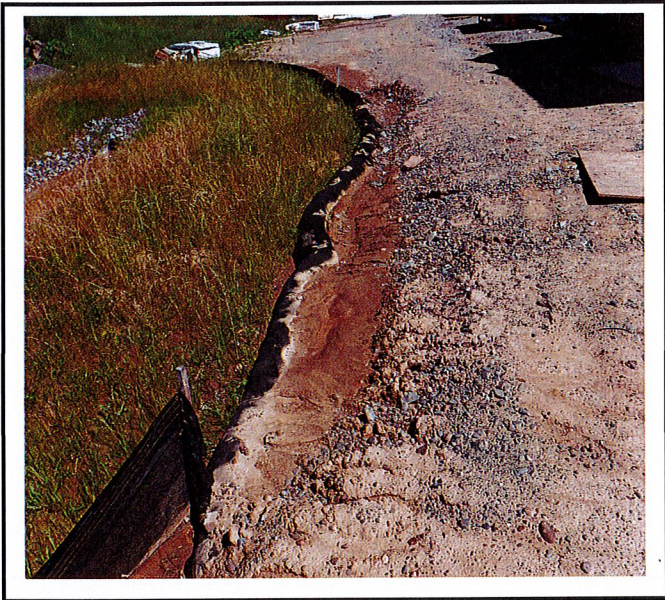
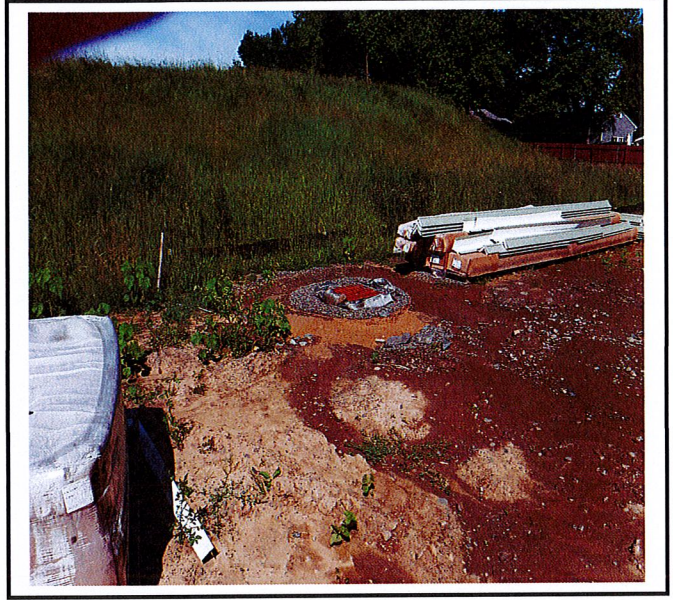
-Compost sock at the rear of the building is 100% filled with sediment and requires maintenance.

Compost sock at the rear of the building is over capacity and needs replacement or silt needs to be removed .
